May 10, 2024

Re: Mountain Valley Pipeline, LLC Request to Place Project Facilities in Service (CP16-10-000)

Coalition Letter to PHMSA re Mountain Valley Pipeline
Consent Order Quarterly Report

In compliance with Environmental Condition Nos. 8 and 14 of the Certificate Order, Mountain Valley submits its status report for April 6, 2024 through April 12, 2024.

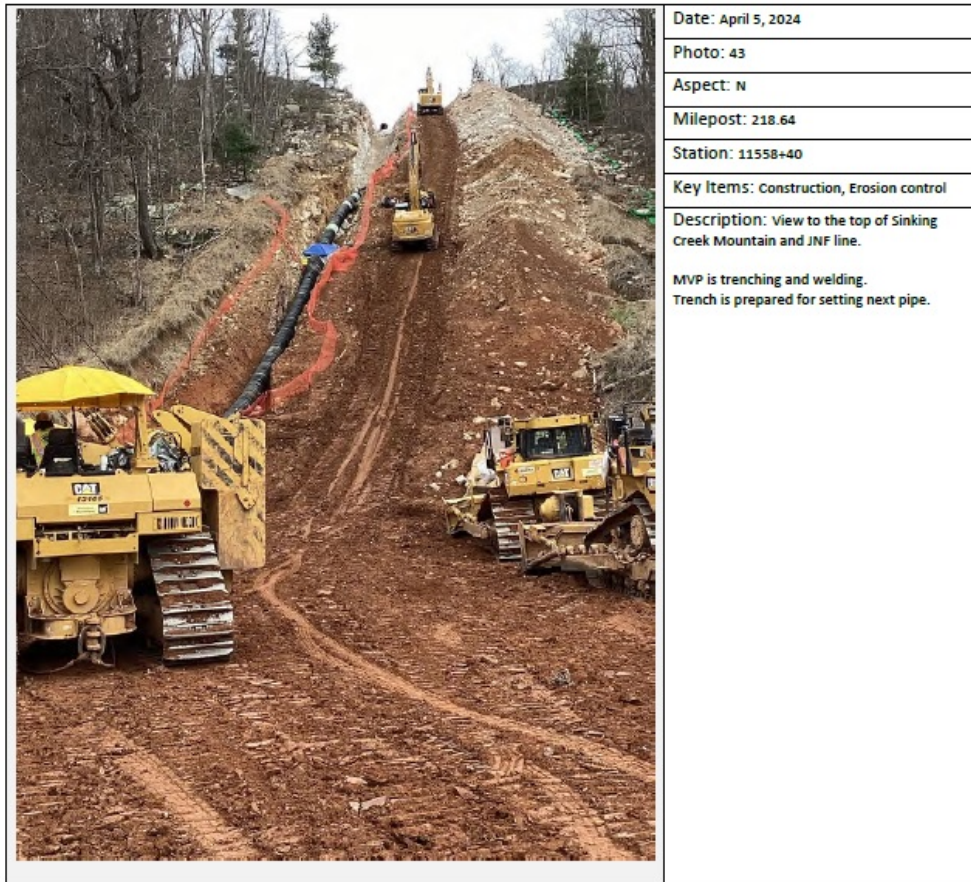
Date: April 5, 2024
Photo: 43
Aspect: N
Milepost: 218.64
Station: 11558+40
Key Items: Construction, Erosion control
Description: View to the top of Sinking Creek Mountain and JNF line. MVP is trenching and welding. Trench is prepared for setting next pipe.

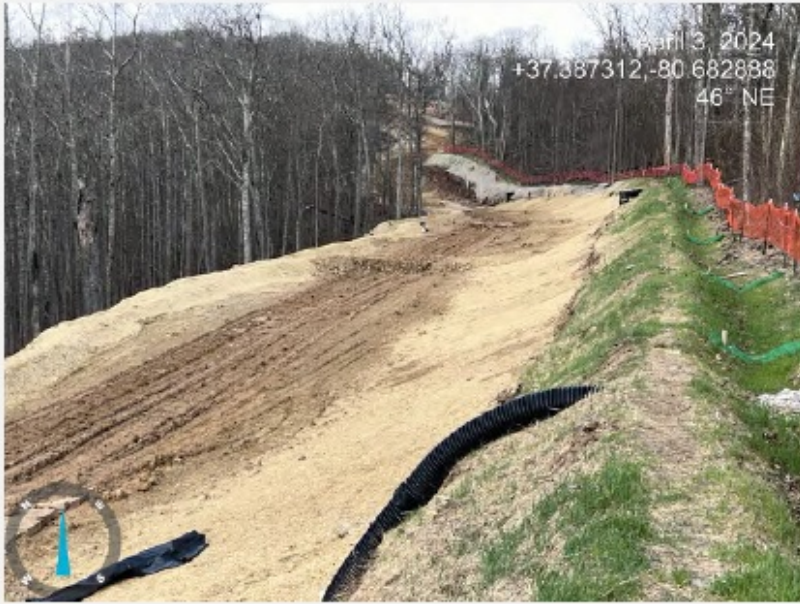
Date: April 3, 2024
	Photo: 18
	Aspect: Northeast
	Milepost: 197.8
	Station: 10457+00
	Key Items: Erosion control
Description: Slope breakers are installed on main section of Peters Mountain ROW.

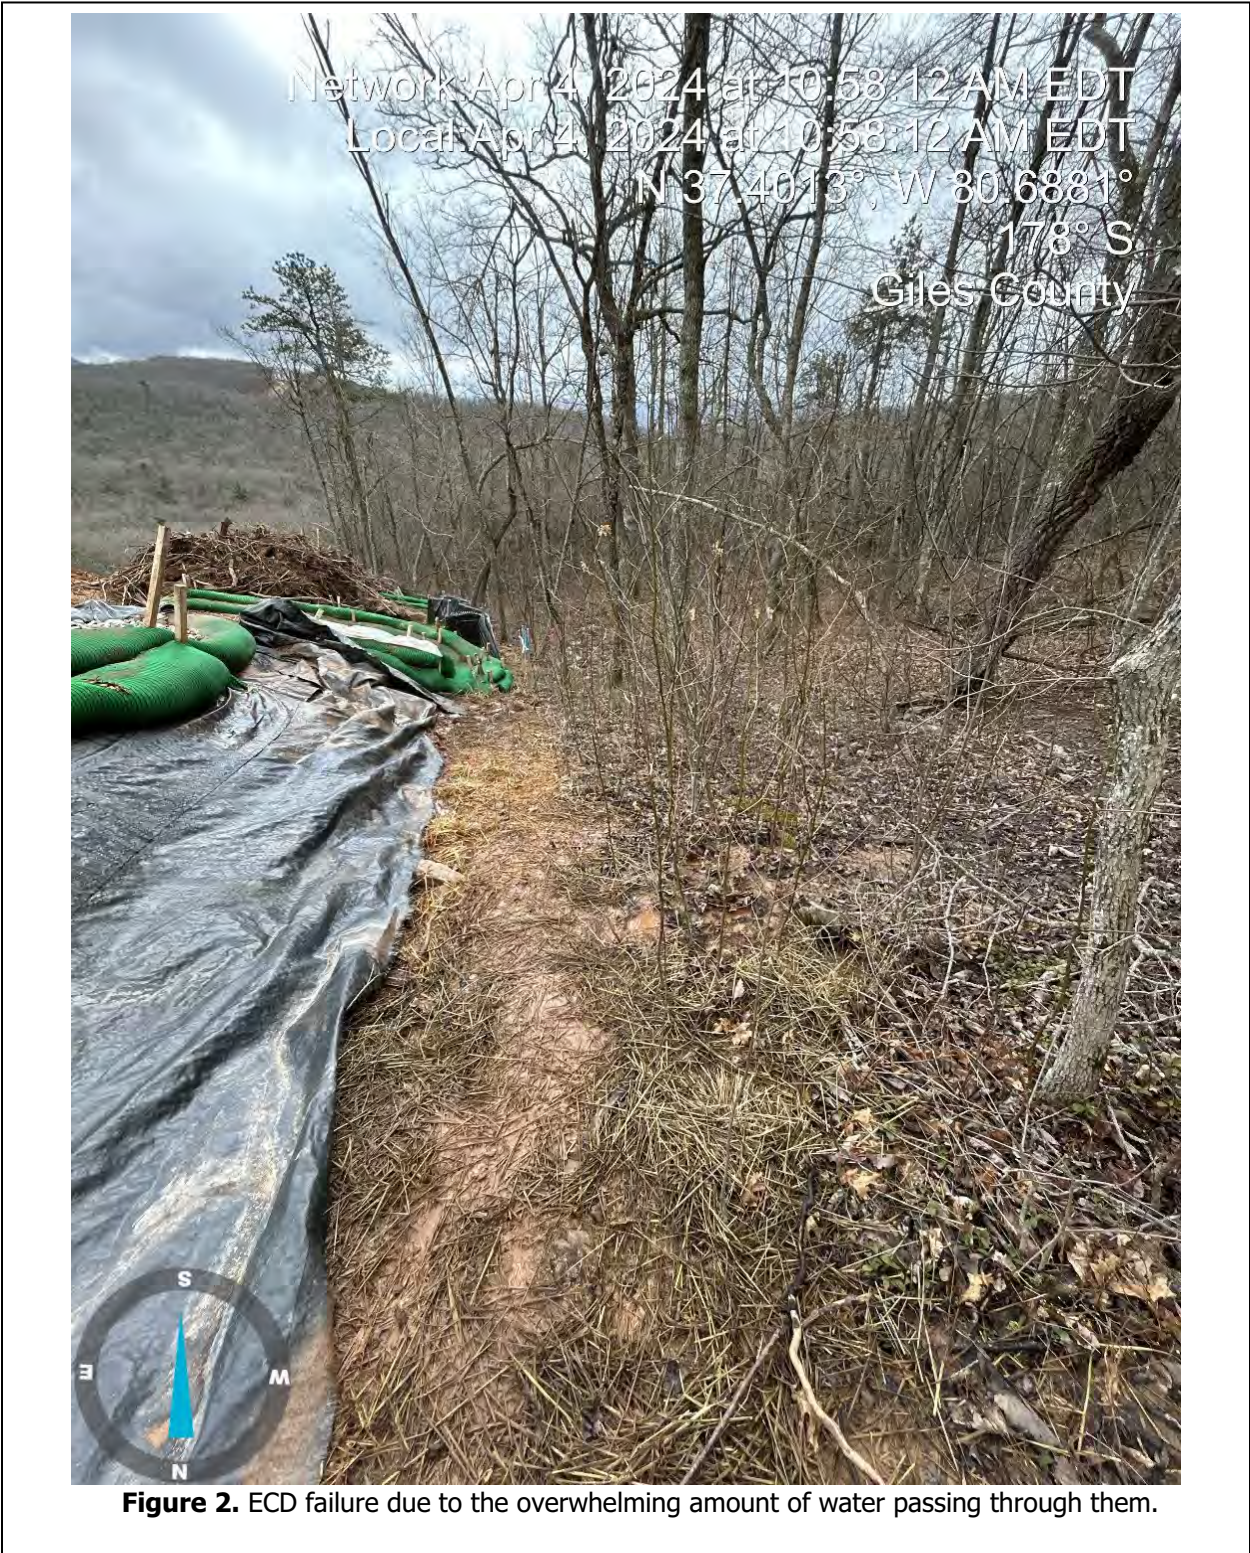
Figure 2. ECD failure due to the overwhelming amount of water passing through them.

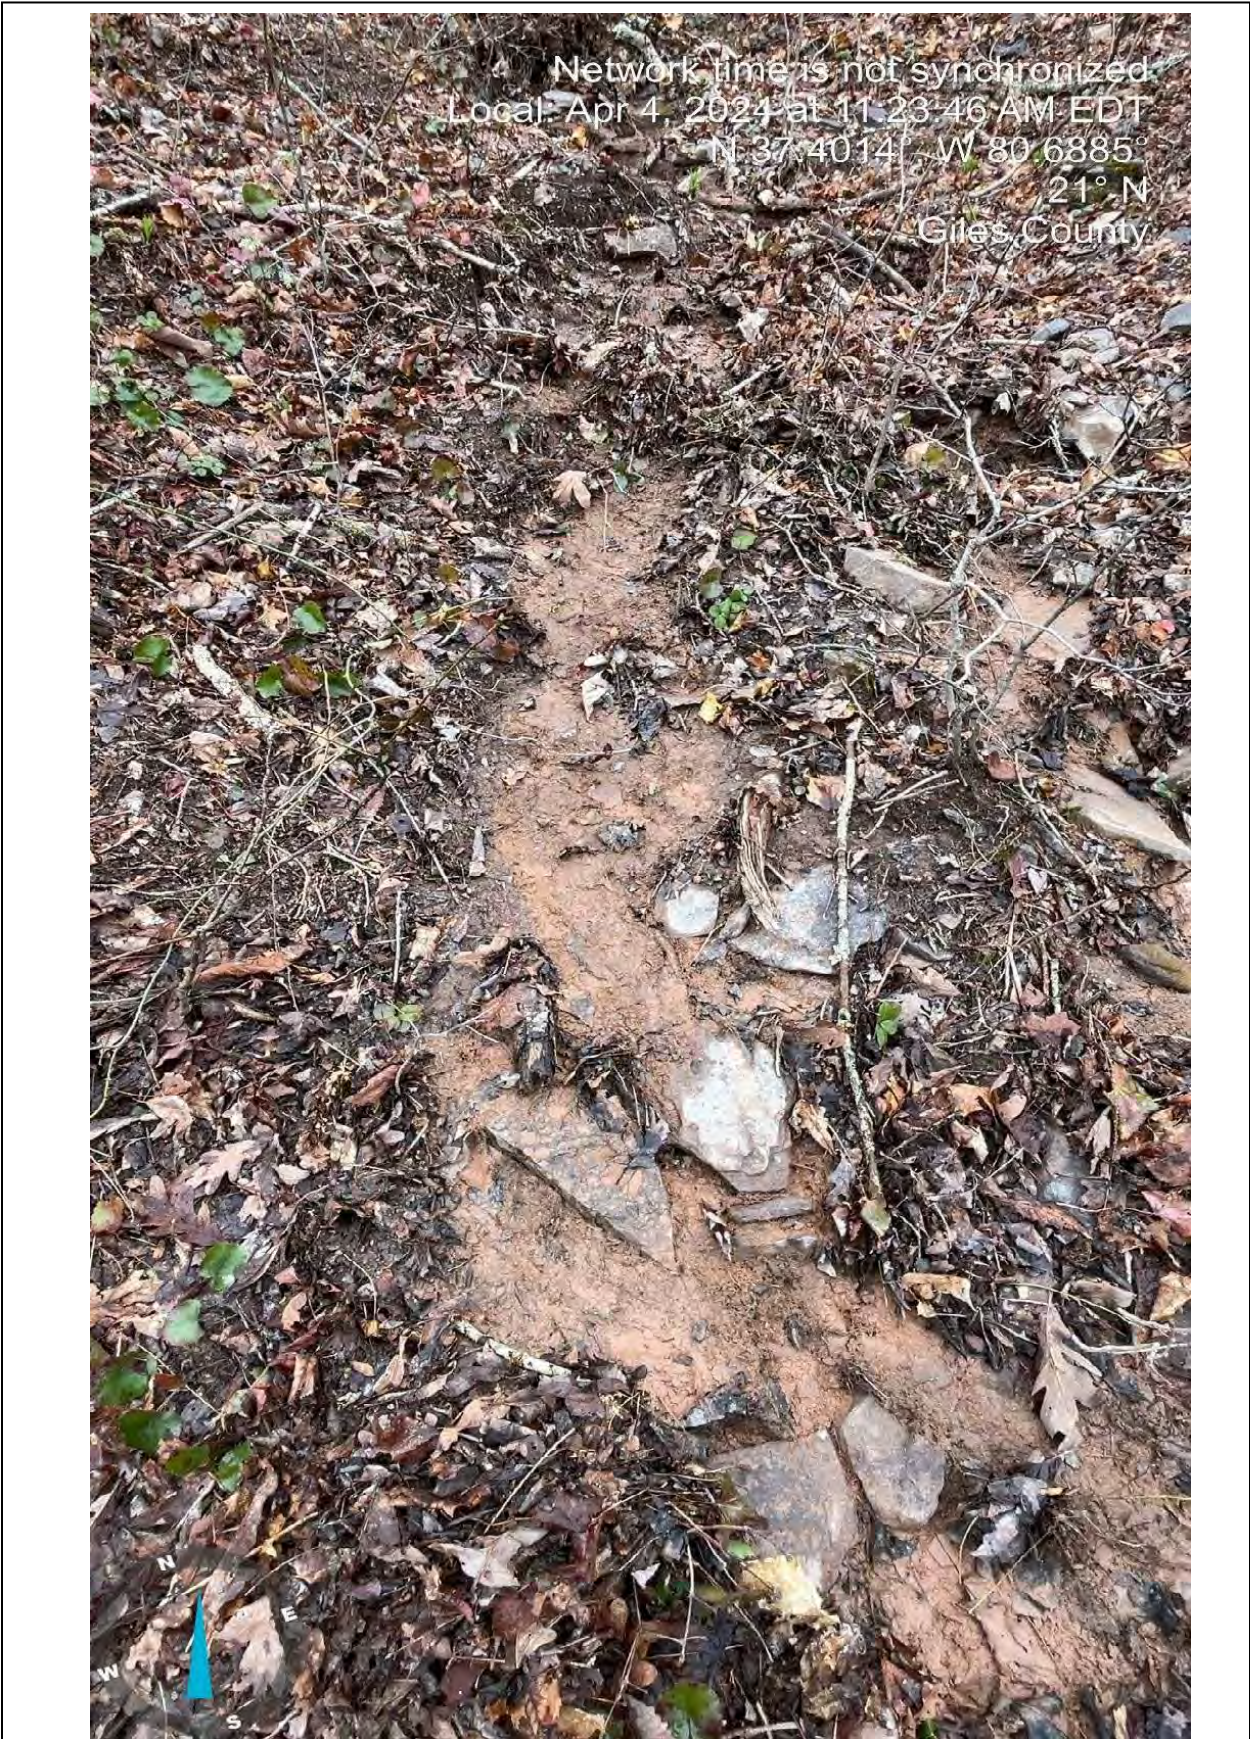
Figure 3. Sediment off-LOD at S-KL24.

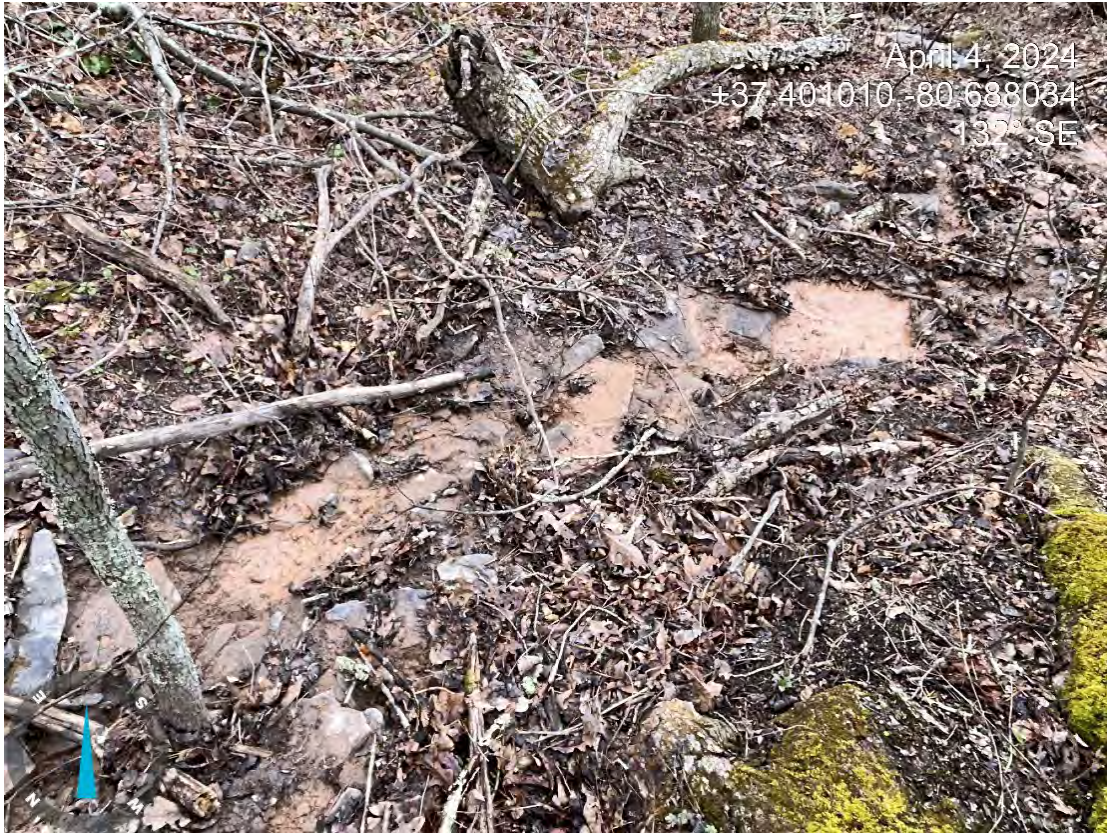
Figure 4. Sediment off-LOD at S-KL24.

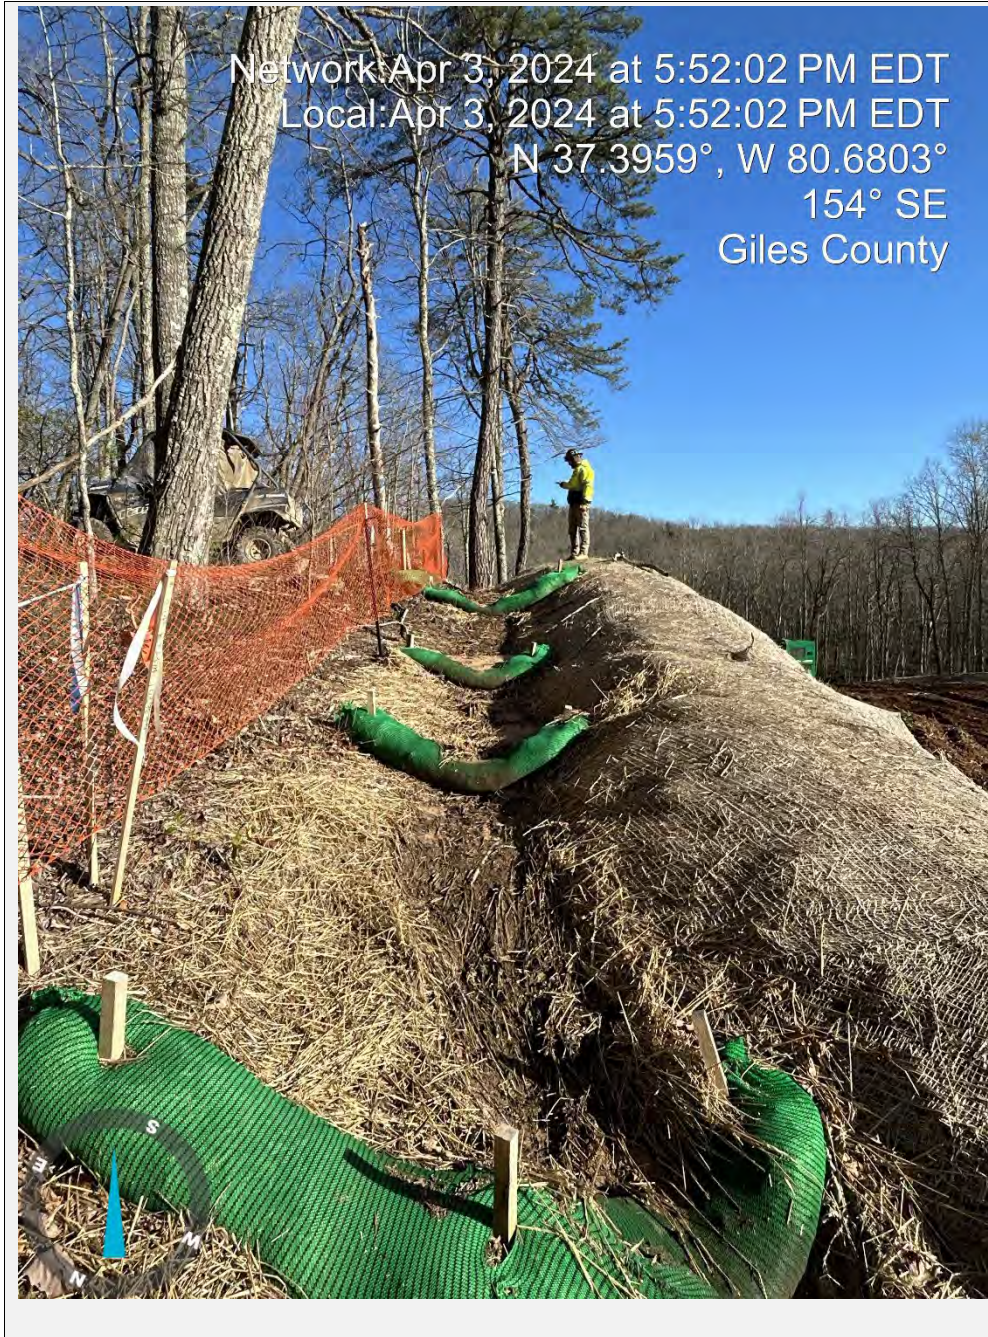
Date: April 3, 2024
Photo: 25
Aspect: s
Milepost: 196.67
Station: 10396+63
Key Items: Erosion control
Description: Silt is greater than half the height of CFS and needs maintenance.

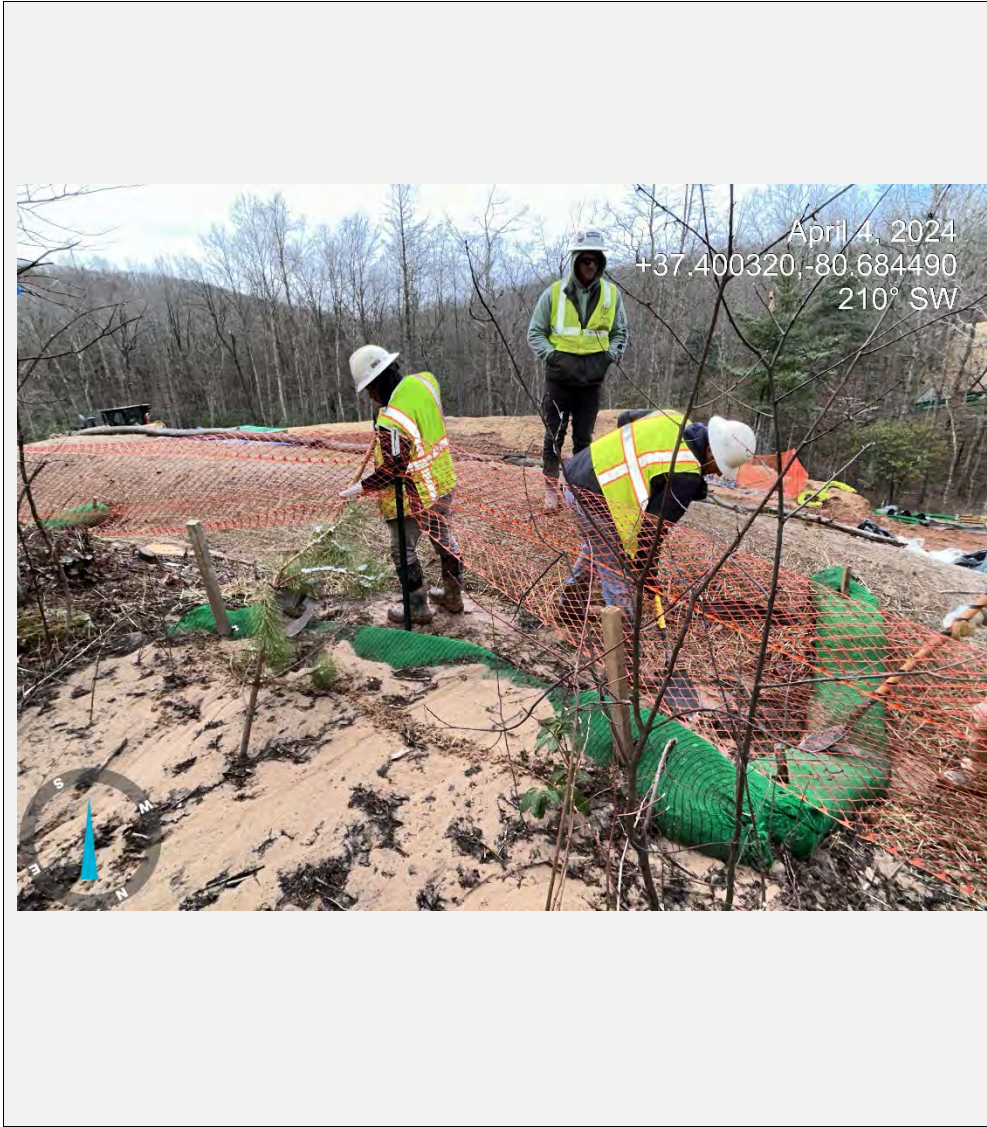
Date: April 4, 2024
Photo: 29
Aspect: Southwest
Milepost: 196.7
Station: 10397+00
Key Items: Construction, Erosion control
Description: Environmental crew cleaning out filter sock check dams. Sediment flowing off Mystery Ridge Road.

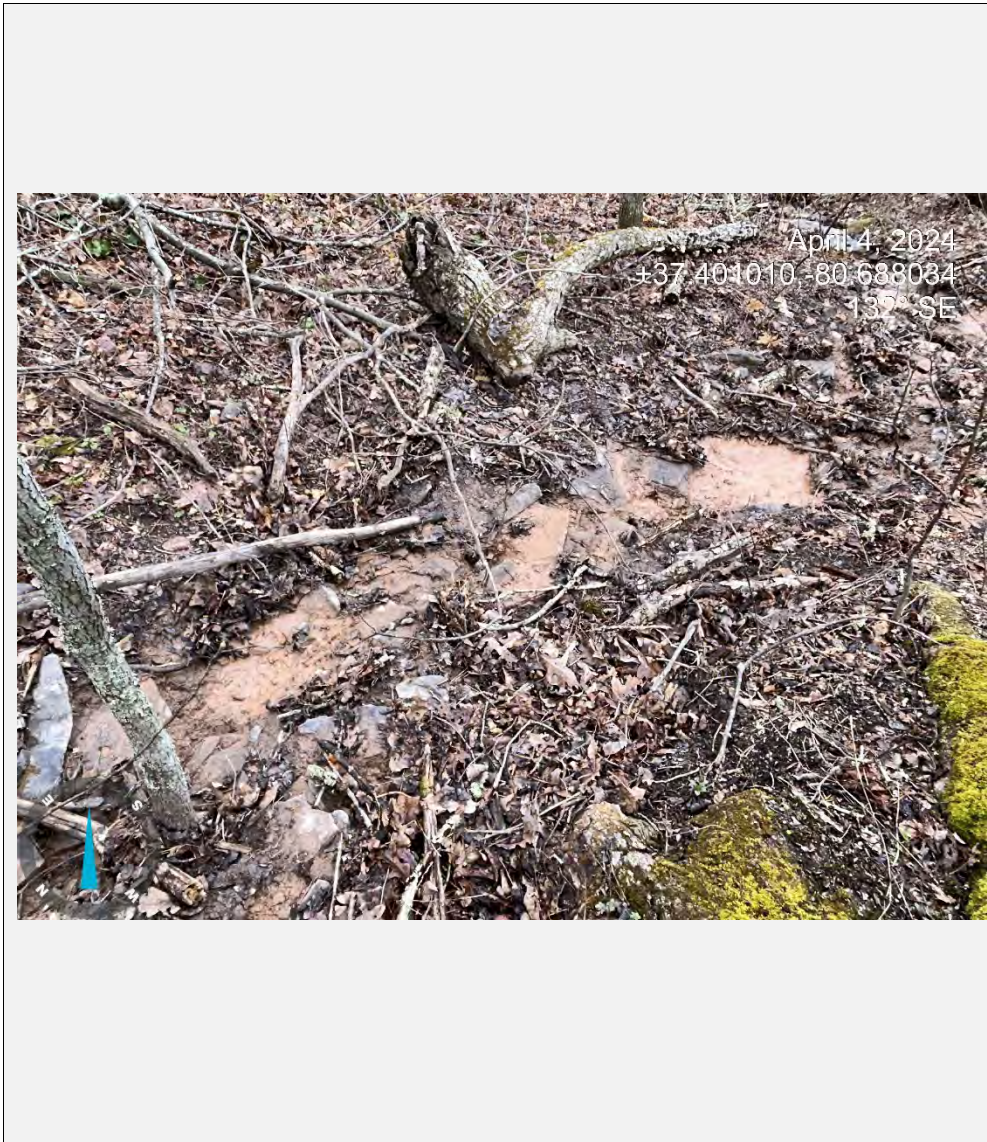
Date: April 4, 2024
Photo: 30
Aspect: Southeast
Milepost: 196.5
Station: 10385+78 to 10386+88
Key Items: Construction, Aquatic resources, Erosion control
Description: ECDs below bore site became overwhelmed on western side of ROW and contaminated S-KL24 again for approximately 110'.

Eocene CIC were contacted by an MVP EI who discovered an area of sediment outside the LOD. CIC personnel arrived at the site and observed sediment outside the LOD at S-KL24 for approximately 110 linear feet (sta. 10386+88 to sta. 10385+78). The flow of water from the ECDs had generally subsided but not stopped entirely. MVP and CIC personnel were appropriately alerted to the issue.

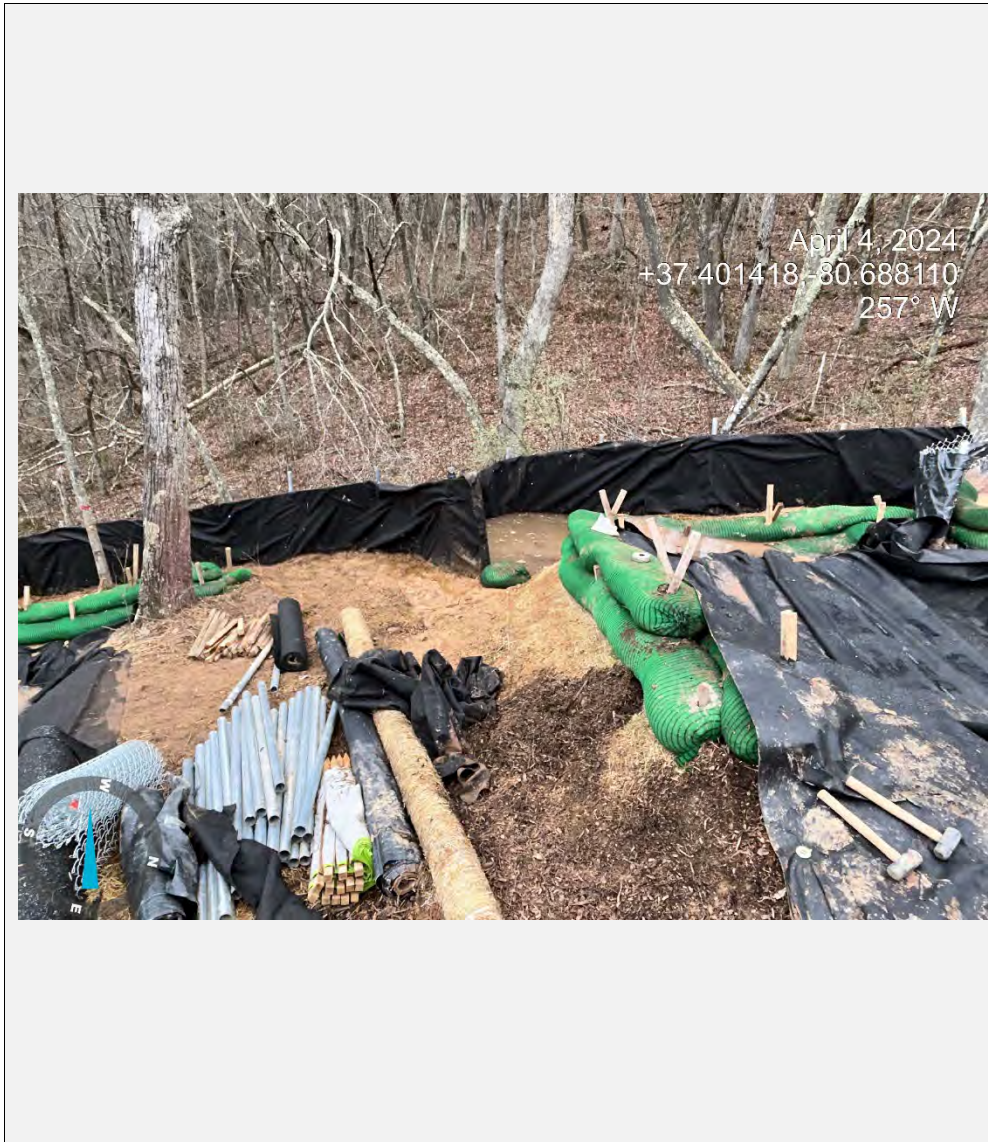
Date: April 4, 2024
Photo: 31
Aspect: West
Milepost: 196.5
Station: 10385+78 to 10386+88
Key Items: Construction, Aquatic resources, Erosion control
Description: ECDs below bore site became overwhelmed on western side of ROW and contaminated S-KL24 again for approximately 110'.

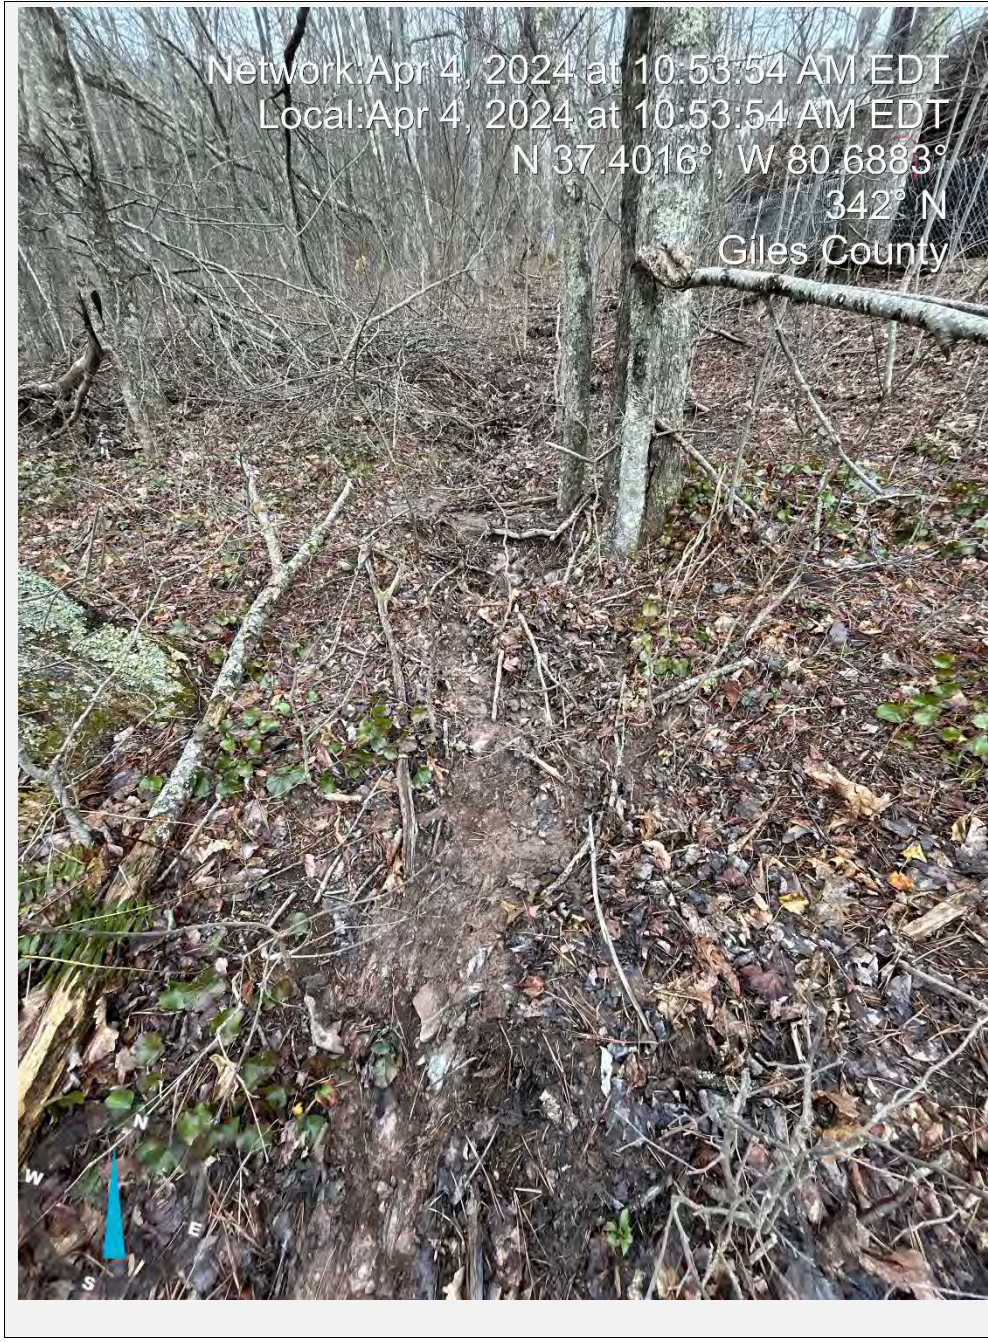
Date: April 4, 2024
Photo: 33
Aspect: N
Milepost: 196.54
Station:
Key Items: Aquatic resources
Description: Water flow had removed leaf coverage in stream flow path in several areas.

Below the impacted area of the stream, water flow had removed leaf coverage in stream channel in several areas. However, sediment was not observed in these downstream areas.

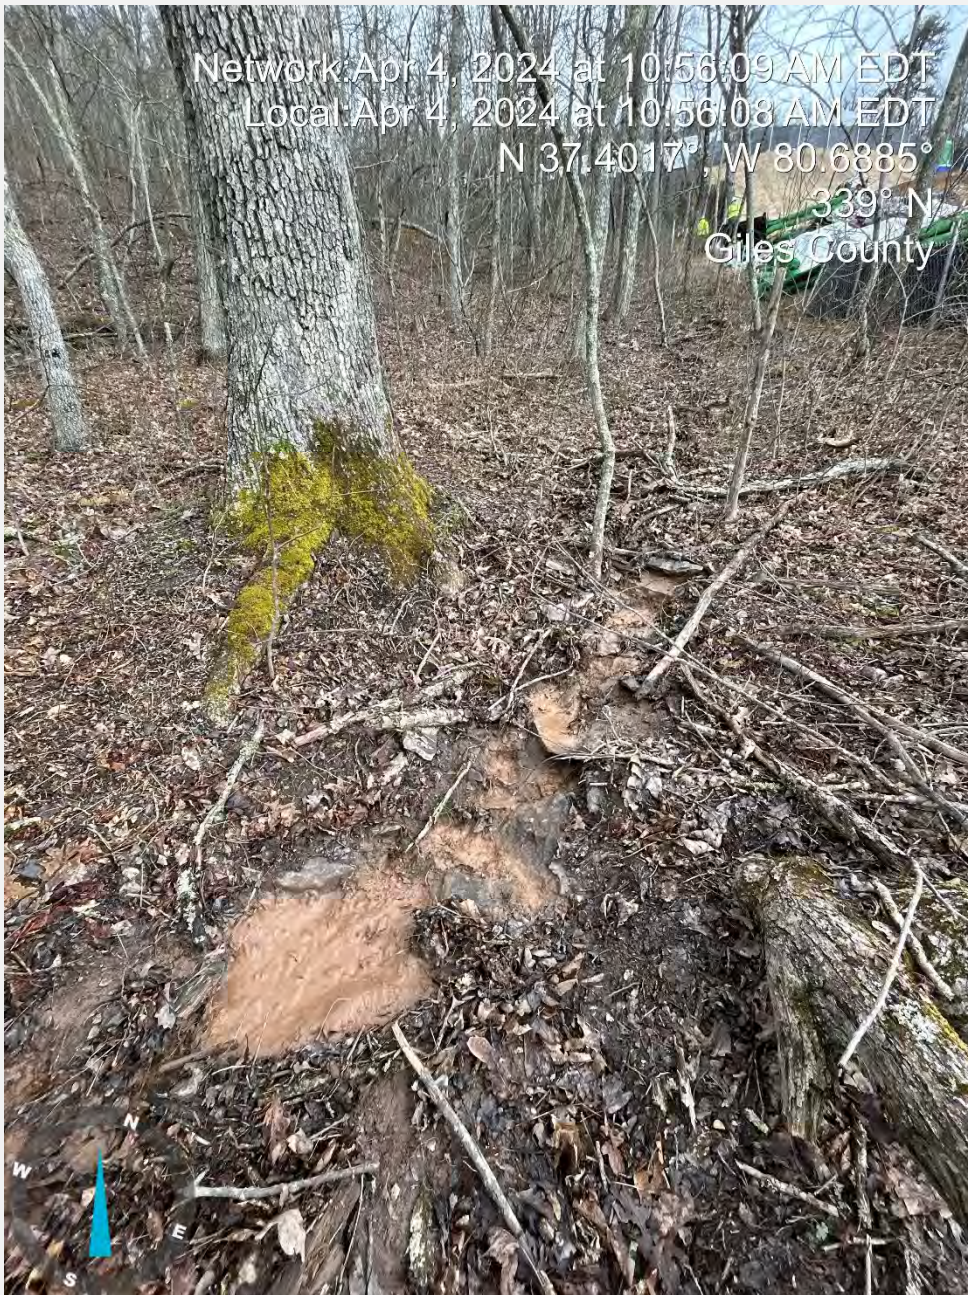
Date: April 4, 2024
Photo: 34
Aspect: N
Milepost: 196.53
Station: 10386+50
Key Items: Aquatic resources, Erosion control
Description: Sediment outside LOD in S-KL24.

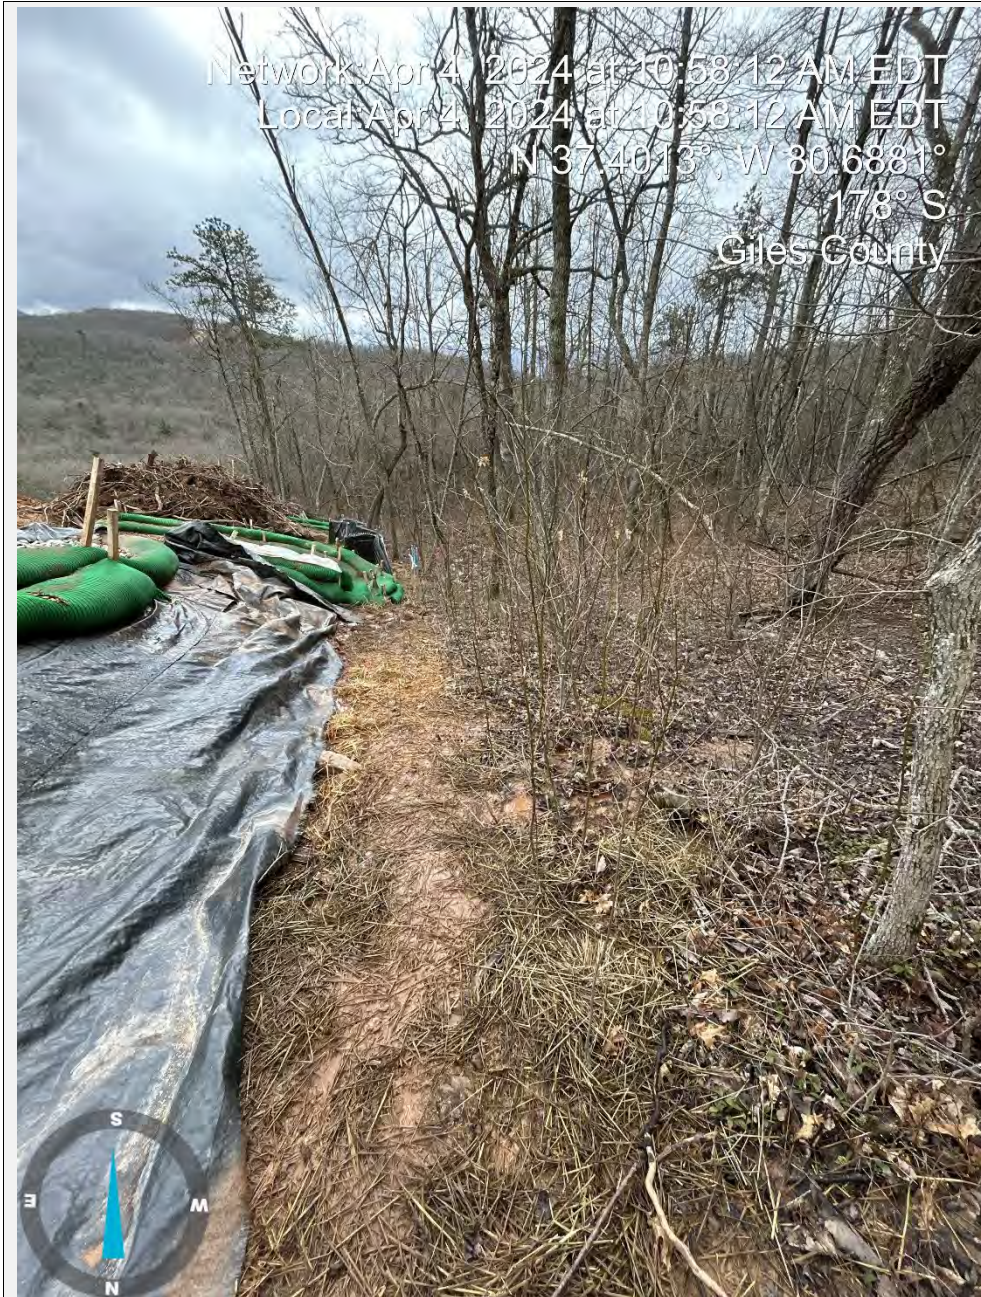
Date: April 4, 2024
Photo: 35
Aspect: s
Milepost: 196.51
Station: 10385+88
Key Items: Erosion control
Description: ECD failure due to overwhelming amount of water flowing to ECD.

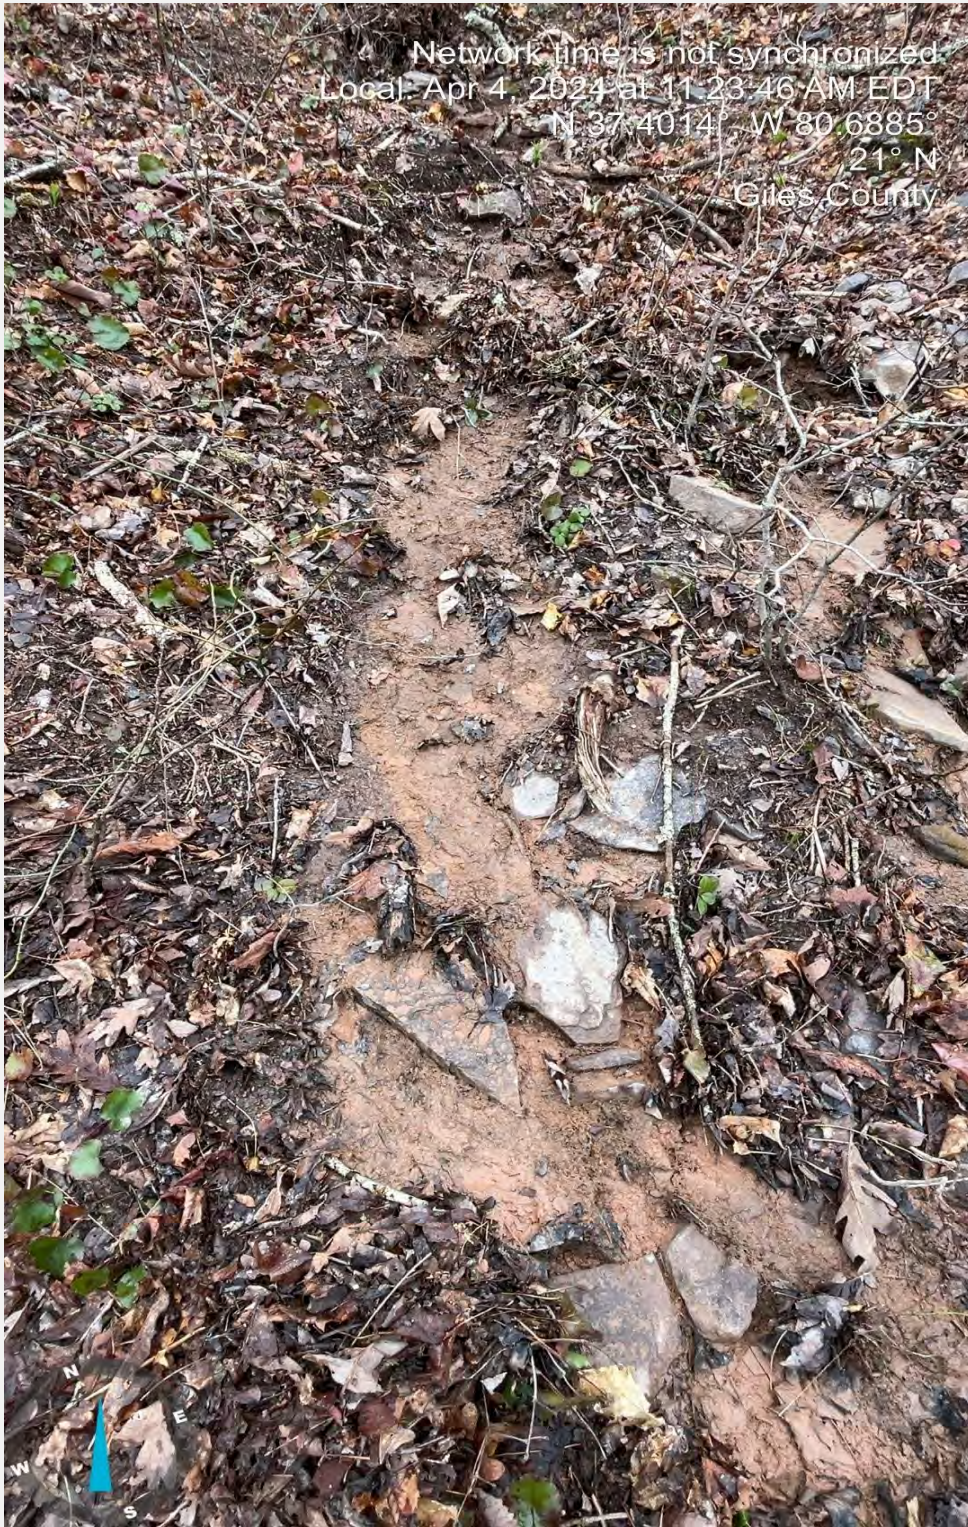
Date: April 4, 2024
Photo: 36
Aspect: NE
Milepost: 196.51
Station: 10386+10
Key Items: Aquatic resources, Erosion control
Description: Sediment outside LOD at S-KL24.

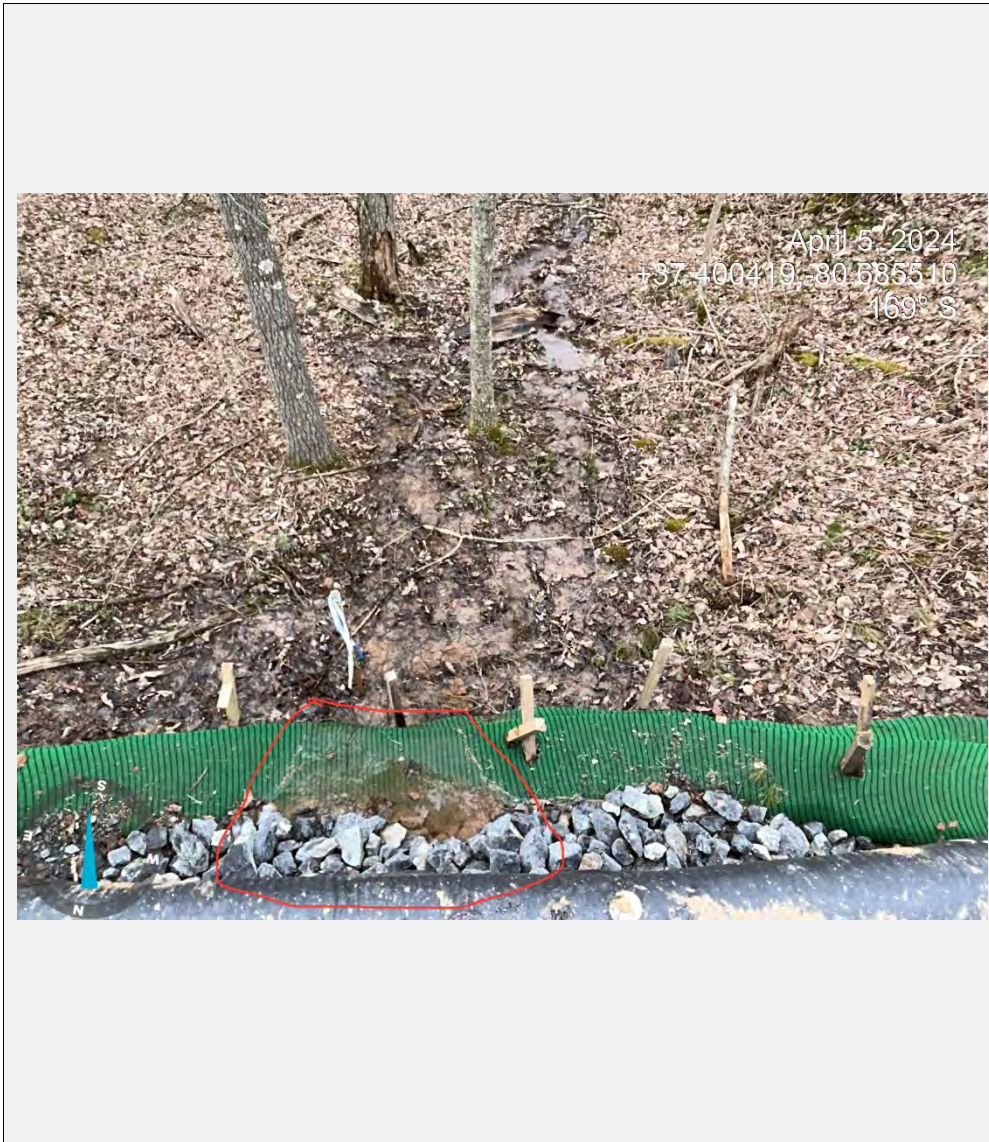
Date: April 5, 2024
Photo: 42
Aspect: South
Milepost: 196.66
Station: 10395+00
Key Items: Construction, Aquatic resources, Erosion control
Description: Seep from cut hillside is flowing heavily after rain event. Water is flowing through rock channel and through filter sock check dams across the ROW. Filter sock is being overwhelmed by the flow, but flow is running clear.

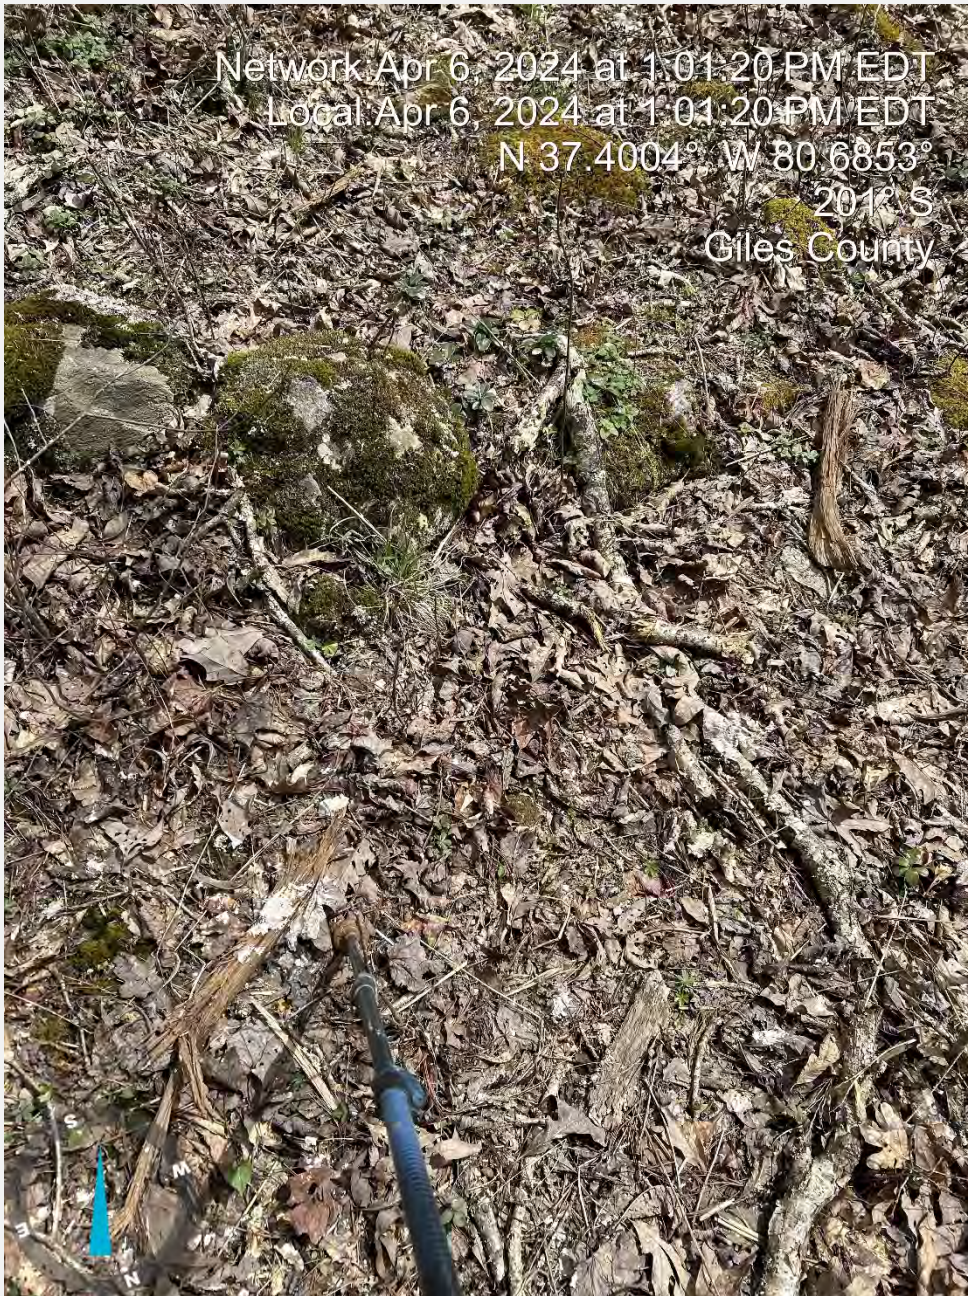
Date: April 6, 2024
Photo: 54
Aspect: s
Milepost: 196.66
Station: 10395+17
Key Items: Erosion control
Description: Bore pit spoils have splattered from equipment to outside the LOD.

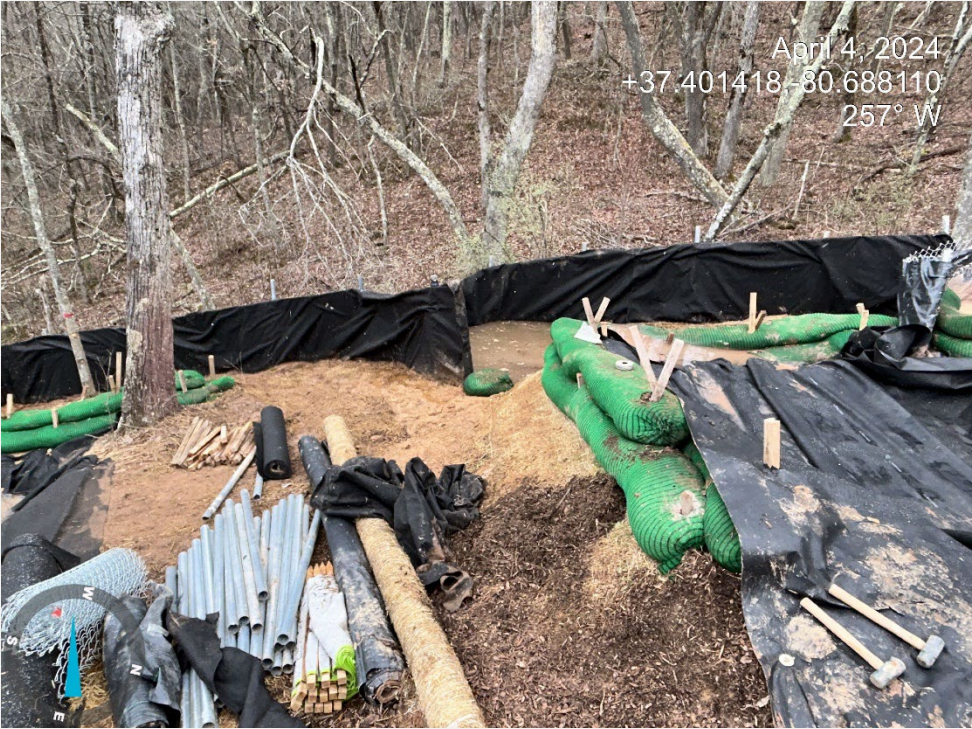
<p>April 4, 2024 +37.401418 -80.688110 257° W</p>	Date: April 4, 2024
	Photo: 1
	Aspect: West
	Milepost: 196.5
	Station: 10385+78 to 10386+88
	Key Items: Construction, Aquatic resources, Erosion control
Description: ECD failure due to overwhelming amount of water passing through ECDs.

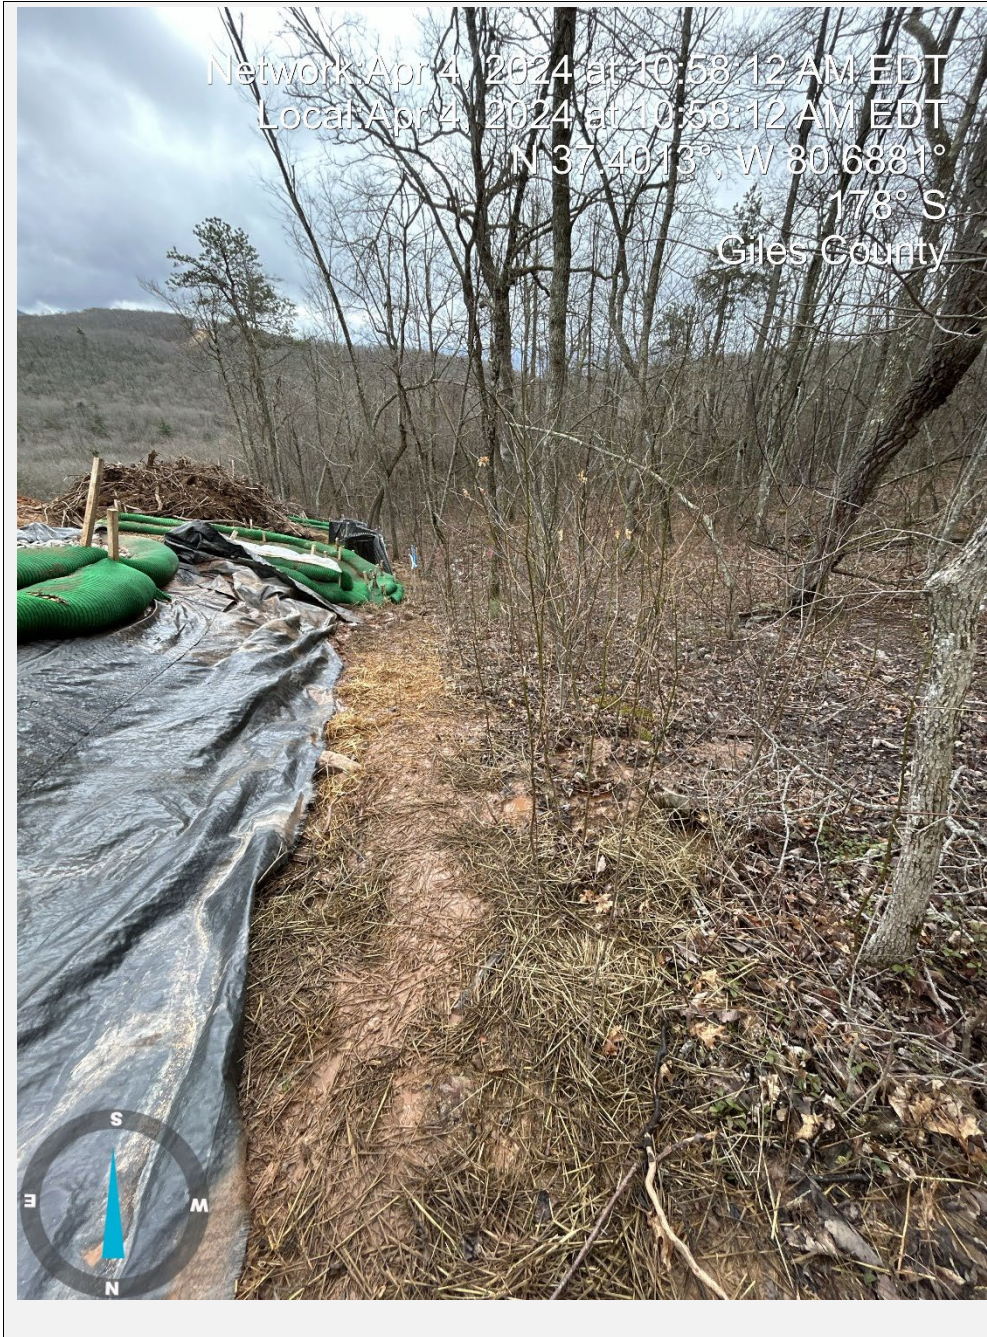
Date: April 4, 2024
Photo: 2
Aspect: s
Milepost: 196.51
Station: 10385+88
Key Items: Erosion control
Description: ECD failure due to overwhelming amount of water passing through ECDs. Sediment observed off LOD in S-KL24 for approximately 110 feet.

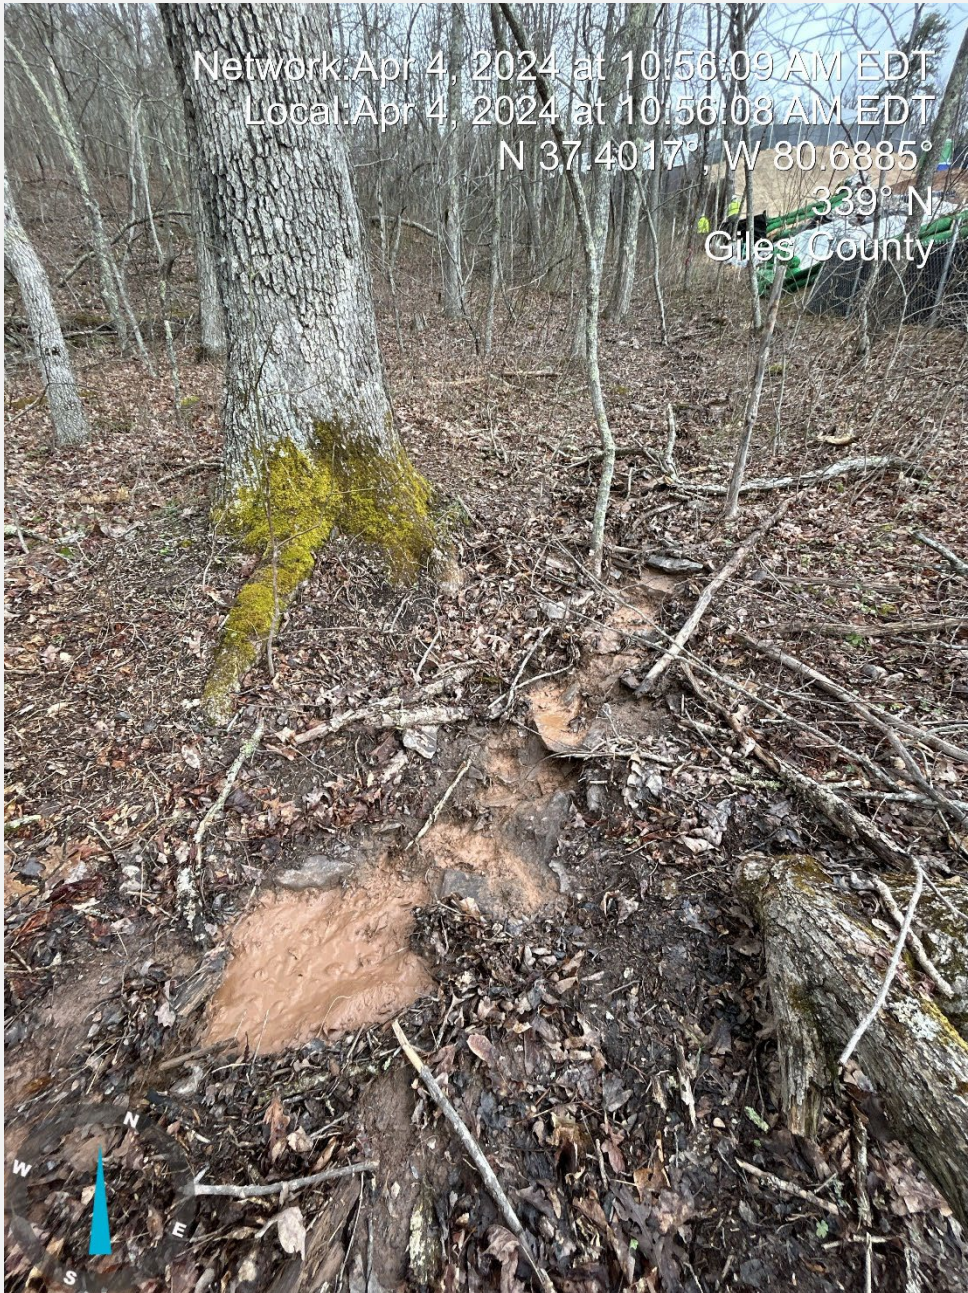
Date: April 4, 2024
Photo: 3
Aspect: N
Milepost: 196.53
Station: 10386+50
Key Items: Aquatic resources, Erosion control
Description: Sediment outside LOD in S-KL24.
