May 10, 2024

Re: Mountain Valley Pipeline, LLC Request to Place Project Facilities in Service (CP16-10-000)

Coalition Letter to PHMSA re Mountain Valley Pipeline
Consent Order Quarterly Report

In compliance with Environmental Condition Nos. 8 and 14 of the Certificate Order, Mountain Valley submits its status report for April 6, 2024 through April 12, 2024.

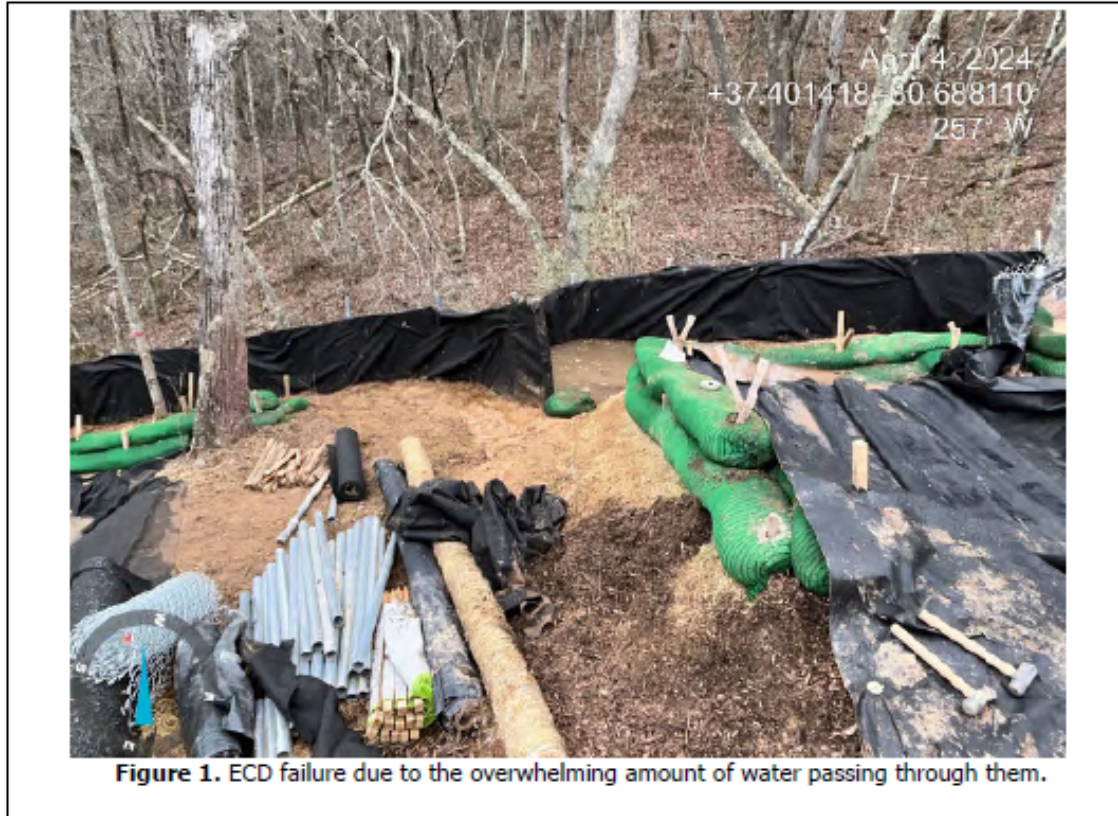
Moreover, rather than progressing toward satisfactory “rehabilitation and restoration” of affected areas, Mountain Valley in recent weeks has continued its years-long pattern of failing to adequately control erosion and sedimentation along the right-of-way. For example, on April 4, 2024, a non-compliance report was issued to Mountain Valley after sediment was observed “outside the [limits of disturbance] at S-KL24 for approximately 110 linear feet,” in an area where Mountain Valley had already received a non-compliance report:¹²

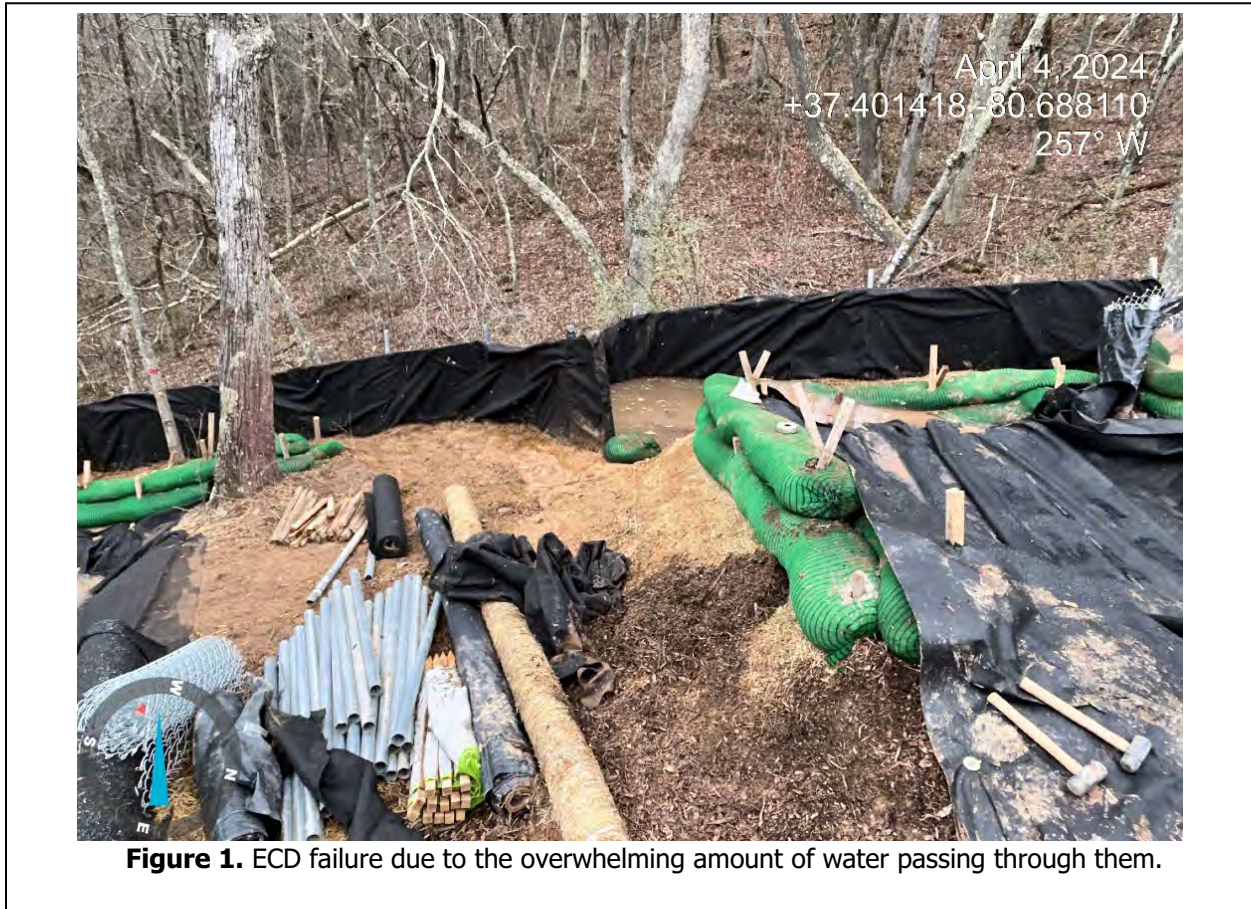
TABLE 3 SUMMARY OF NON-COMPLIANCE REPORTS FOR MVP				
Date Issued	Location (Spread, MP, etc.)	Follow-up Required (Yes/No)	Date Resolved	Description
4/4/2024	Spread G – Peters Mountain – MP 196.52	Yes	TBD	<p>CIC observed sediment outside the LOD at S-KL24 for approximately 110 linear feet, from station 10386+88 to station 10385+78. The flow of water from the ECDs had generally subsided at the time of observation, but it had not stopped entirely. Retrieval of sediment within this 110-foot section is recommended once conditions allow.</p> <p>Below the impacted area of the stream, water flow had removed leaf coverage in the stream channel in several areas. However, sediment was not observed in these downstream areas.</p> <p>This area was previously impacted by sediment outside the LOD, observed on March 10, for</p>

which a non-compliance report was issued. Consistent with the previous non-compliance, a contributing issue appears to be the that the ECDs at this location are handling both stormwater runoff plus flow from the bore site area.
--	--	--	--	---

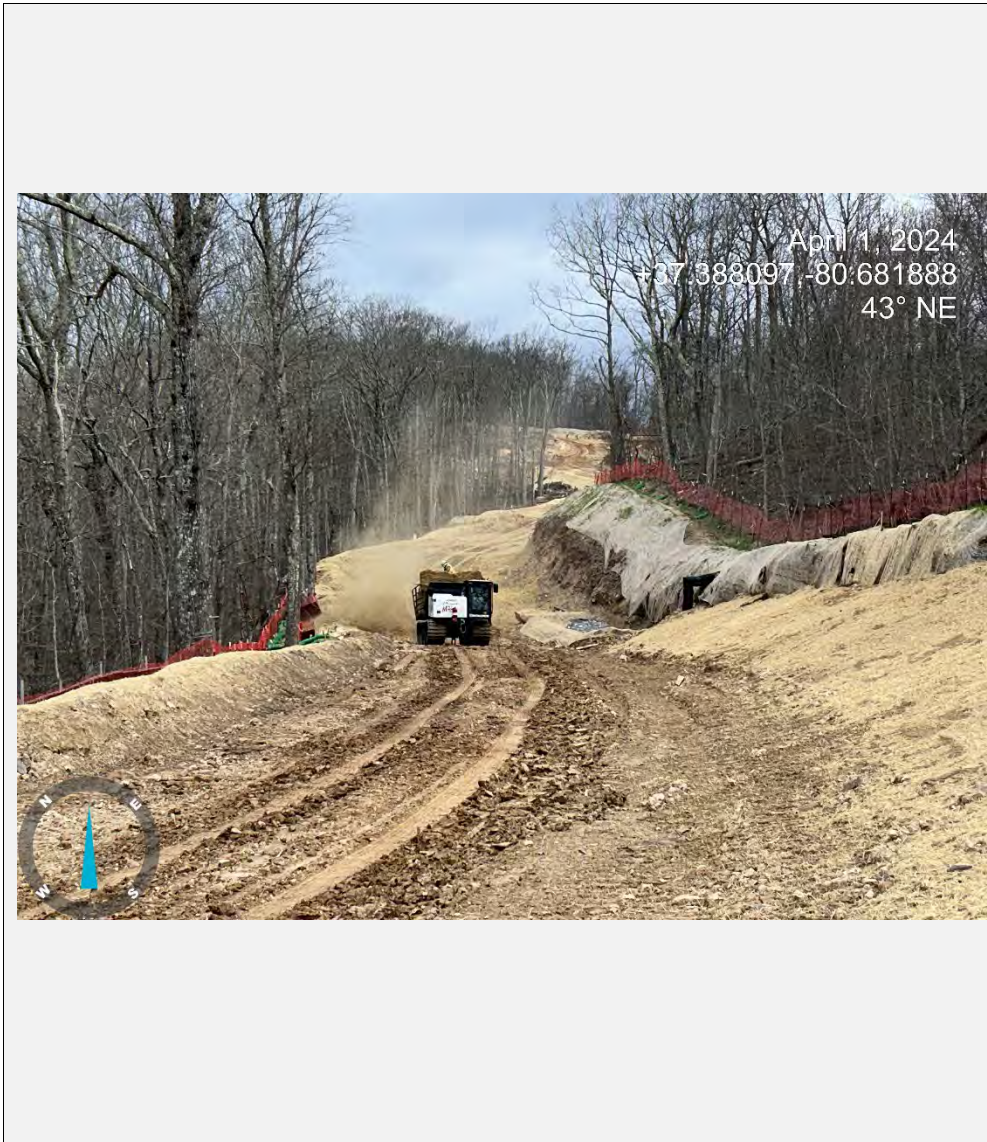
Date: April 1, 2024
Photo: 1
Aspect: Northeast
Milepost: 197.7
Station: 10452+00
Key Items: Construction, Equipment, Erosion control
Description: Crew distributing straw on ROW.

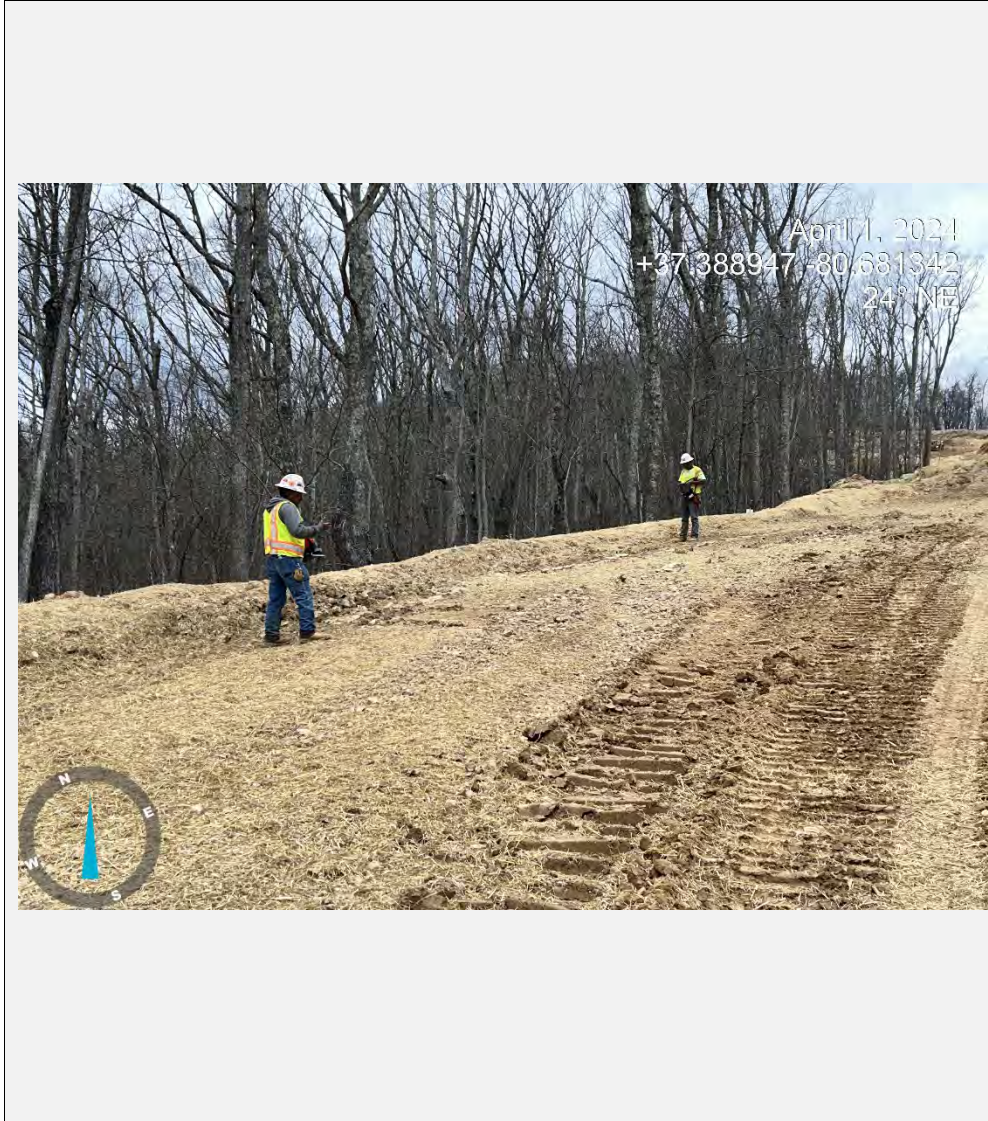
Photo: 2

Description: Environmental crew seeded the construction berms.

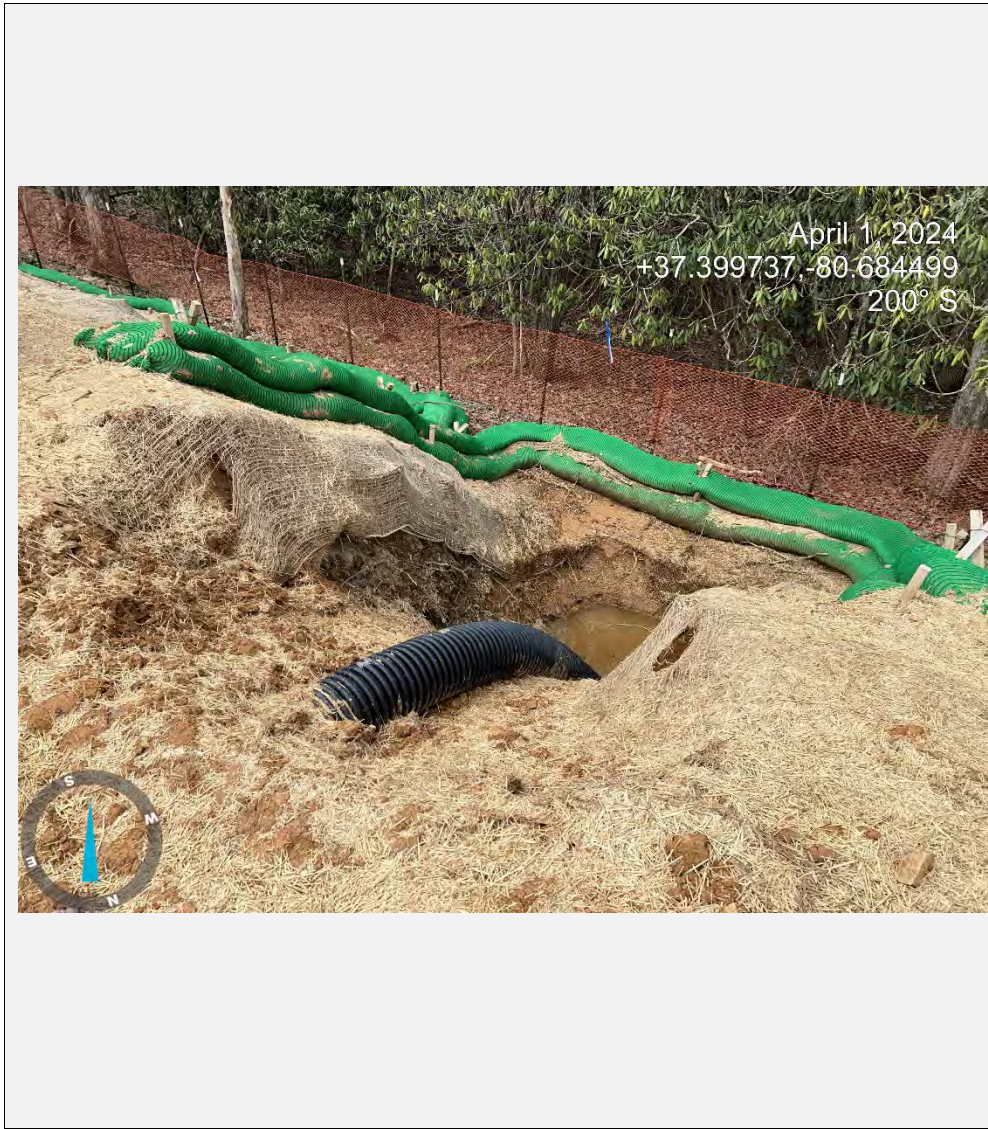
Date: April 1, 2024
Photo: 3
Aspect: South
Milepost: 196.8
Station: 10399+00
Key Items: Construction, Erosion control
Description: ECDs throughout the ROW appear to be functioning properly.

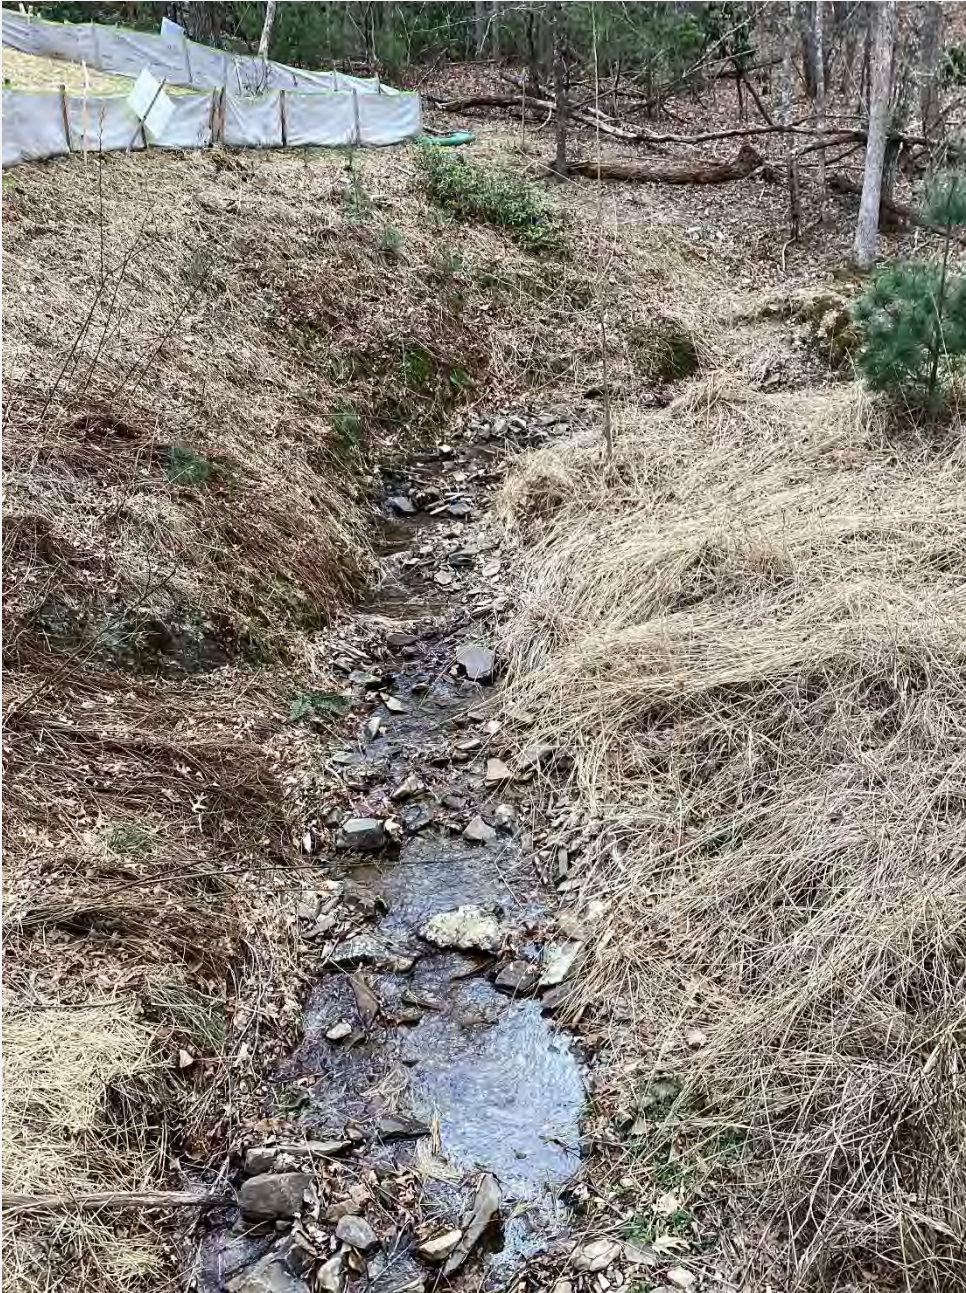
Date: April 1, 2024
Photo: 4
Aspect: SW
Milepost: 219.91
Station: 11626+70
Key Items: Aquatic resources, Erosion control
Description: Stream crossing S-HH18 is flowing clear water. ECDs are functional and effective.

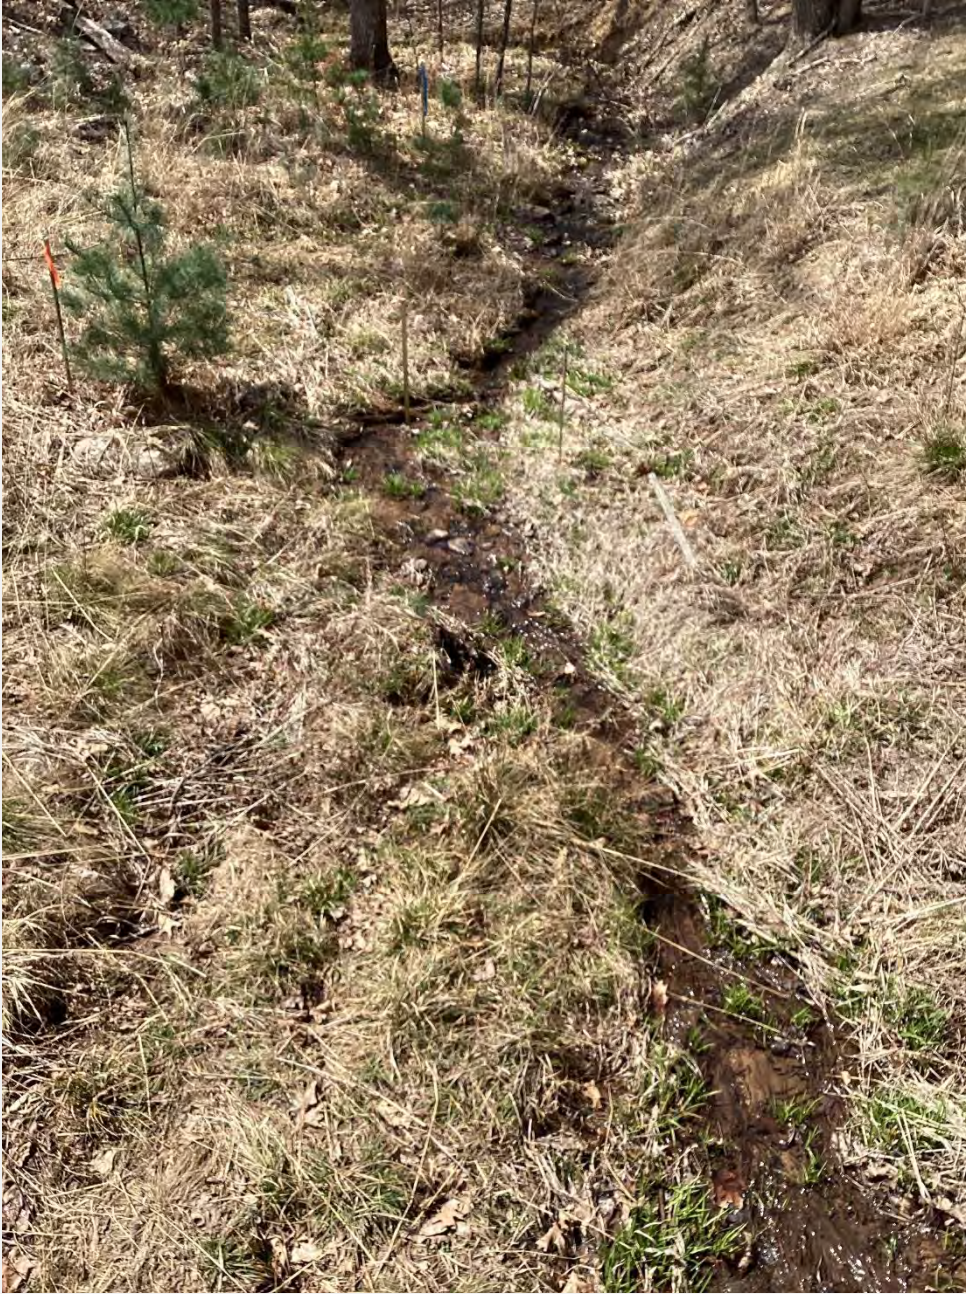
Date: April 1, 2024
Photo: 5
Aspect: SW
Milepost: 219.13
Station: 11585+30
Key Items: Aquatic resources, Erosion control
Description: Stream crossing S-PP21 is flowing clear water. ECDs are functional and effective.

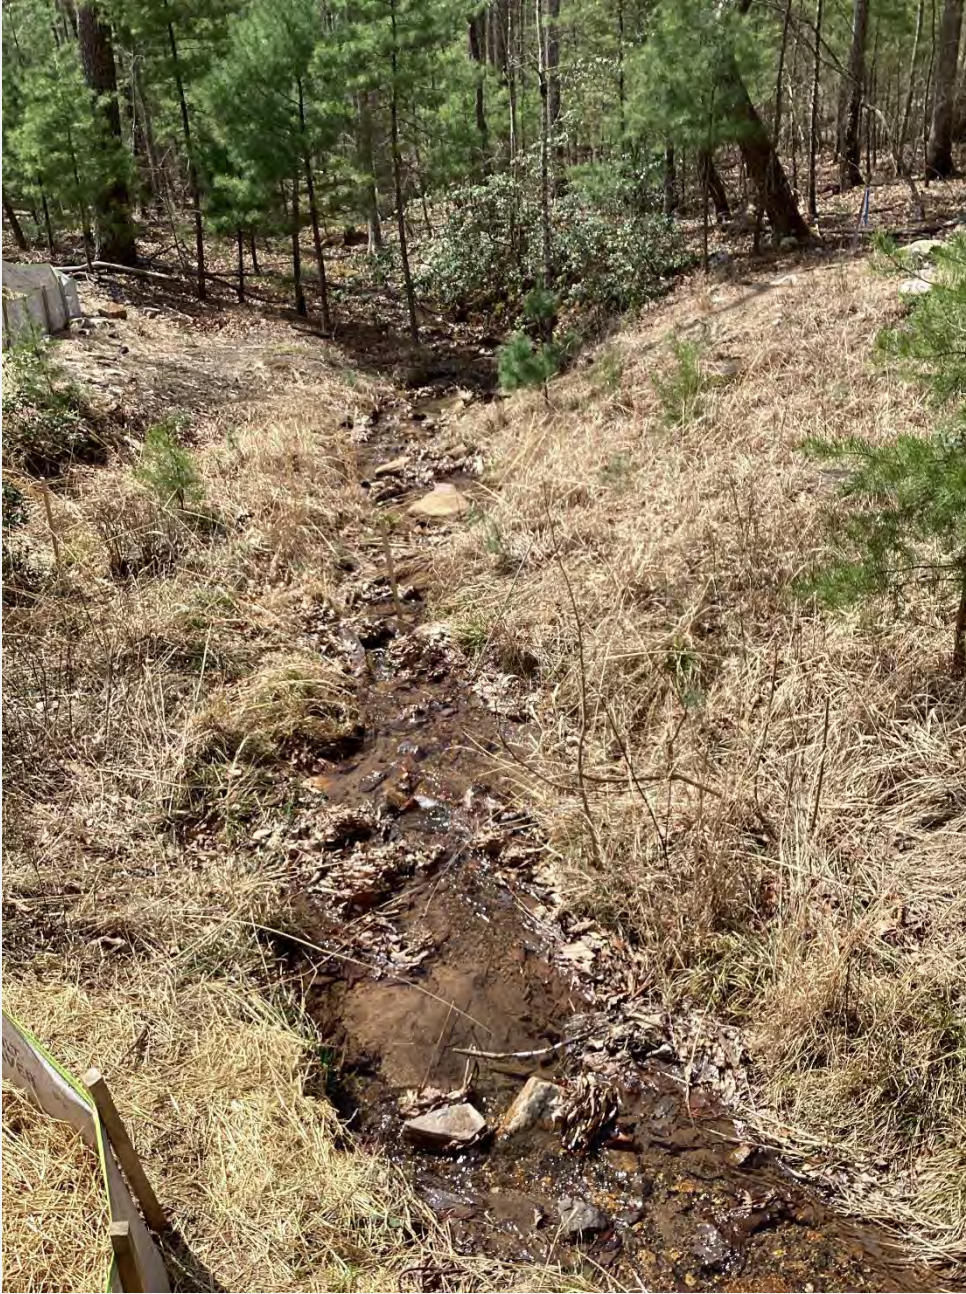
Date: April 1, 2024
Photo: 6
Aspect: SW
Milepost: 219.18
Station: 11588+40
Key Items: Aquatic resources, Erosion control
Description: Stream crossing S-PP20 is flowing clear water.
ECDs are functional and effective.

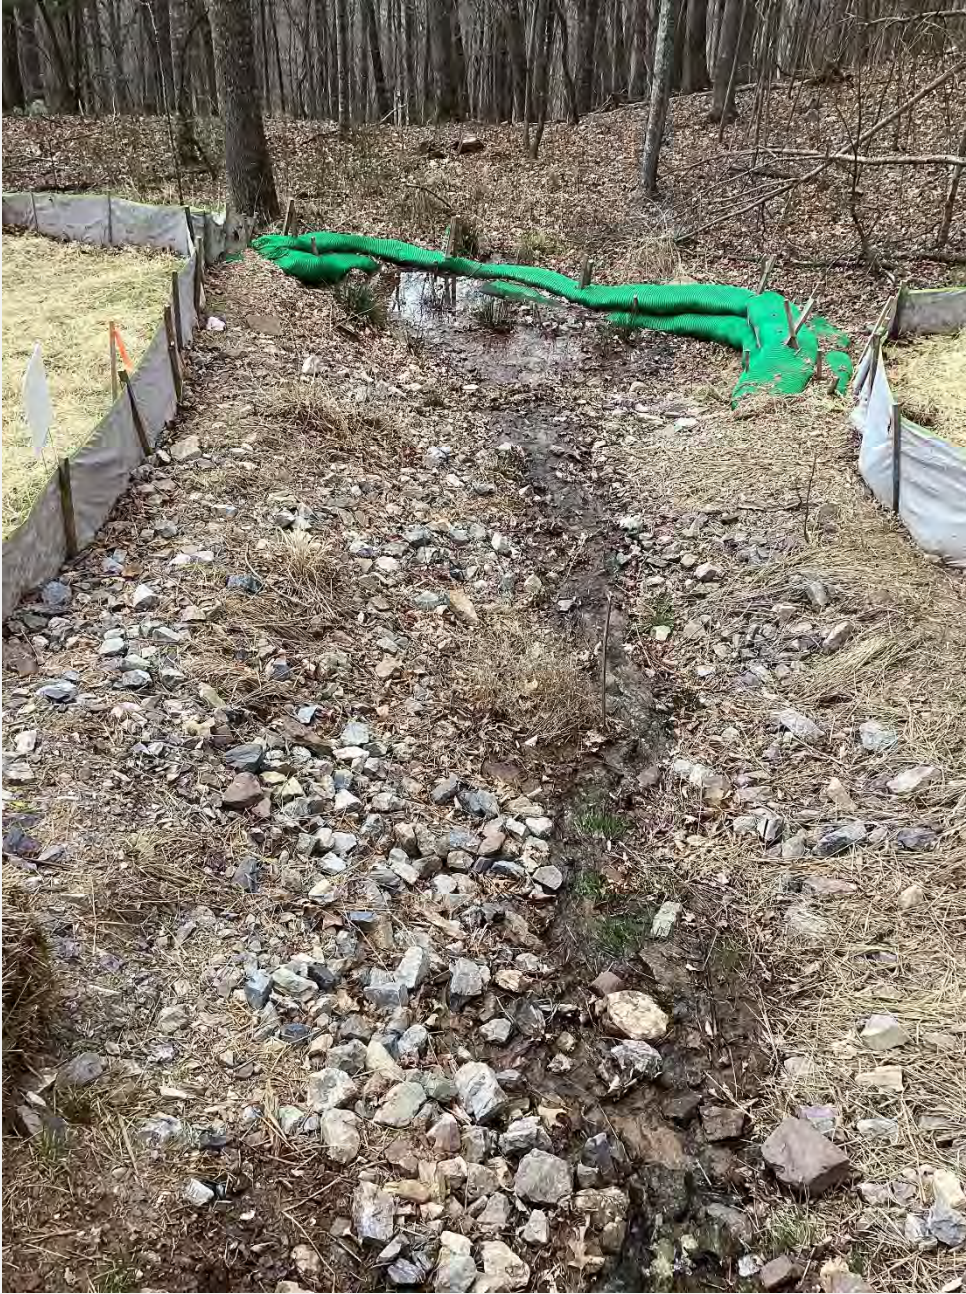
Date: April 1, 2024
Photo: 7
Aspect: SW
Milepost: 218.83
Station: 11568+00
Key Items: Aquatic resources, Erosion control
Description: Stream crossing S-PP22 is flowing clear water. ECDs are functional and effective.

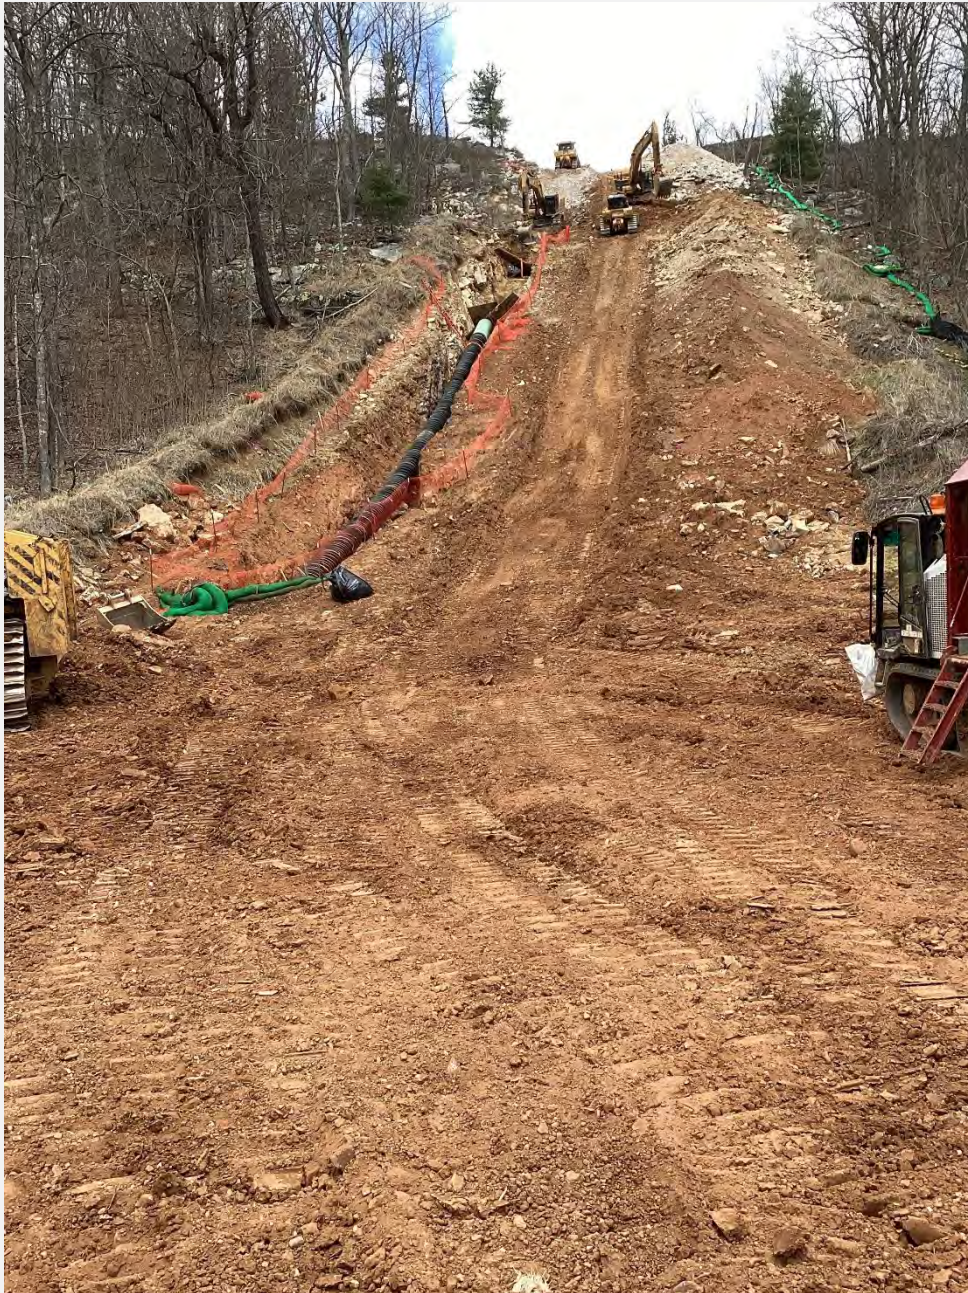
Date: April 1, 2024
Photo: 8
Aspect: N
Milepost: 218.64
Station: 11558+40
Key Items: Construction, Erosion control
Description: View toward the top of Sinking Creek Mountain and JNF line. MVP is trenching. Wildlife escape ramps and exclusion fences are in-place.

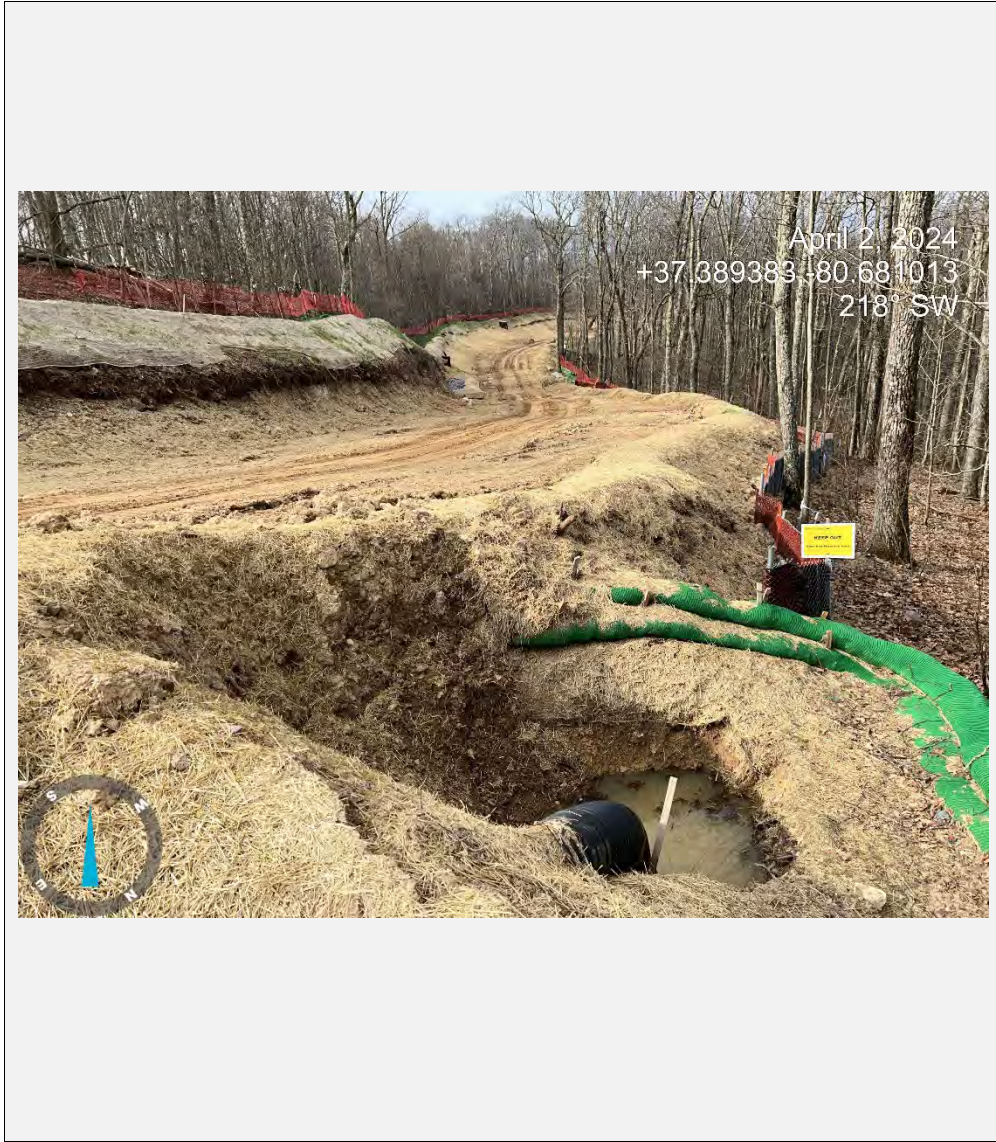
Photo: 9

Description: Rock skullcap signage remains in place.

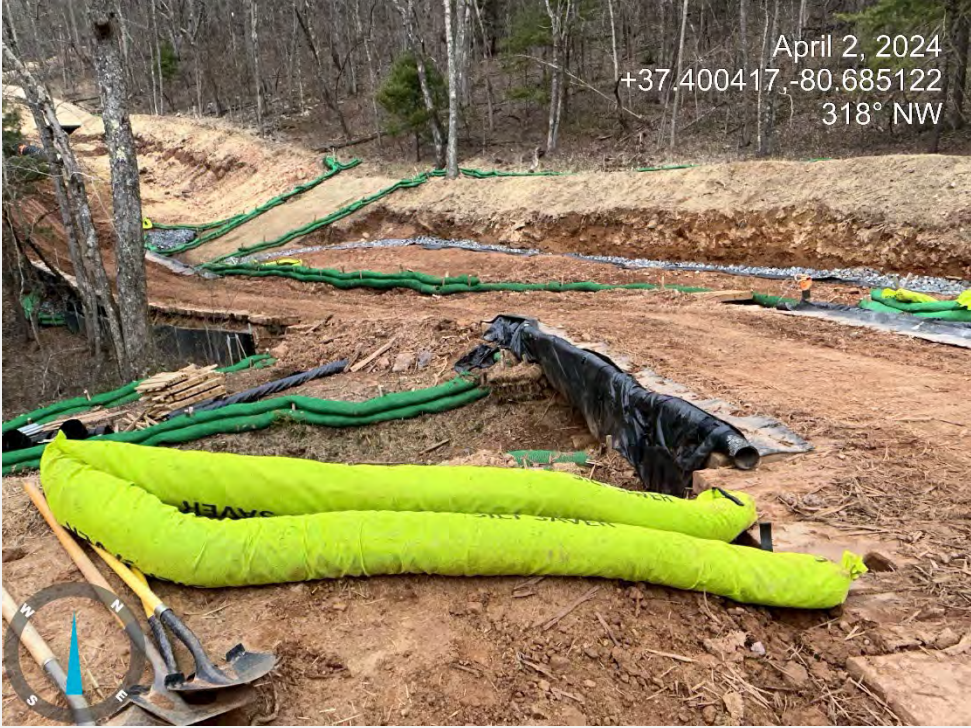
<p>April 2, 2024 +37.400417, -80.685122 318° NW</p>	Date: April 2, 2024
	Photo: 10
	Aspect: Northwest
	Milepost: 196.7
	Station: 10396+00
	Key Items: Construction, Aquatic resources, Erosion control
	Description: New straw wattles in use at bridges over ROW.

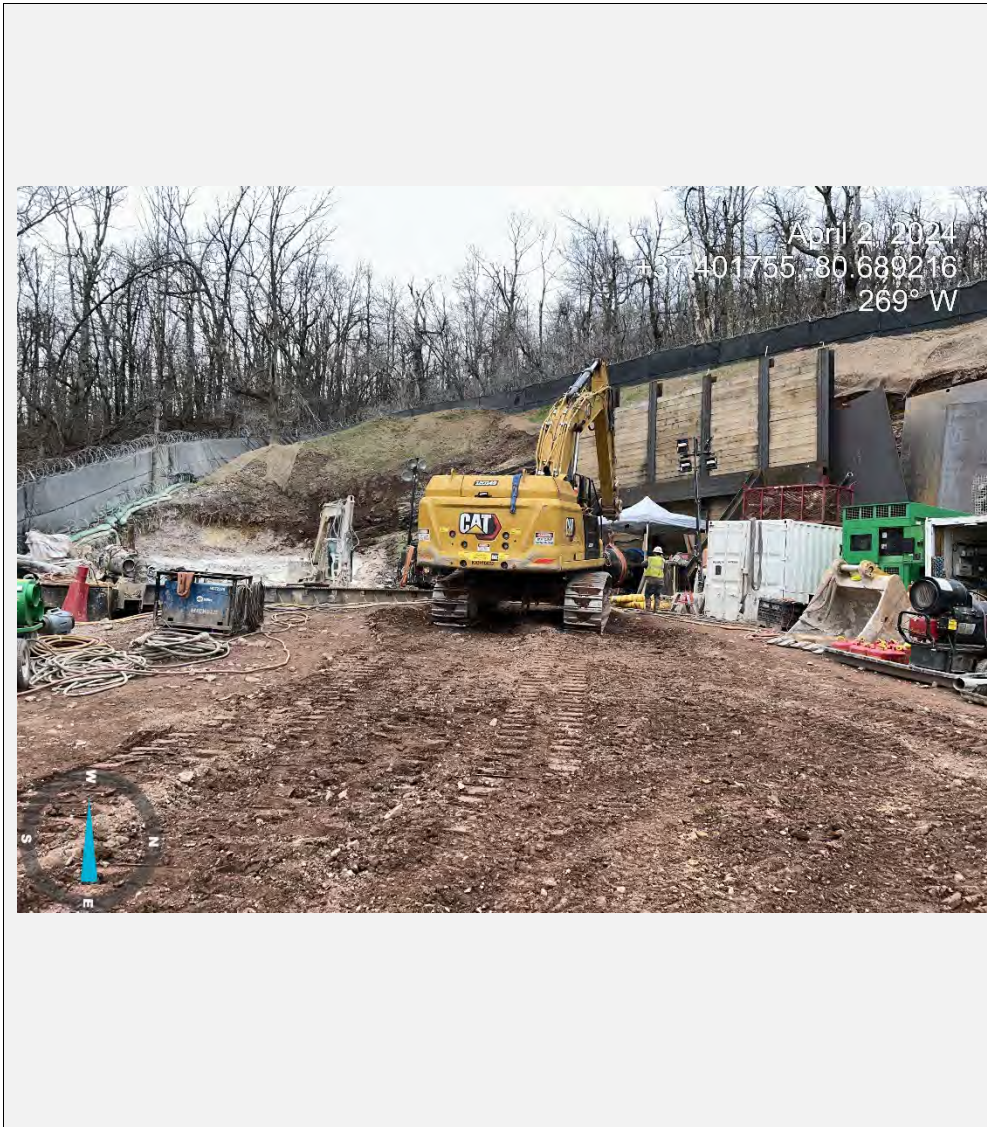
Date: April 2, 2024
Photo: 11
Aspect: West
Milepost: 196.4
Station: 10380+00
Key Items: Construction, Equipment
Description: Bore crew continues to reinstall pipe casing into the mountain.

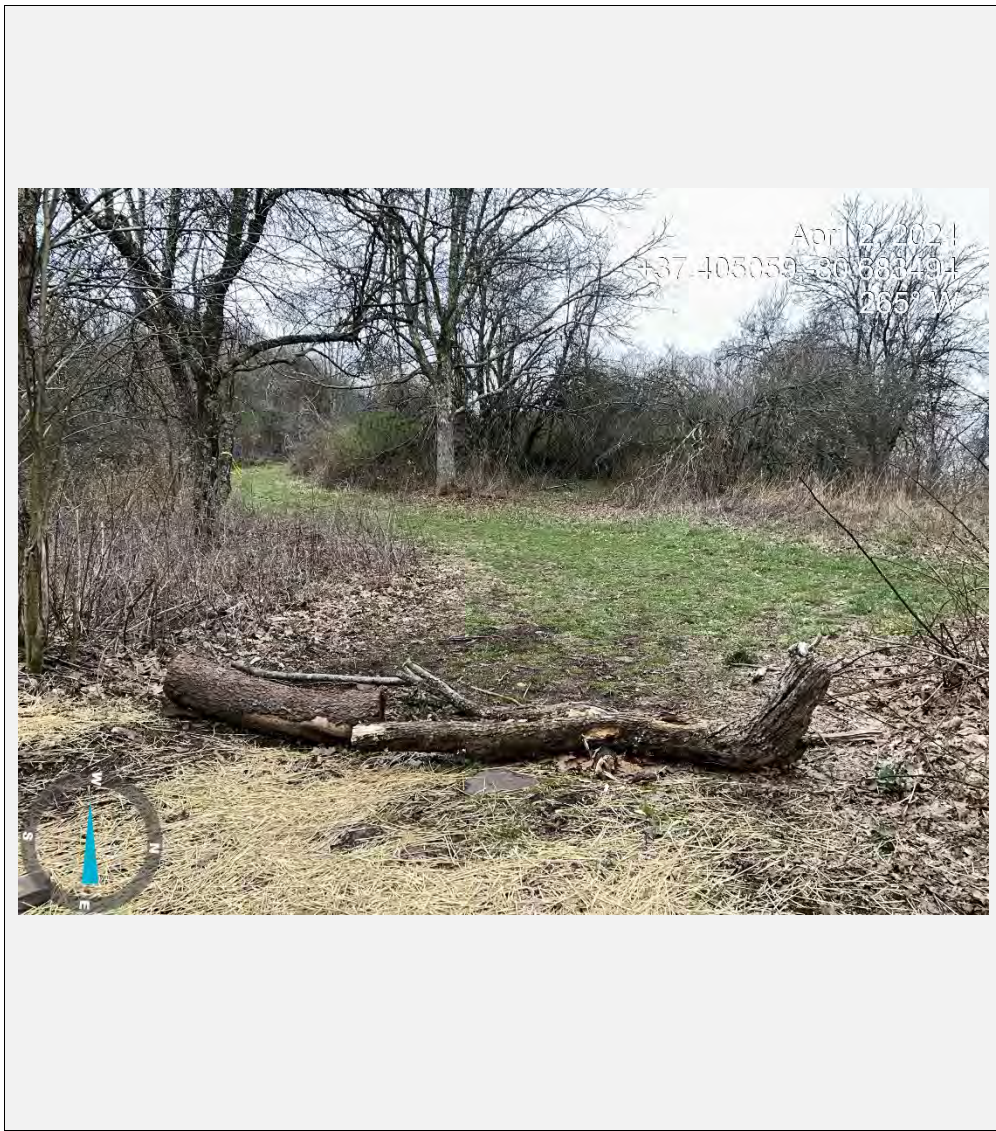
Date: April 2, 2024
Photo: 12
Aspect: West
Milepost: N/A
Station: N/A
Key Items: Cultural Resources
Description: No evidence of vehicle traffic on ANST.

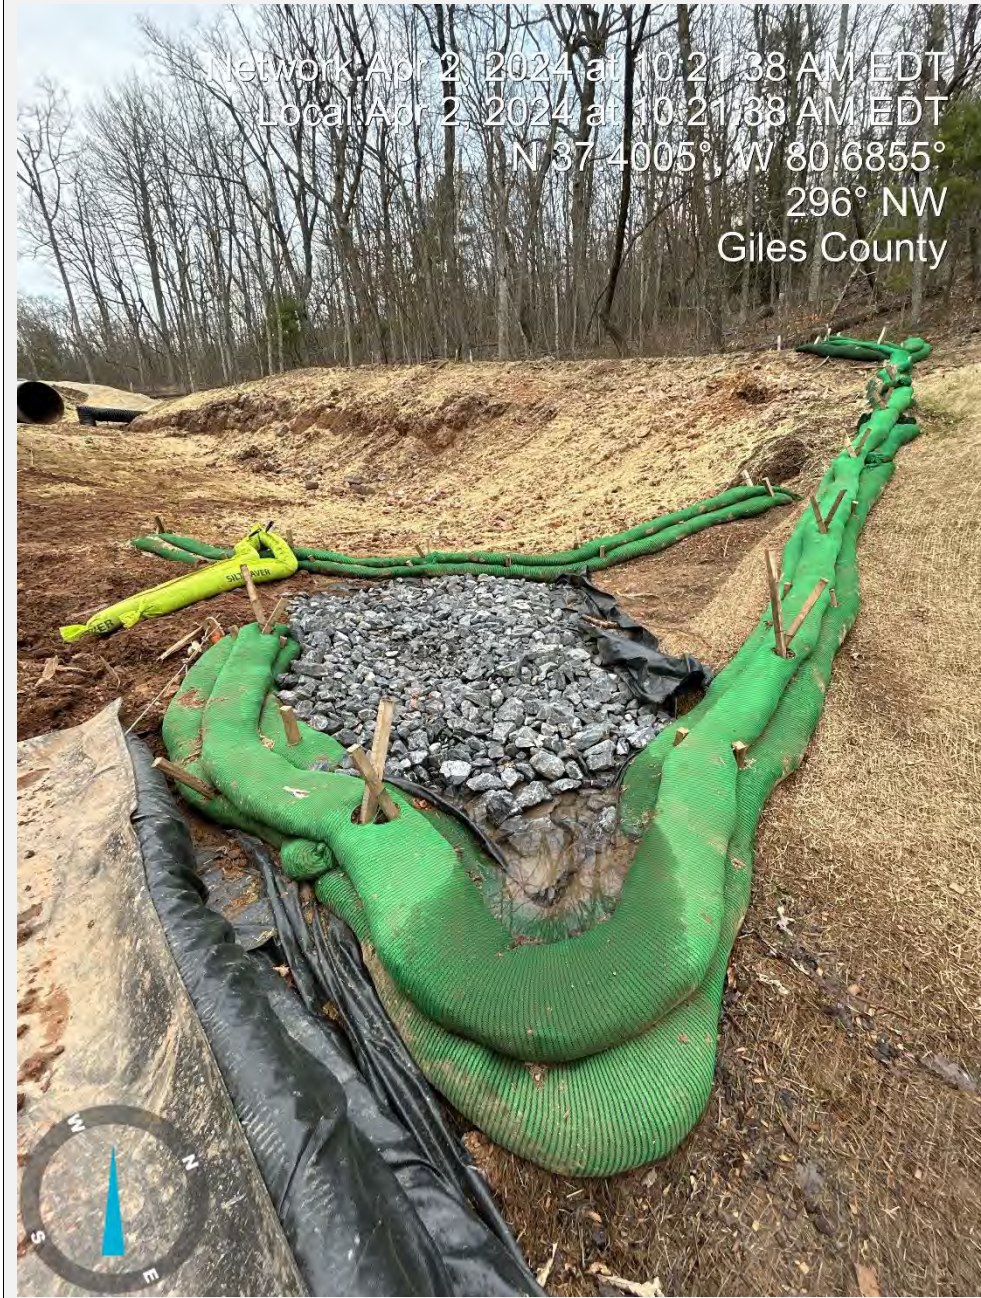
Date: April 2, 2024
Photo: 13
Aspect: NW
Milepost: 196.65
Station:
Key Items: Aquatic resources
Description: Springs continue to flow clear through the ROW and exit the LOD.

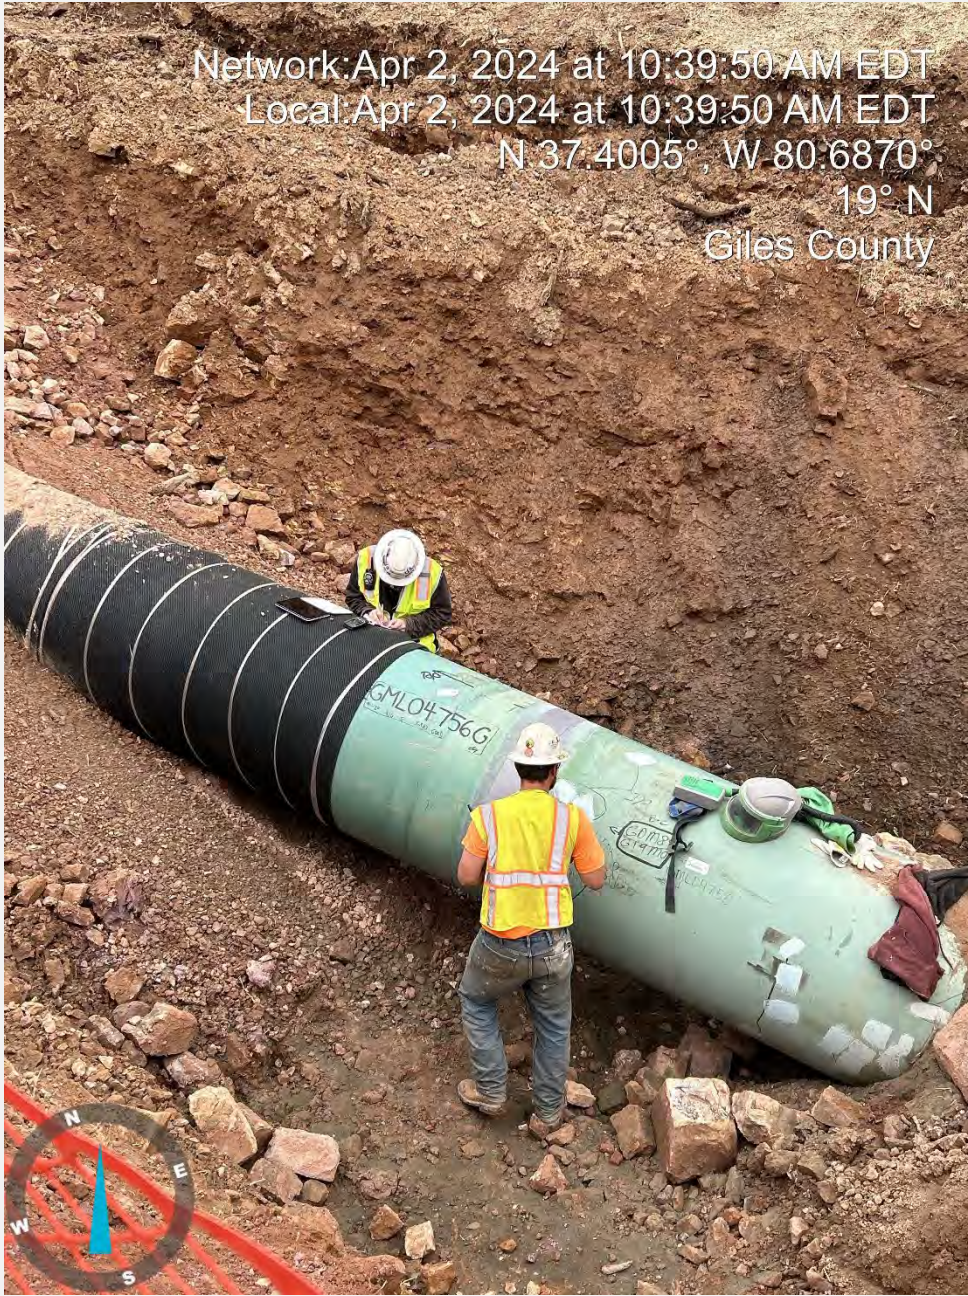
Date: April 2, 2024
Photo: 14
Aspect: N
Milepost: 196.58
Station:
Key Items: Construction
Description: Crews are coating pipe.

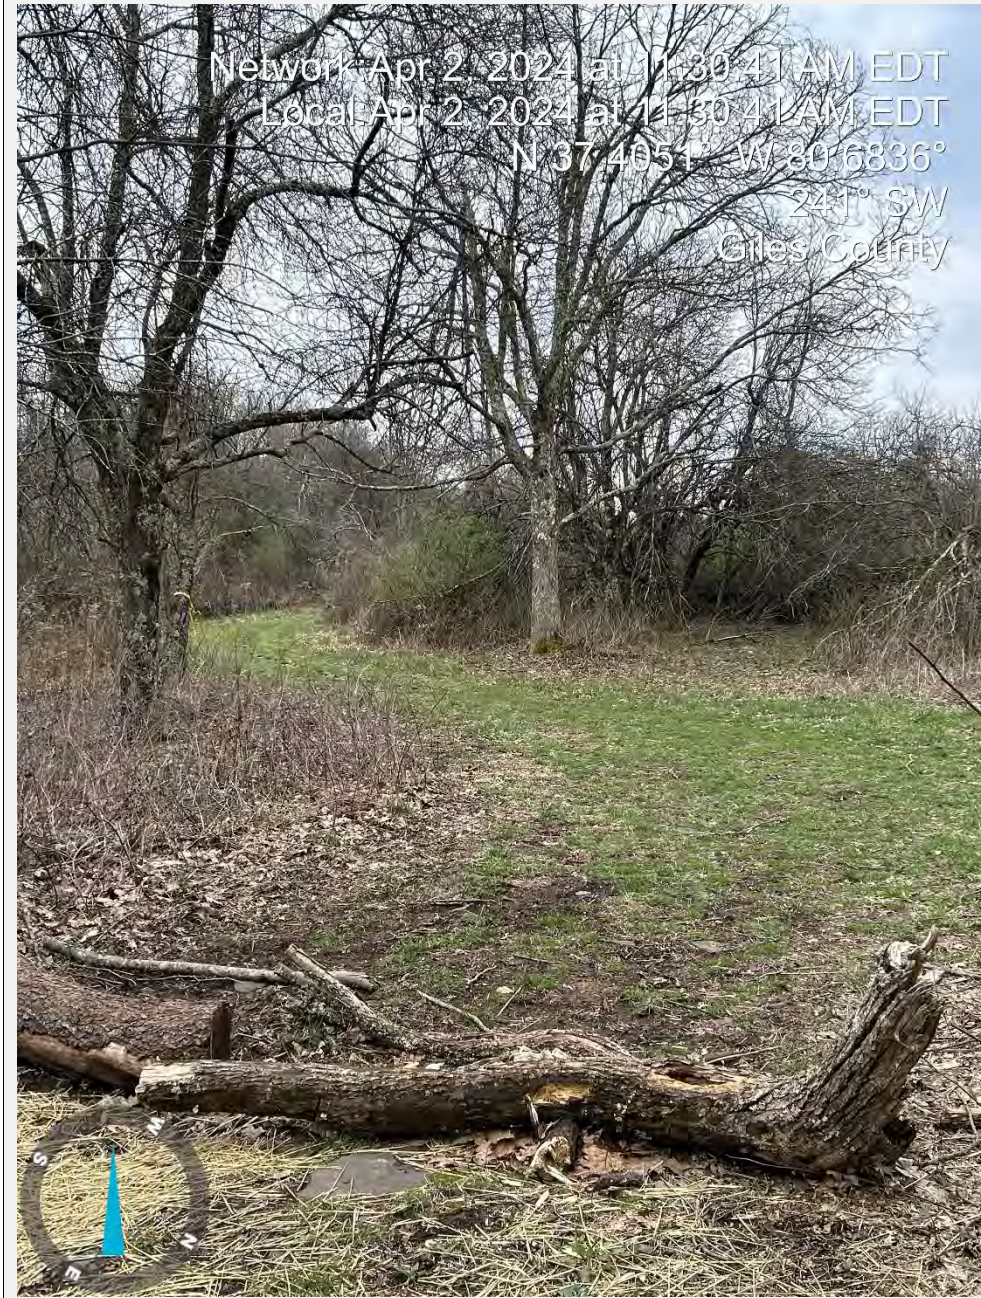
Date: April 2, 2024
Photo: 15
Aspect: sw
Milepost:
Station:
Key Items: Cultural Resources
Description: Barrier marks ANST to prevent vehicles on Mystery Ridge Rd. from accessing trail. Trail appears grassy as shown in photo.

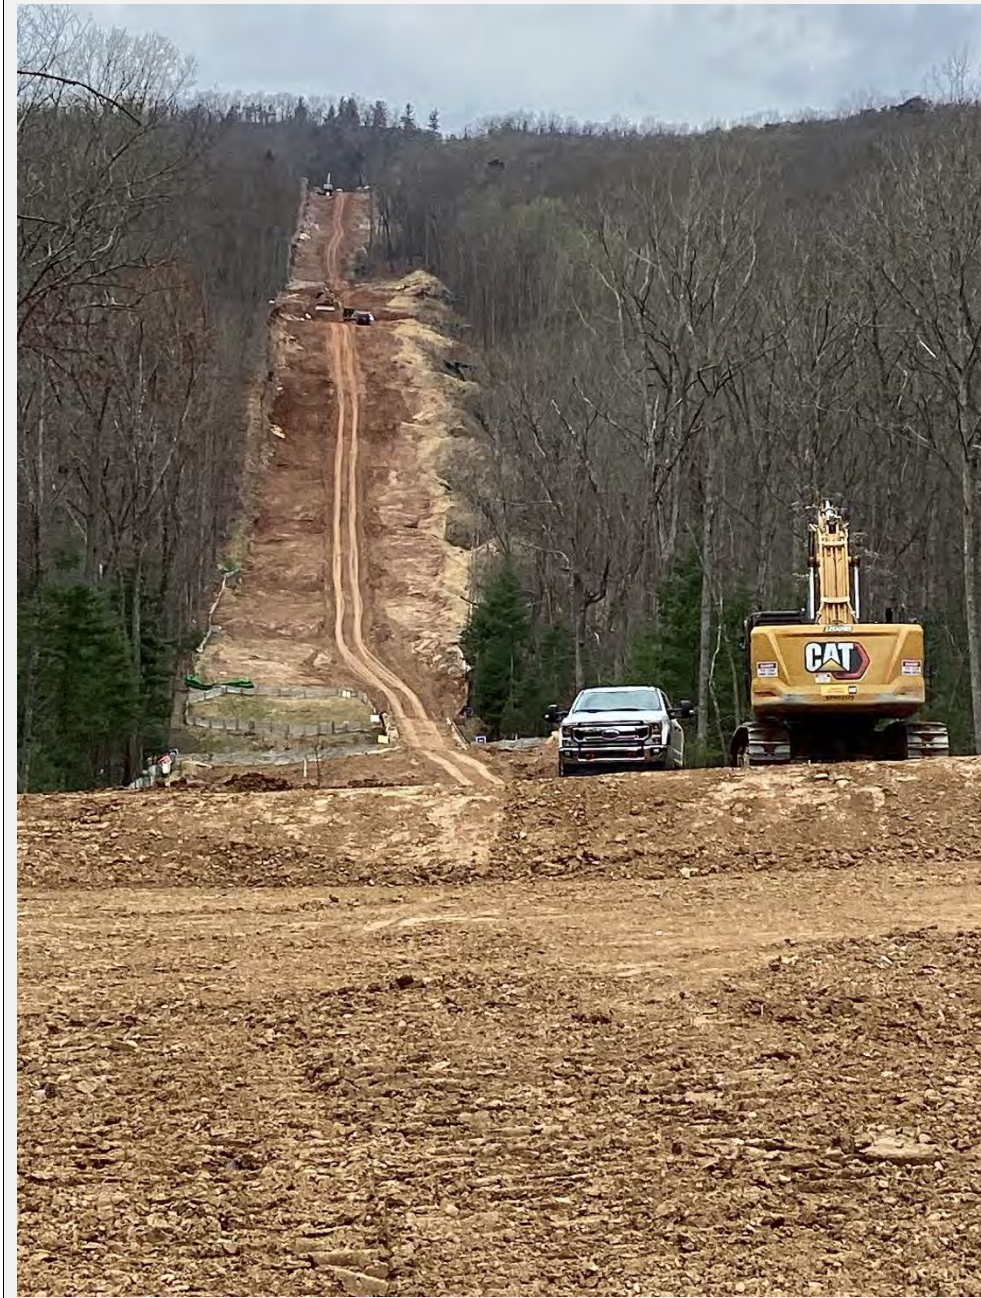
Date: April 2, 2024
Photo: 16
Aspect: N
Milepost: 219.22
Station: 11591+60
Key Items: Construction, Erosion control
Description: View to the top of Sinking Creek Mountain and JNF line. MVP is trenching and hammering rock near the peak. The environmental crew is reworking water bars from lower to mid Sinking Creek Mountain.
