May 10, 2024

Re: Mountain Valley Pipeline, LLC Request to Place Project Facilities in Service (CP16-10-000)

Coalition Letter to PHMSA re Mountain Valley Pipeline
Consent Order Quarterly Report

In compliance with Environmental Condition Nos. 8 and 14 of the Certificate Order, Mountain Valley submits its status report for April 6, 2024 through April 12, 2024.

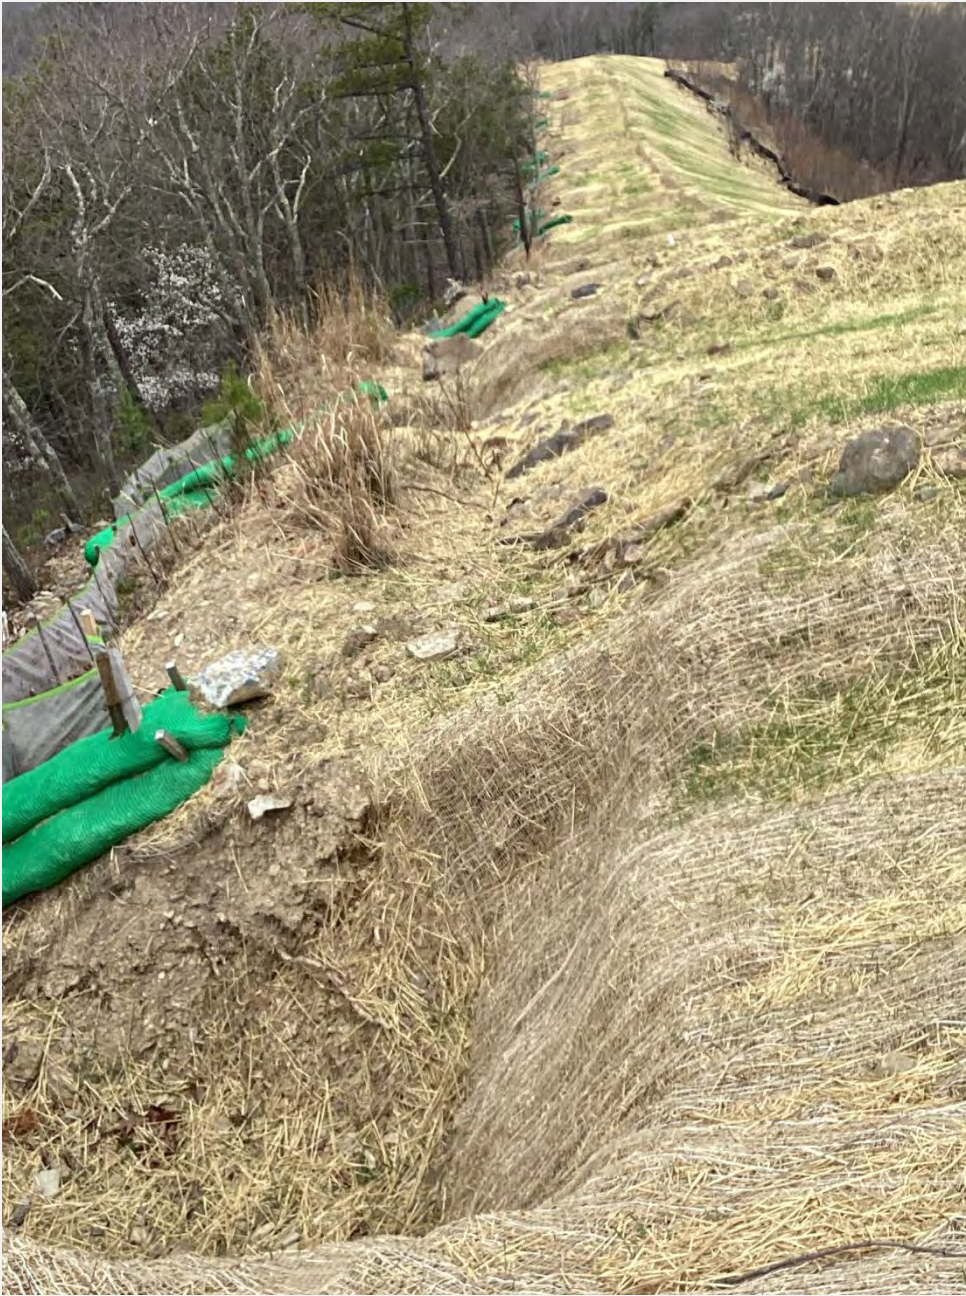
Date: April 2, 2024
Photo: 17
Aspect: N
Milepost: 220.63
Station: 11664+00
Key Items: Erosion control
<p>Description: Upper Brush Mountain is stable with effective ECDs. Grass seedlings have sprouted.</p> <p>Sumps with triple stacked filter socks are functional and effective.</p>

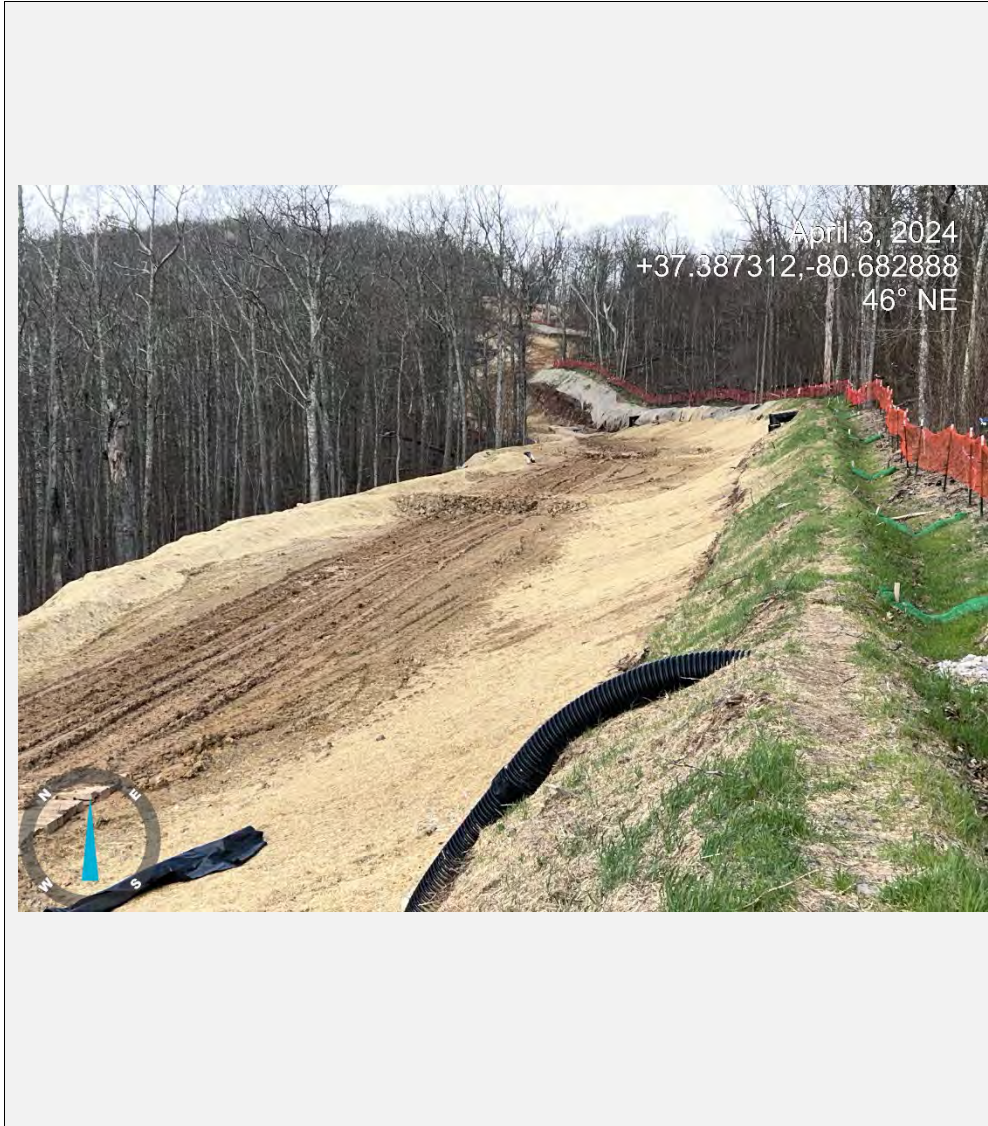
Date: April 3, 2024
Photo: 18
Aspect: Northeast
Milepost: 197.8
Station: 10457+00
Key Items: Erosion control
Description: Slope breakers are installed on main section of Peters Mountain ROW.

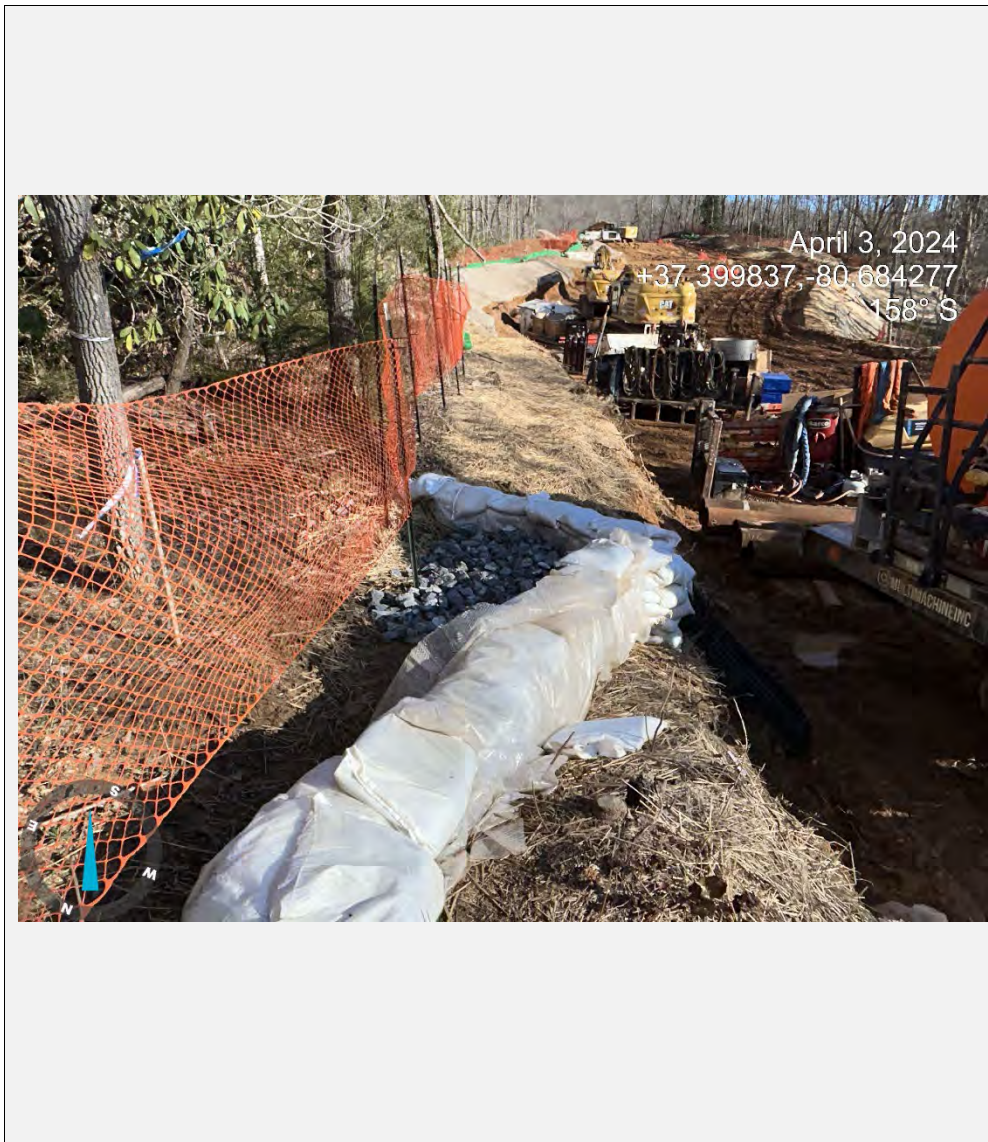
Photo: 19

Description: Clean water diversion drains water from Mystery Ridge Road across the ROW.

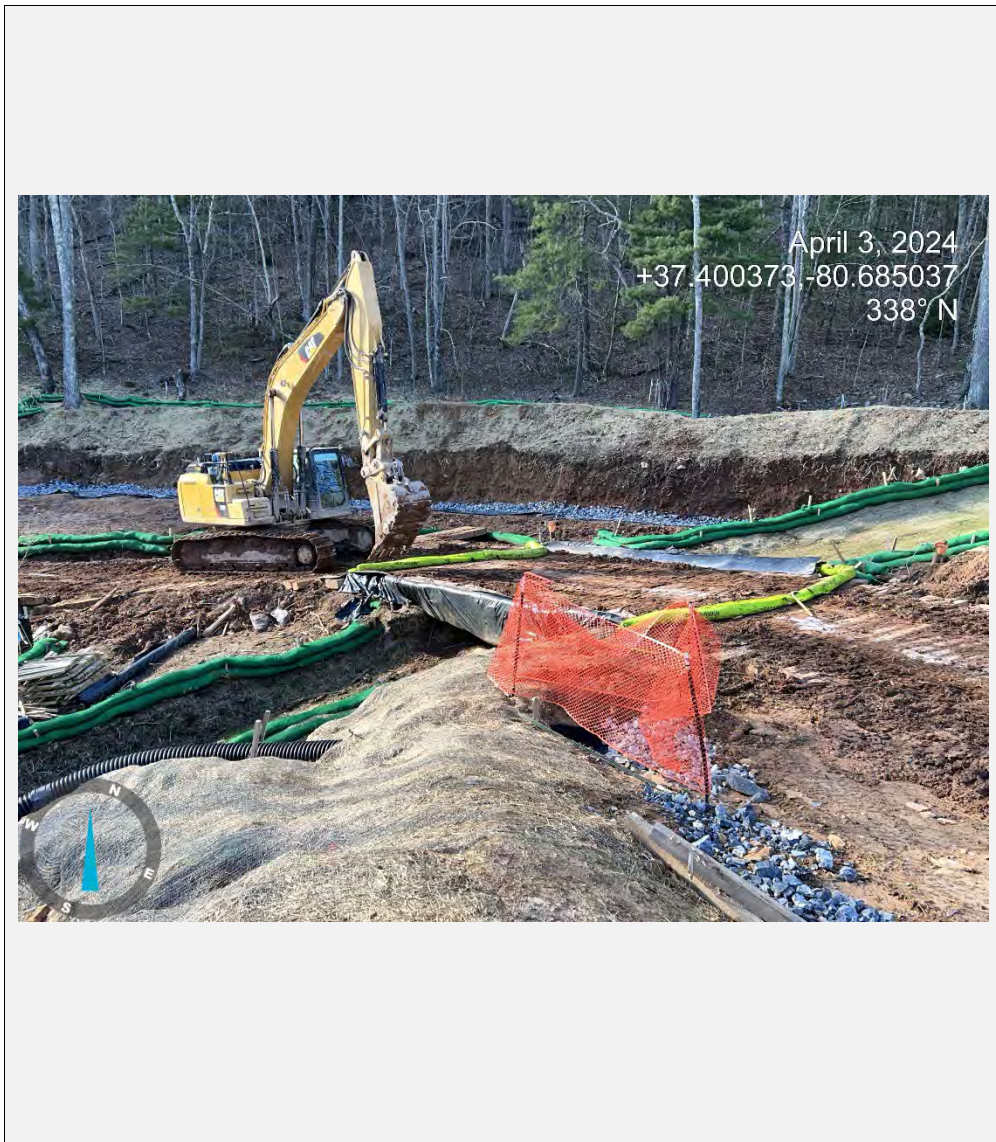
Date: April 3, 2024
Photo: 20
Aspect: North
Milepost: 196.7
Station: 10396+00
Key Items: Construction, Equipment, Aquatic resources, Erosion control
Description: Crew cleaned the bridges across the ROW at the end of the day and installed straw wattles across the travel lane.

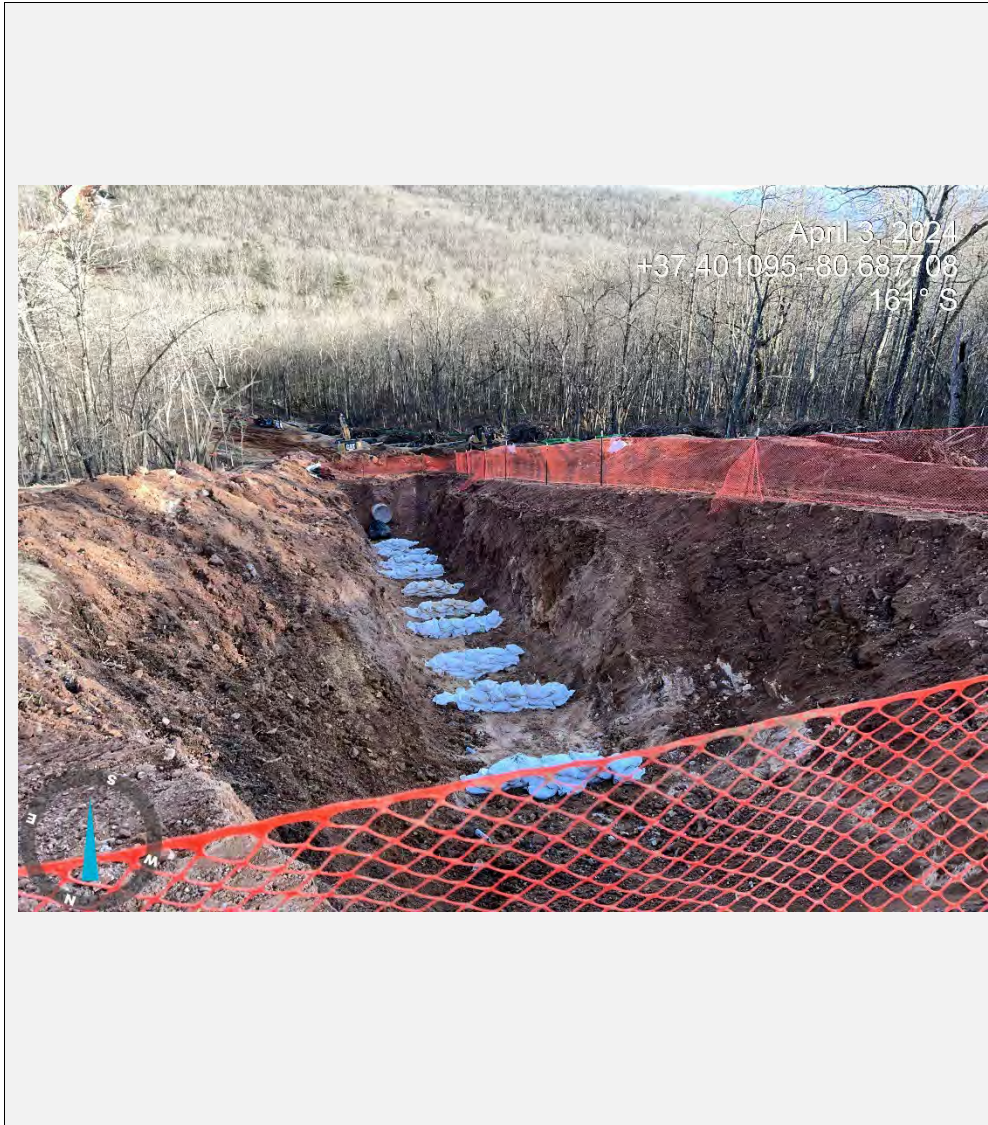
Date: April 3, 2024
Photo: 21
Aspect: South
Milepost: 196.5
Station: 10387+00
Key Items: Construction, Equipment
Description: Tie-in crew dug a new section of trench today. Wildlife ramps are properly installed, and safety fence is present on three sides.

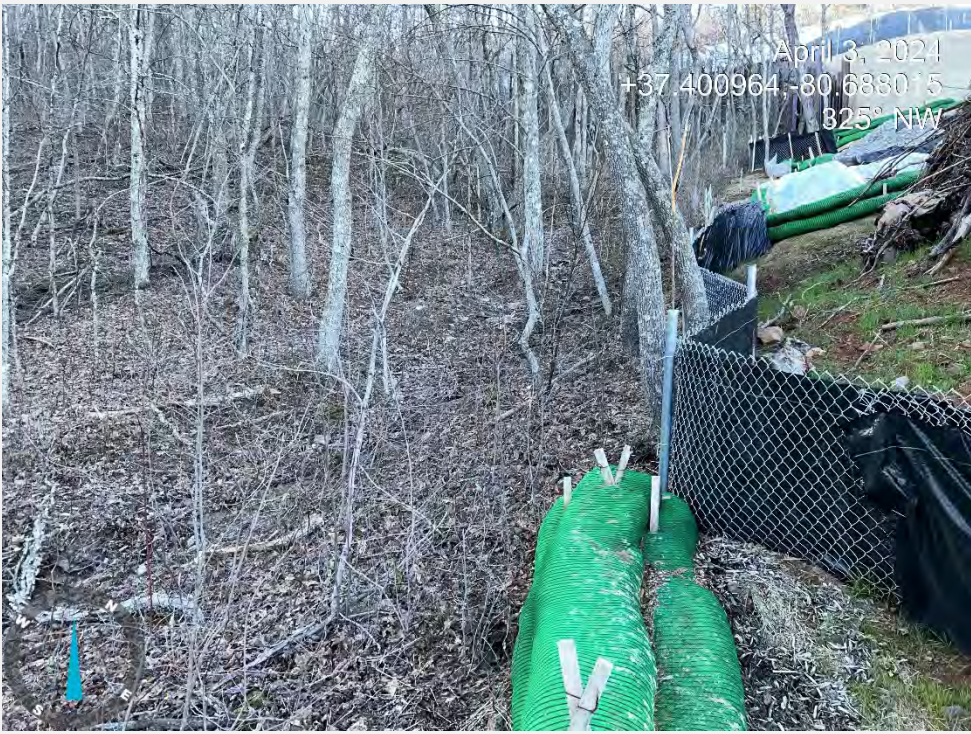
A photograph showing a construction site in a wooded area. In the foreground, there are two parallel rows of green erosion control fabric (likely straw or coconut fiber) laid out on the ground. To the right, a chain-link fence runs along the edge of the site. In the background, there are bare trees and a structure covered with a blue tarp. A blue flag is visible on the left side of the image. A semi-transparent watermark in the upper right of the photo reads: "April 3, 2024 +37.400964, -80.688015 325° NW".	Date: April 3, 2024
	Photo: 22
	Aspect: Northwest
	Milepost: 196.5
	Station: 10387+00
	Key Items: Construction, Aquatic resources, Erosion control
	Description: S-KL24 flowing clear after rain event, ECDs functioning properly after rebuild.

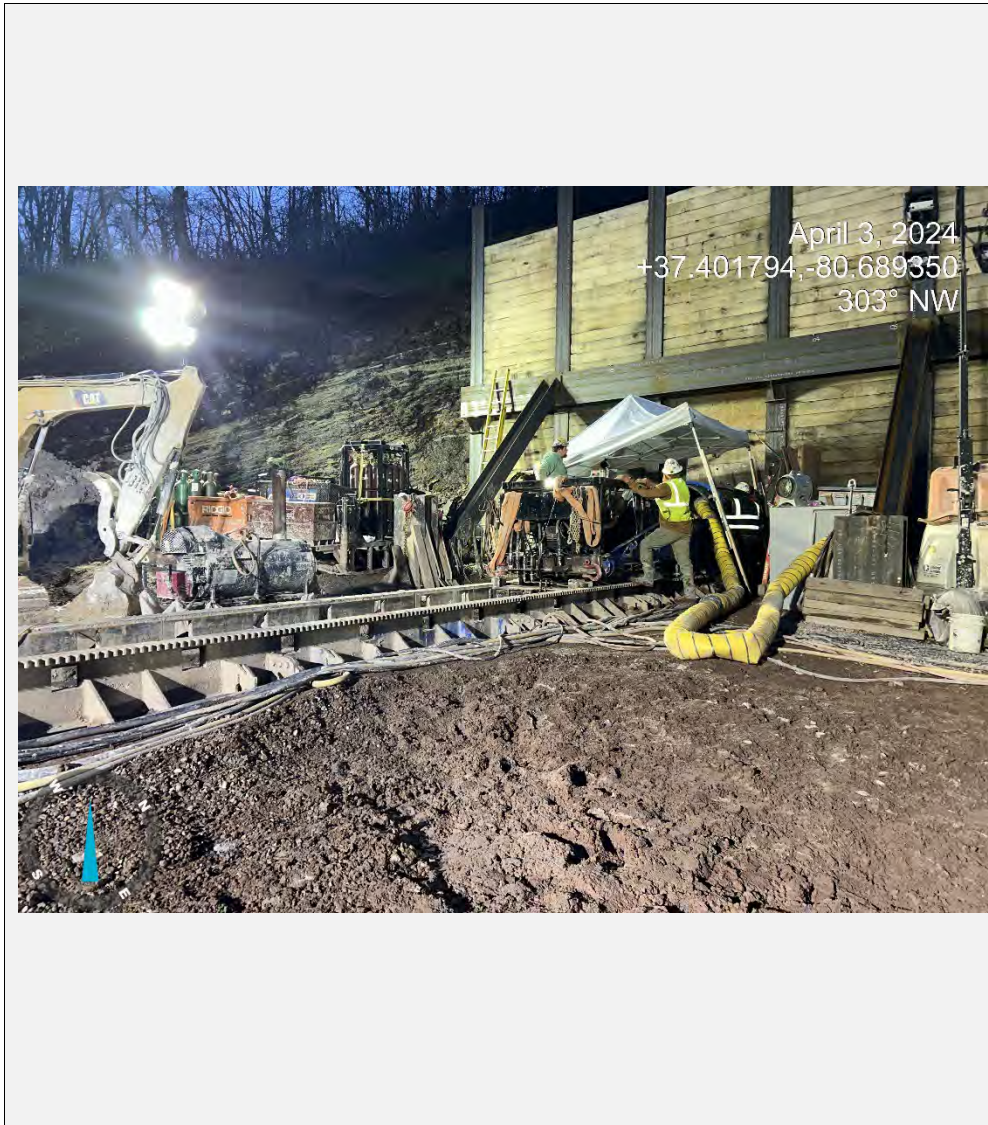
Date: April 3, 2024
Photo: 23
Aspect: Northwest
Milepost: 196.4
Station: 10380+00
Key Items: Construction, Equipment
Description: Night shift continues drilling under the ANST.

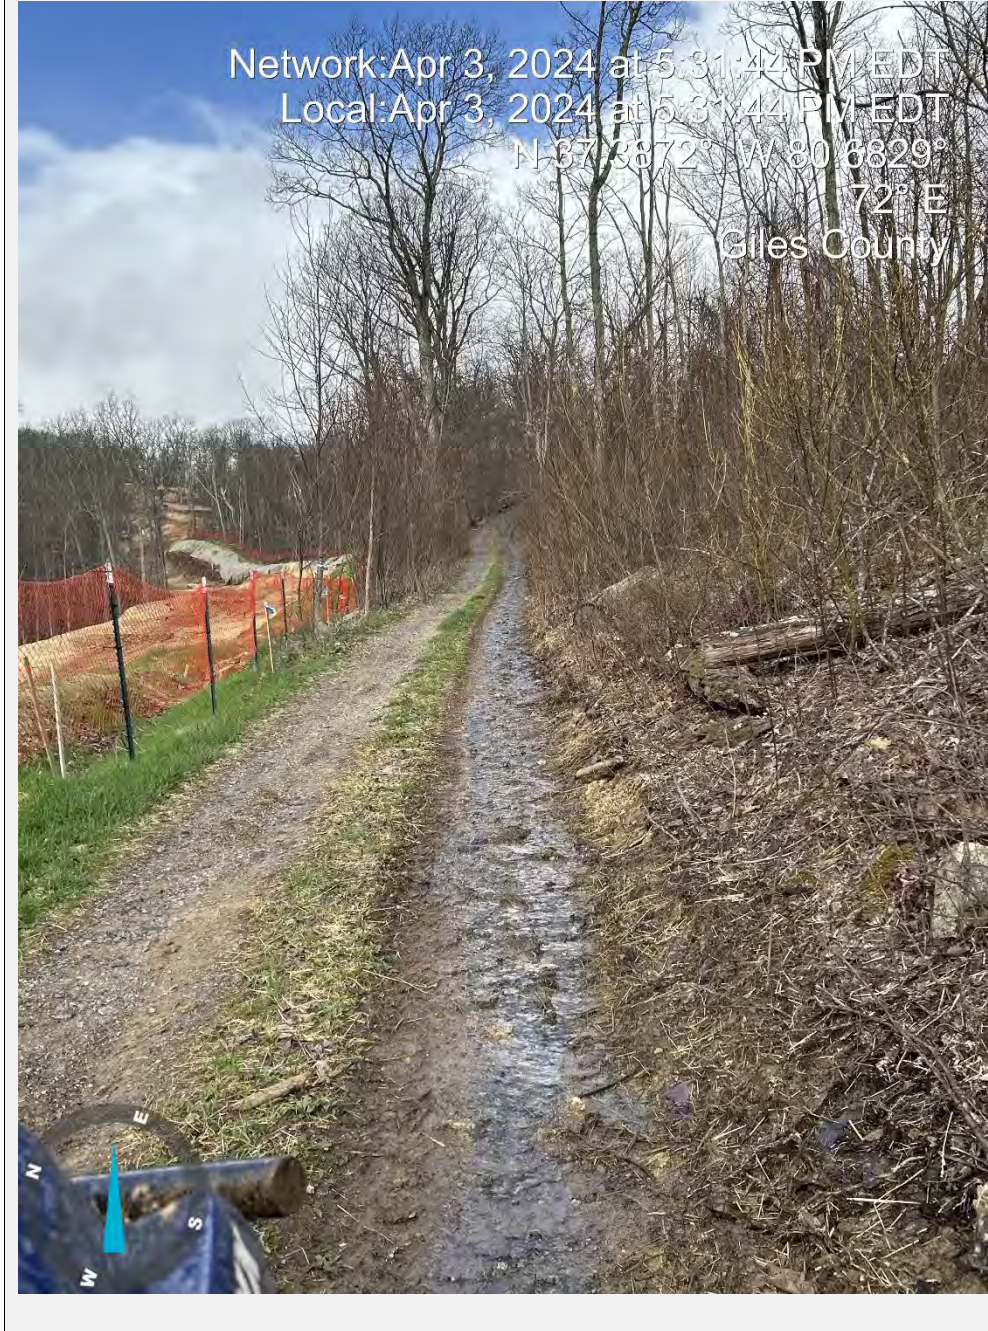
Date: April 3, 2024
Photo: 24
Aspect: E
Milepost: 197.80
Station:
Key Items: Other
Description: Water flowing clear from Mystery Ridge Road onto ROW.

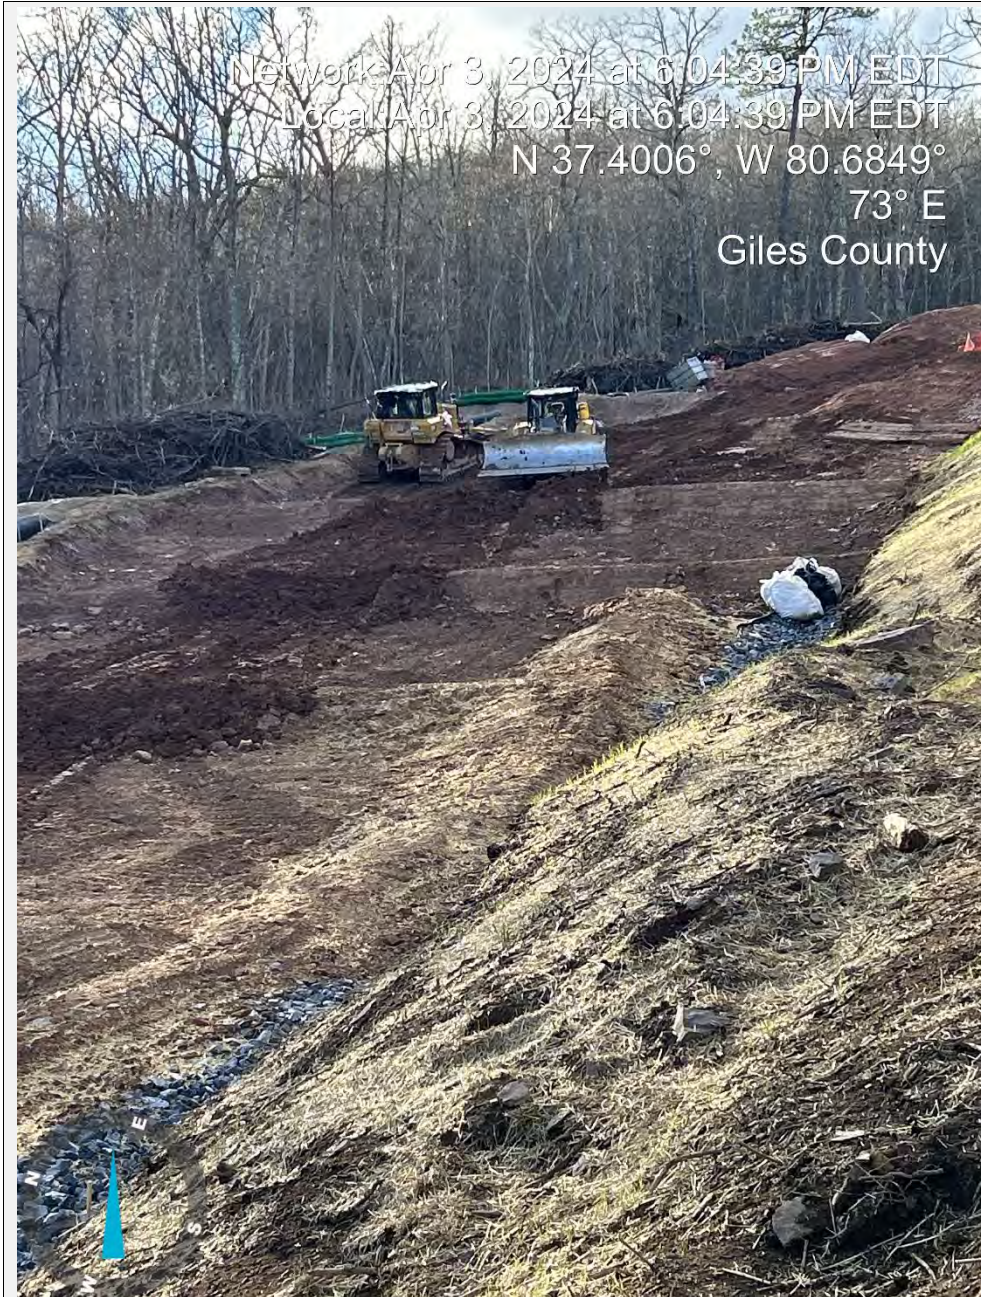
Date: April 3, 2024
Photo: 26
Aspect: E
Milepost: 196.61
Station:
Key Items: Erosion control
Description: Contractor reinstalled water bars at end of day shift.

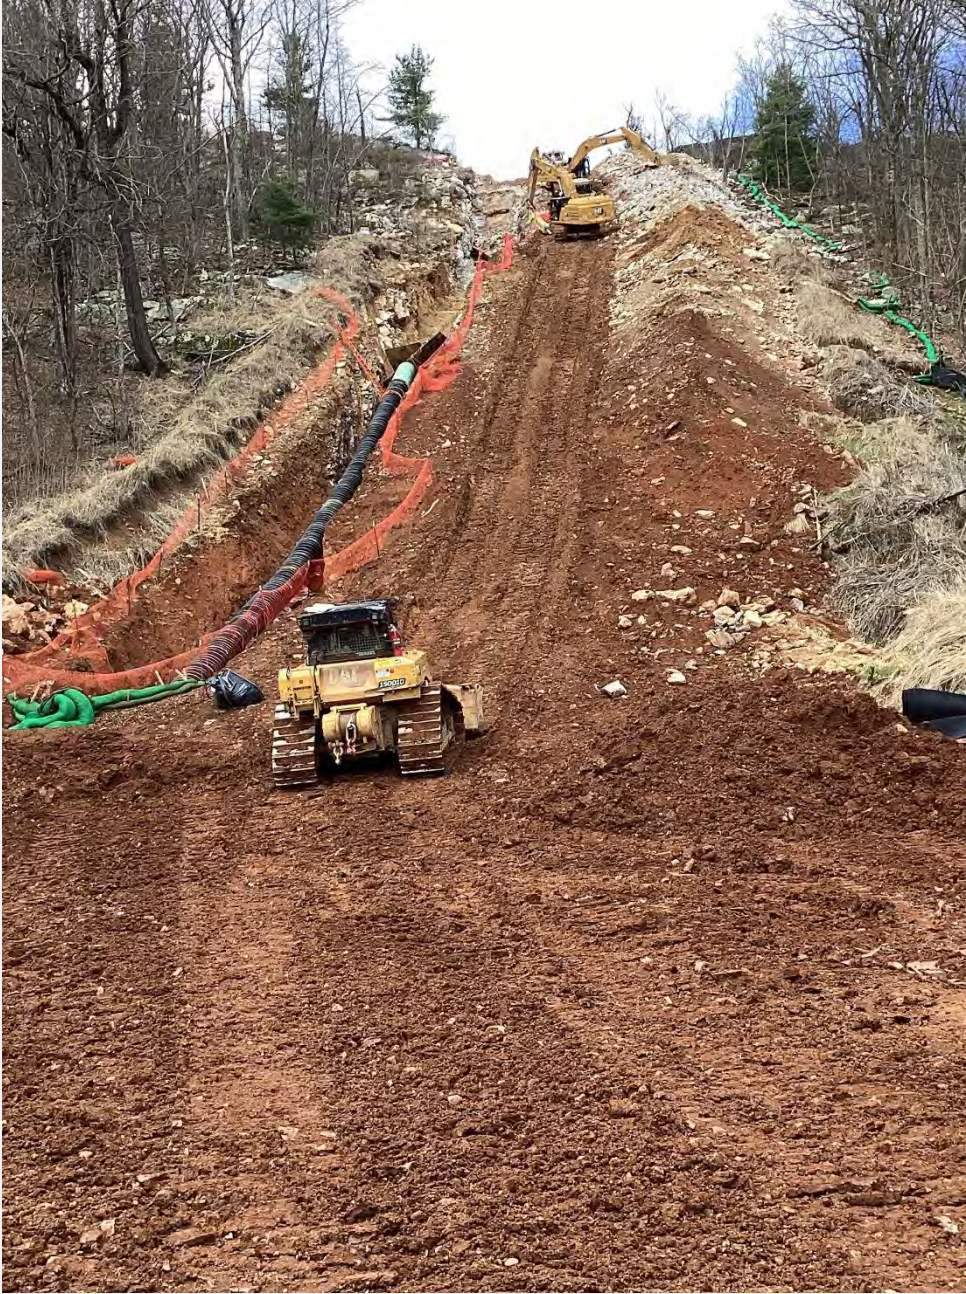
Date: April 3, 2024
Photo: 27
Aspect: N
Milepost: 218.64
Station: 11558+60
Key Items: Construction, Erosion control
Description: View to the top of Sinking Creek Mountain and JNF line. MVP is trenching and hammering rock near the peak.

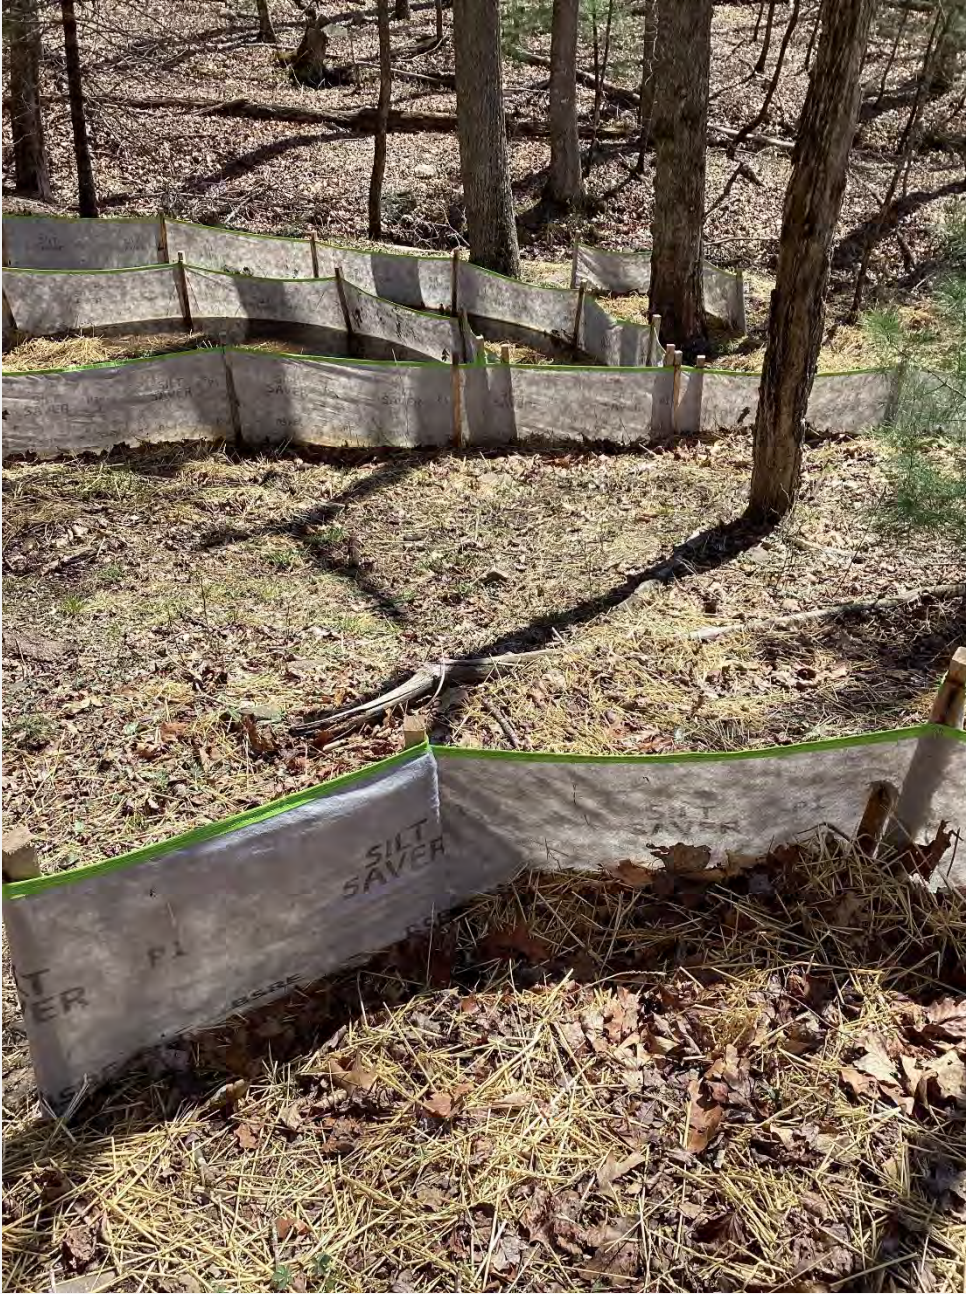
Date: April 3, 2024
Photo: 28
Aspect: SE
Milepost: 219.11
Station: 11584+00
Key Items: Aquatic resources, Erosion control
Description: The stacked silt fences above stream crossing S-PP21 are effective.

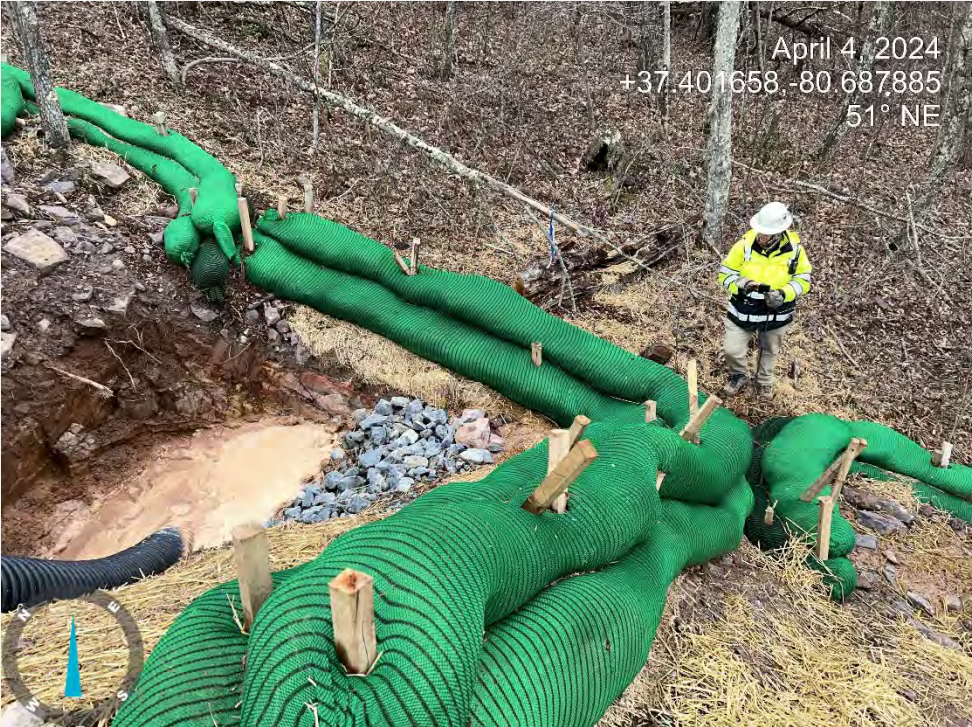
Date: April 4, 2024
	Photo: 32
	Aspect: Northeast
	Milepost: 196.5
	Station: 10385+00
	Key Items: Construction, Equipment, Erosion control
Description: Filter sock at the edge of a sump was being undercut, but no sediment left the LOD. Spoke with environmental foreman who added additional staking to secure sock.

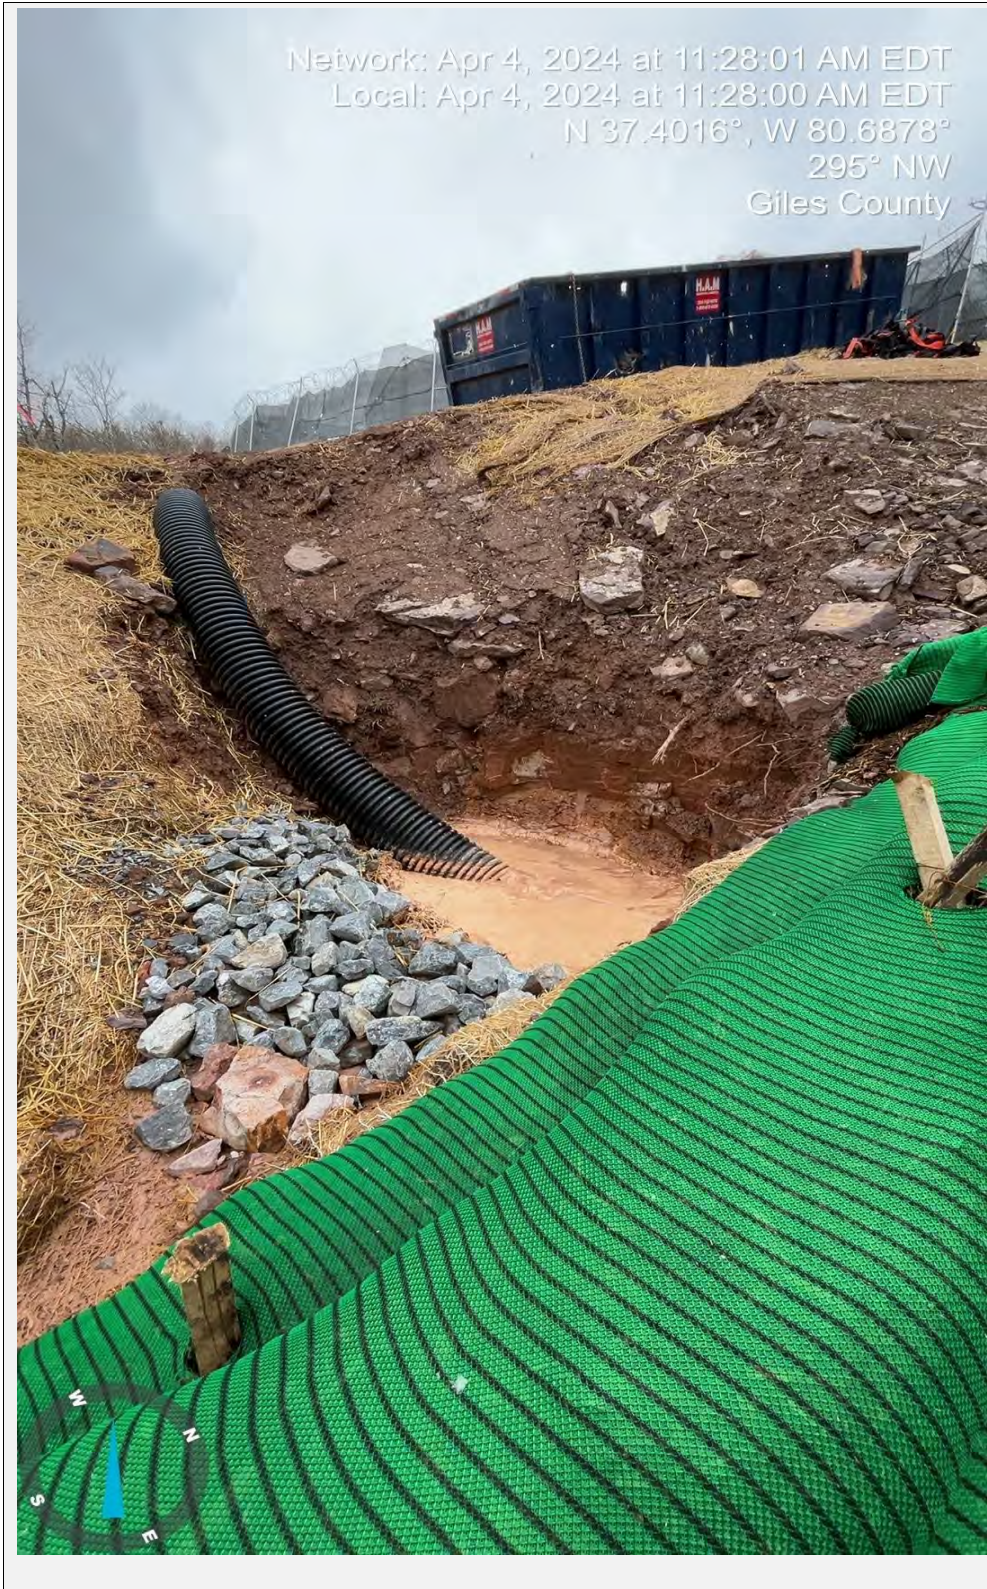
Date: April 4, 2024
Photo: 37
Aspect: w
Milepost: 196.49
Station:
Key Items: Erosion control

Description: The additional sumps that were recently added below personnel facility to divert some of the water were observed to be functioning correctly. No sediment was observed outside the LOD.

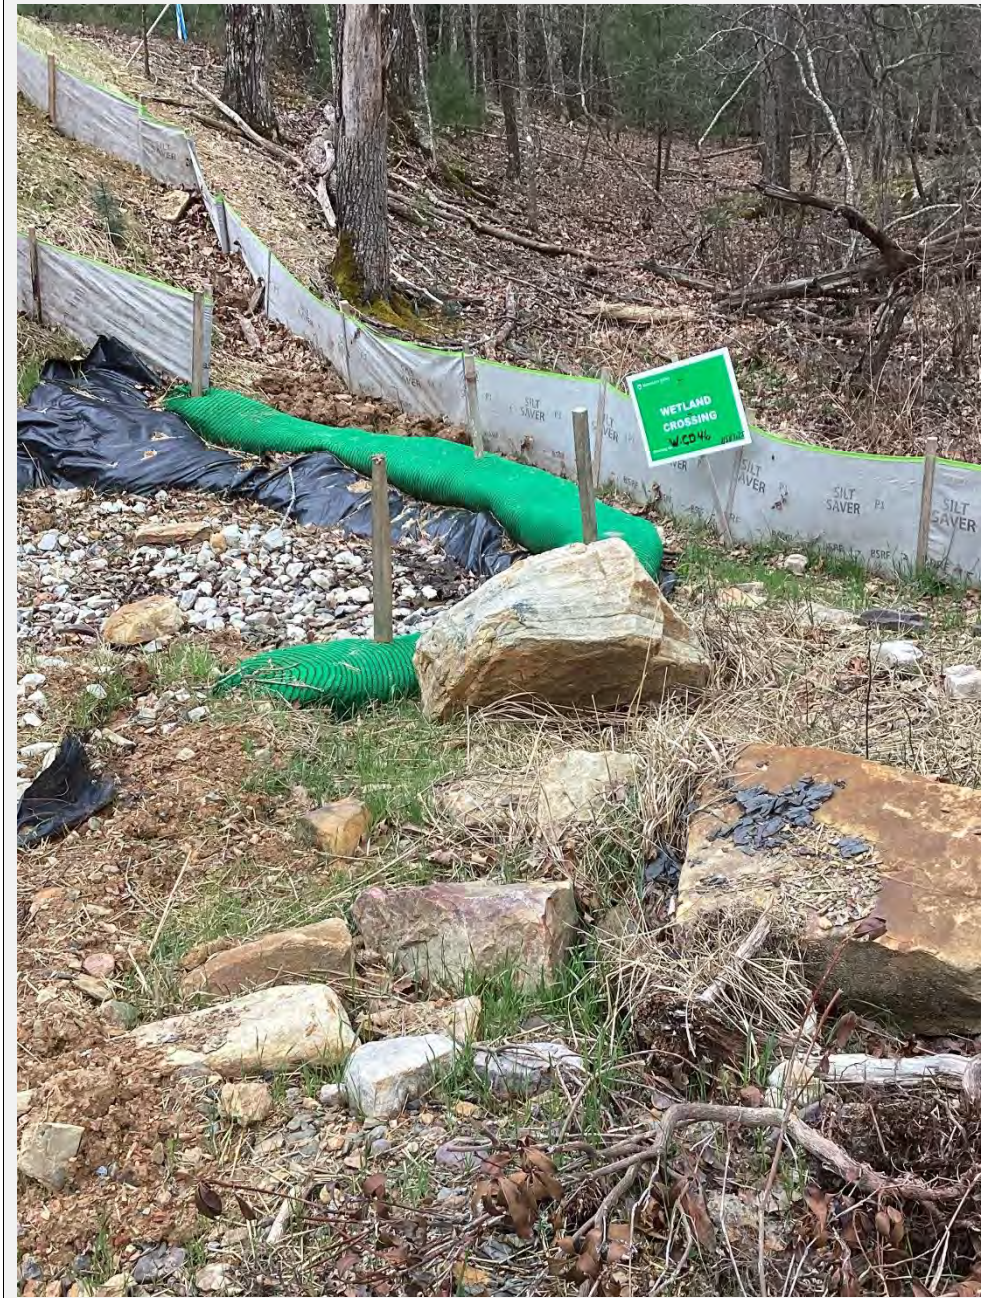
Date: April 4, 2024
Photo: 38
Aspect: SW
Milepost: 219.20
Station: 11589+35
Key Items: Aquatic resources, Erosion control
Description: Wetland crossing W-CD46 is stable with effective ECDs.

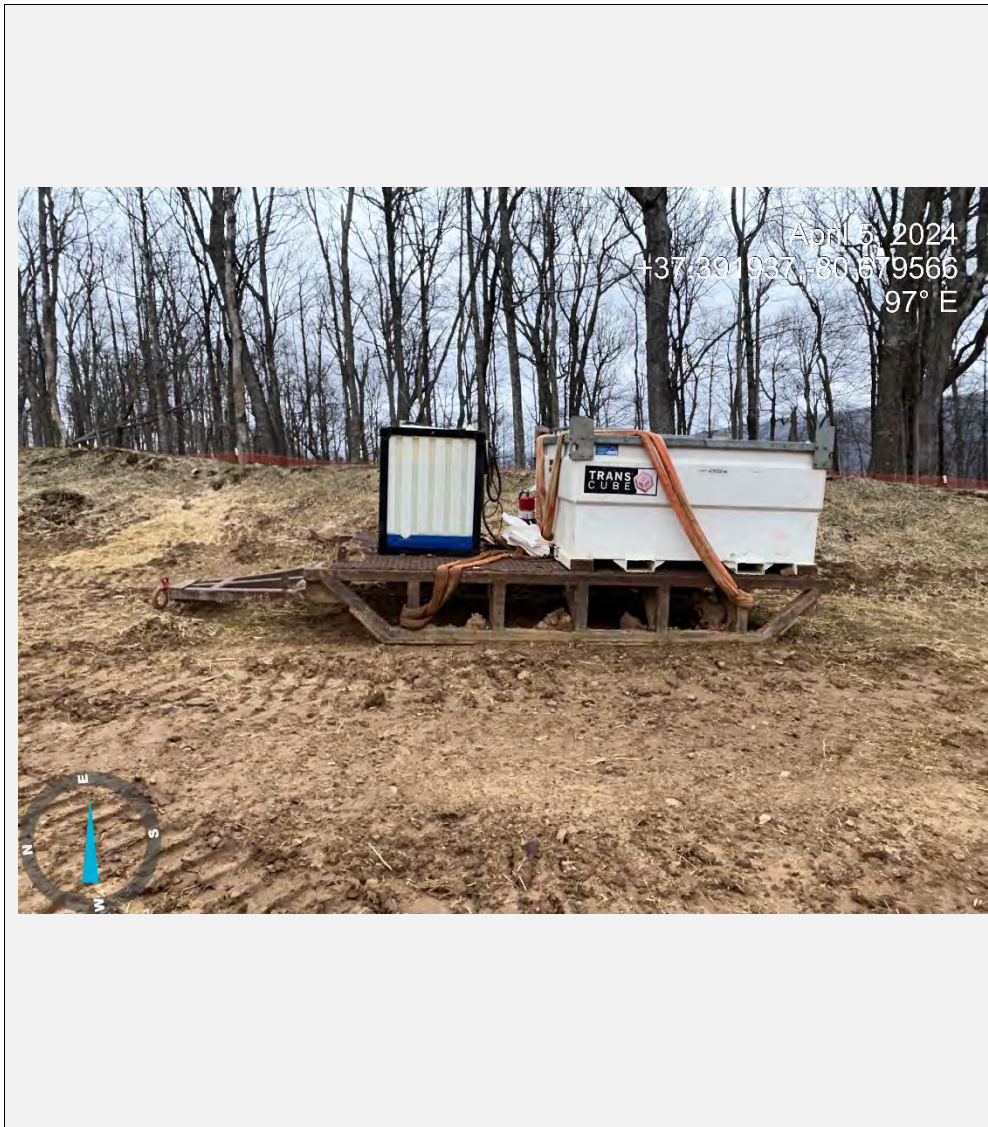
Date: April 5, 2024
Photo: 39
Aspect: East
Milepost: 197.4
Station: 10437+00
Key Items: Equipment
Description: Fuel skid staged on ROW, no leaks observed.

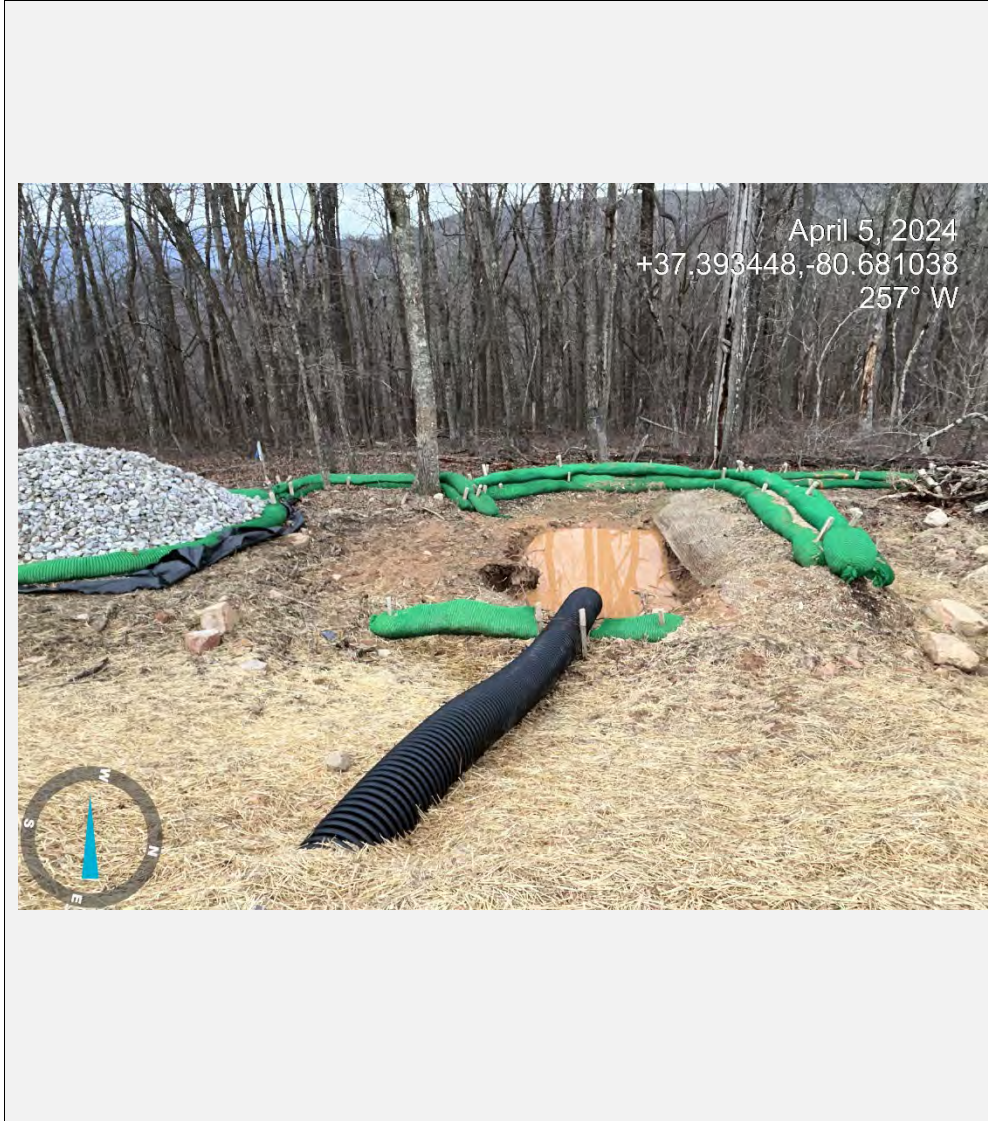
Date: April 5, 2024
Photo: 40
Aspect: West
Milepost: 197.3
Station: 10430+00
Key Items: Construction, Erosion control
Description: Slope drain sumps are near capacity, however ECDs appear to be functioning properly.

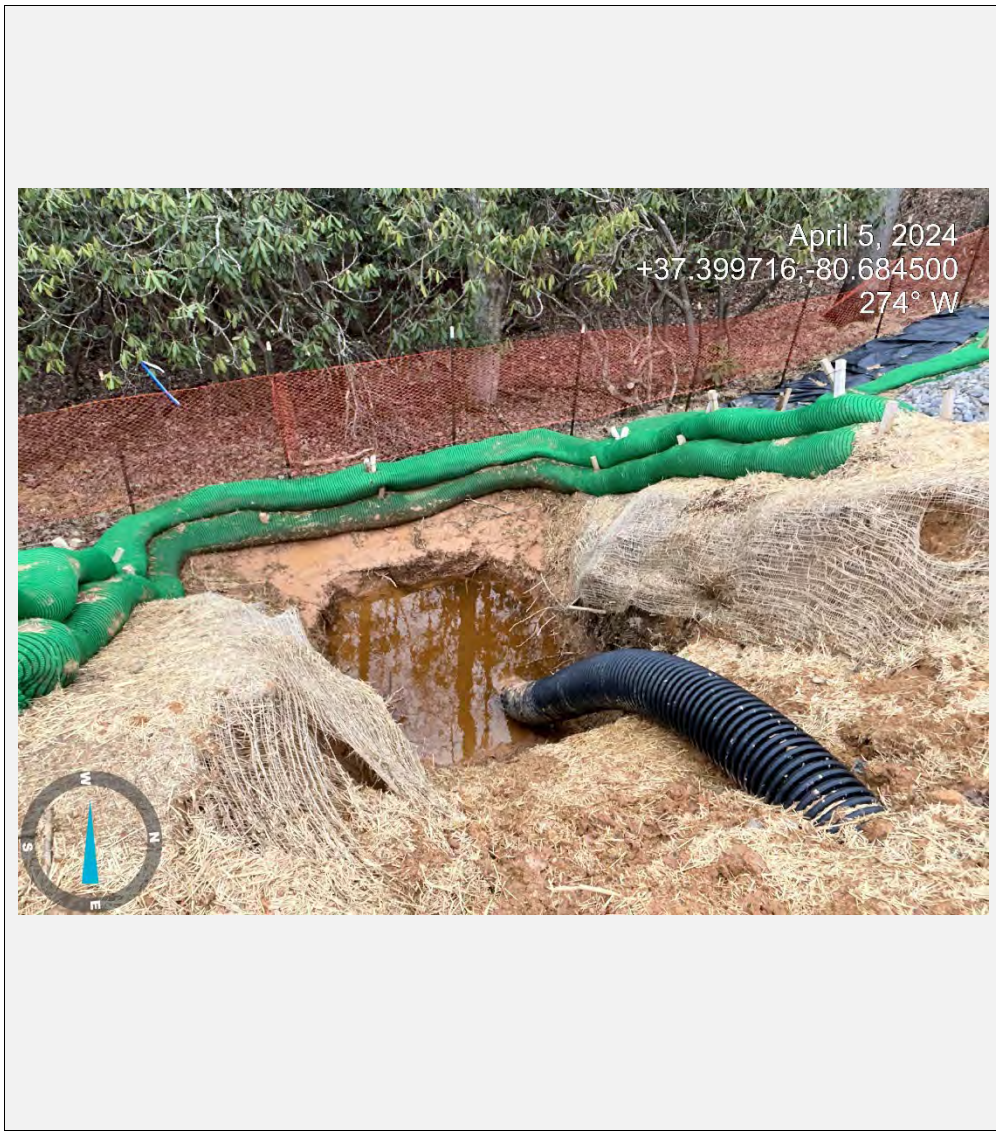
Date: April 5, 2024
Photo: 41
Aspect: West
Milepost: 196.7
Station: 10400+00
Key Items: Construction, Erosion control
Description: ECDs appear to be functioning properly.

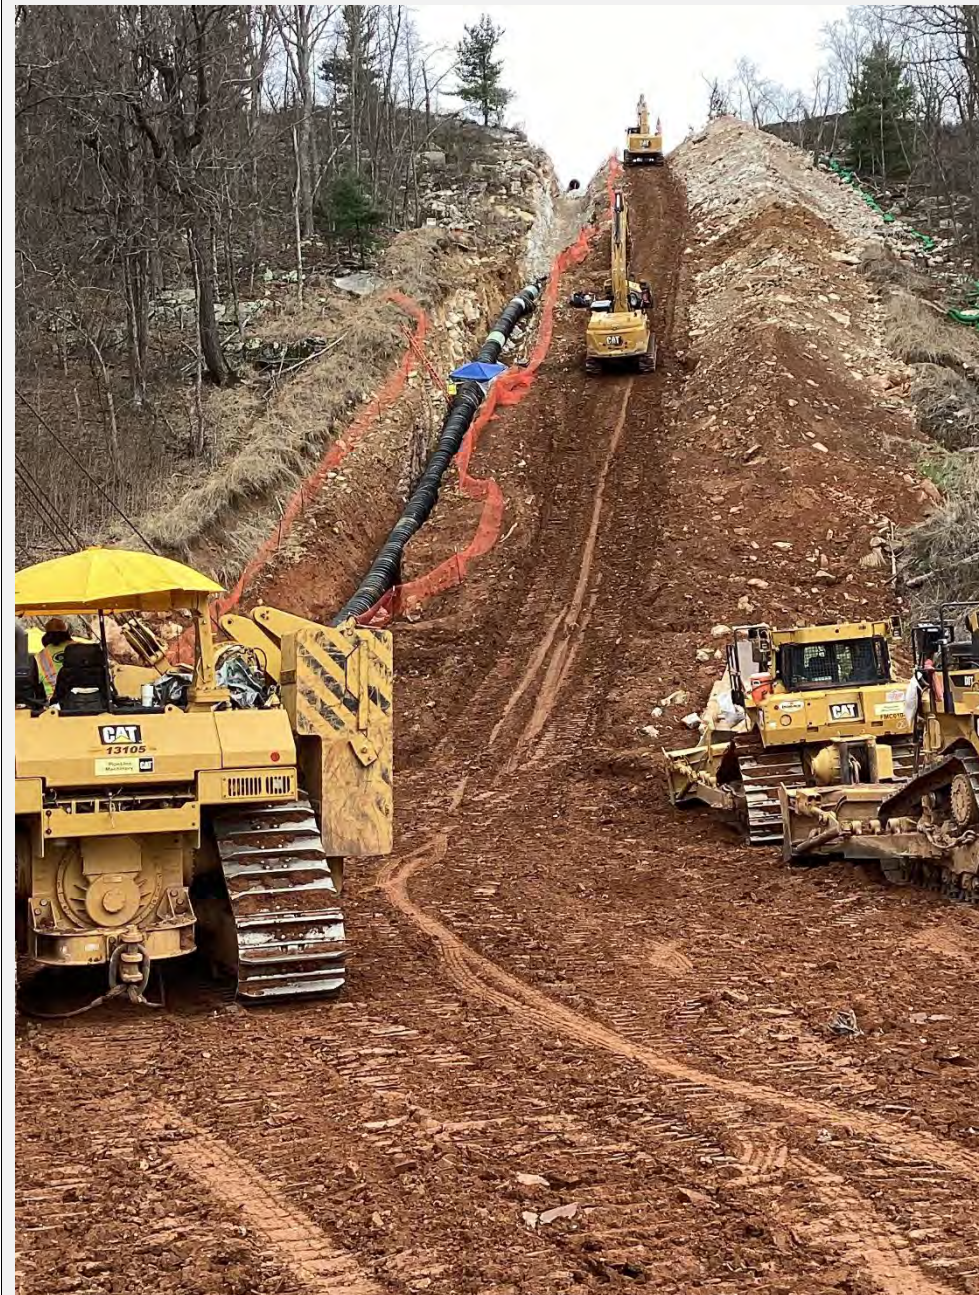
Date: April 5, 2024
Photo: 43
Aspect: N
Milepost: 218.64
Station: 11558+40
Key Items: Construction, Erosion control
Description: View to the top of Sinking Creek Mountain and JNF line. MVP is trenching and welding. Trench is prepared for setting next pipe.
