May 10, 2024

Re: Mountain Valley Pipeline, LLC Request to Place Project Facilities in Service (CP16-10-000)

Coalition Letter to PHMSA re Mountain Valley Pipeline
Consent Order Quarterly Report

In compliance with Environmental Condition Nos. 8 and 14 of the Certificate Order, Mountain Valley submits its status report for April 6, 2024 through April 12, 2024.

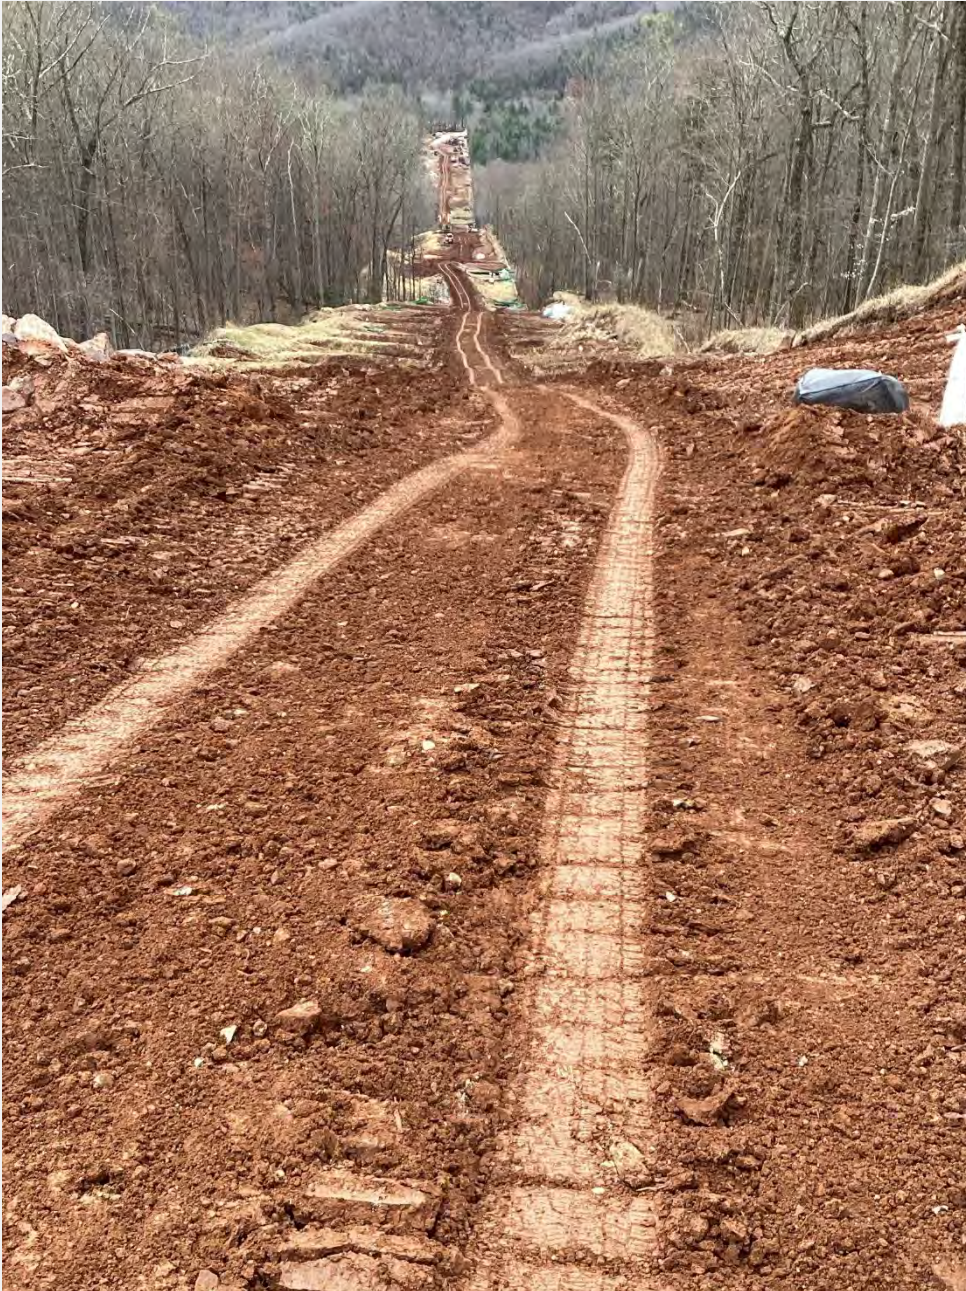
Date: April 5, 2024
Photo: 44
Aspect: s
Milepost: 218.66
Station: 11559+50
Key Items: Erosion control
Description: View down Sinking Creek Mountain. ECDs are effective.

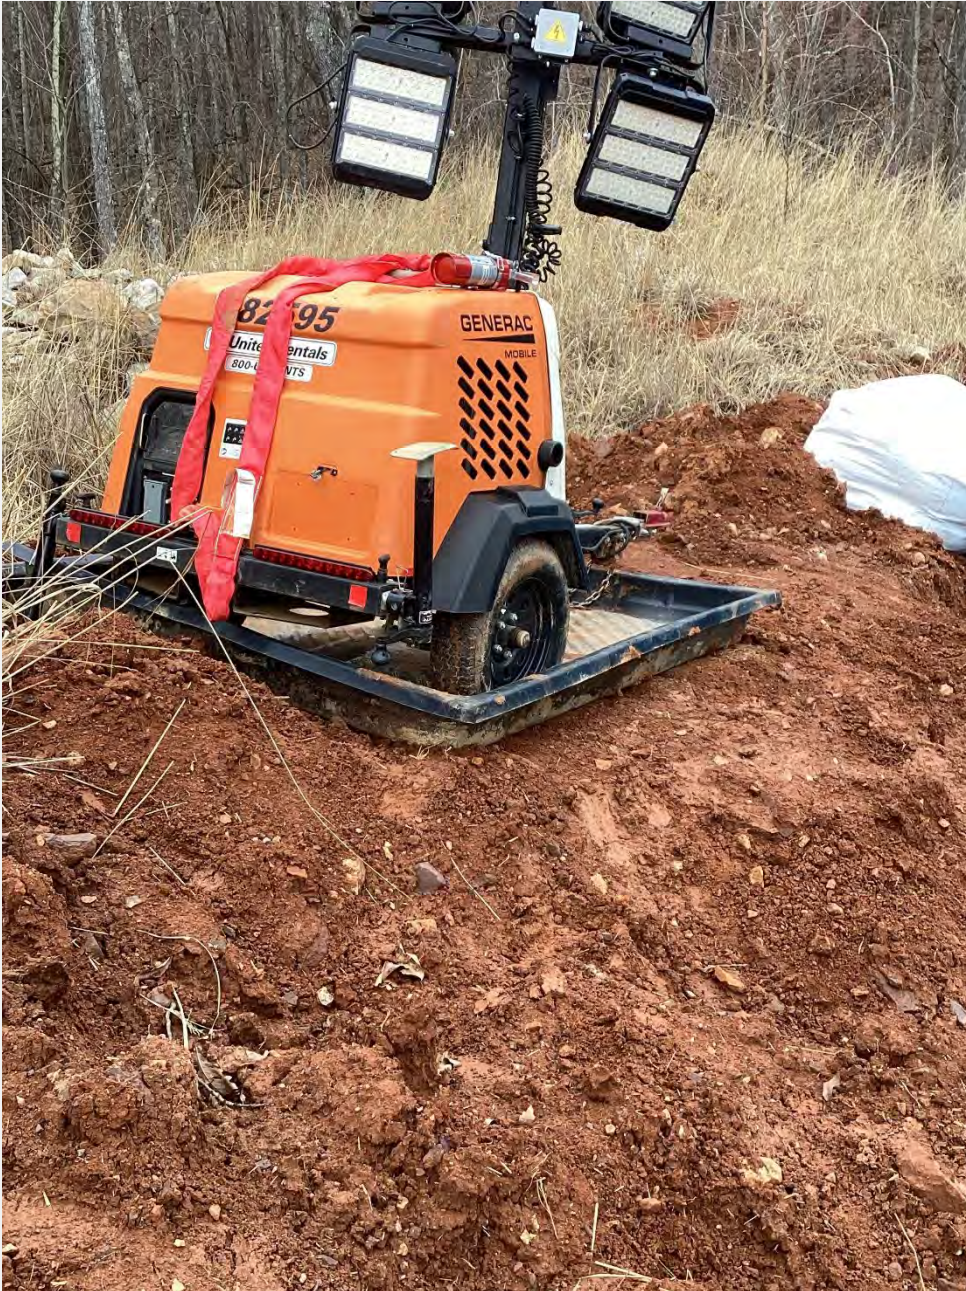
Date: April 5, 2024
Photo: 45
Aspect: w
Milepost: 218.65
Station: 11559+00
Key Items: Construction, Leaks
Description: Containment is in-place, no leaks.

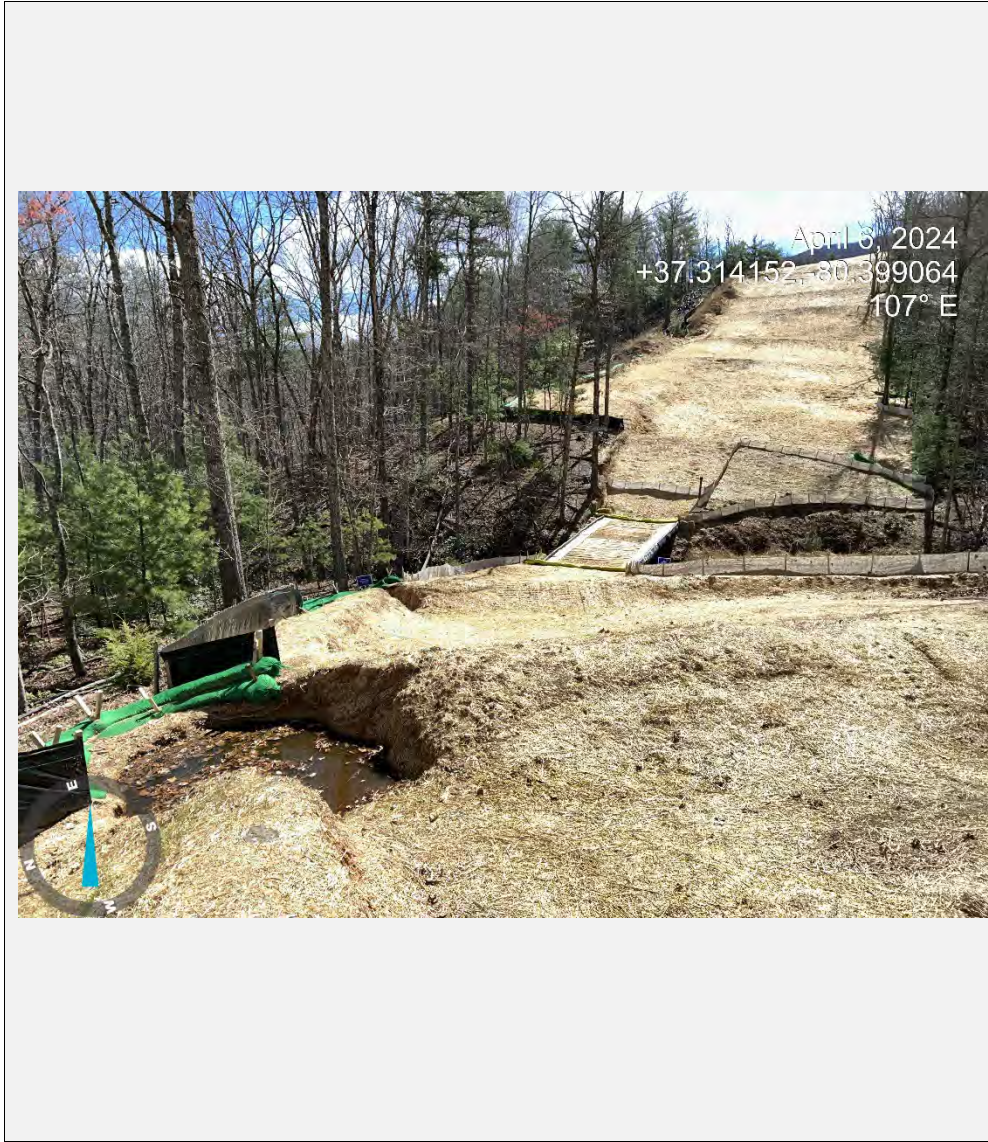
Date: April 6, 2024
Photo: 46
Aspect: East
Milepost: 219.9
Station: 11626+00
Key Items: Aquatic resources, Erosion control
Description: Steep slope above S-HH18 remains stable.

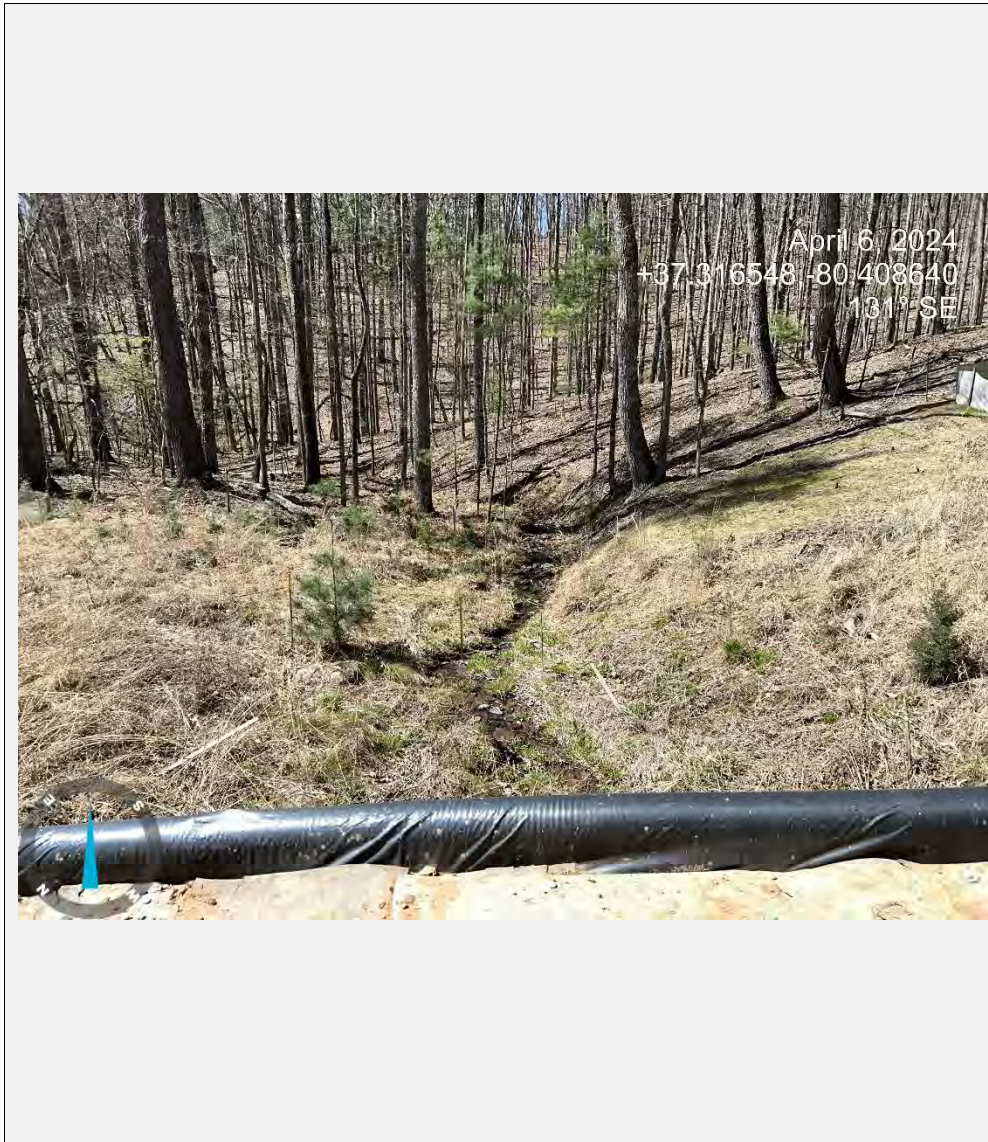
Date: April 6, 2024
	Photo: 47
	Aspect: Southeast
	Milepost: 219.2
	Station: 11588+00
	Key Items: Construction, Aquatic resources, Erosion control
Description: S-PP20 flows clear, ECDs appear to be functioning properly.

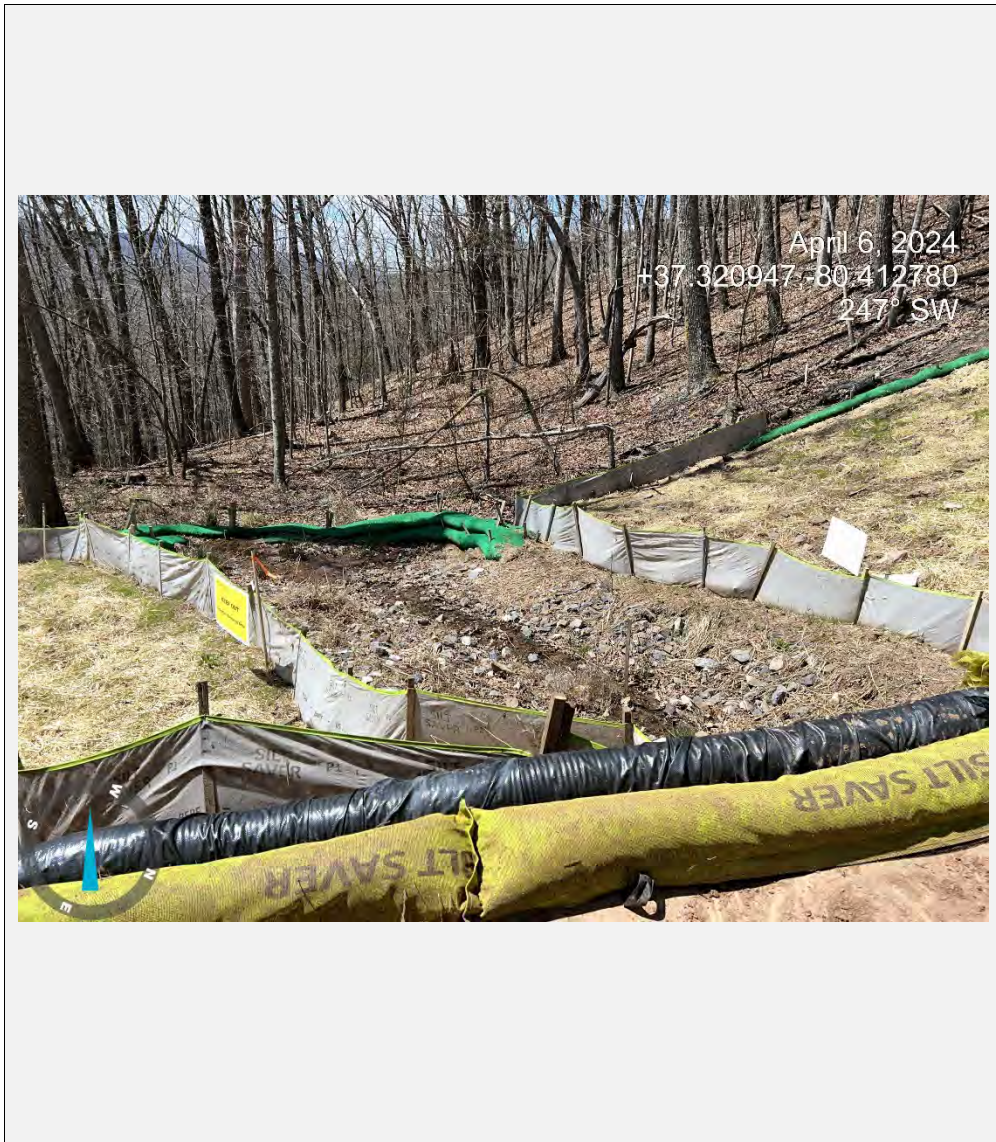
Date: April 6, 2024
Photo: 48
Aspect: Southeast
Milepost: 219.1
Station: 11585+00
Key Items: Construction, Aquatic resources, Erosion control
Description: S-PP21 flows clear, ECDs appear to be functioning properly.

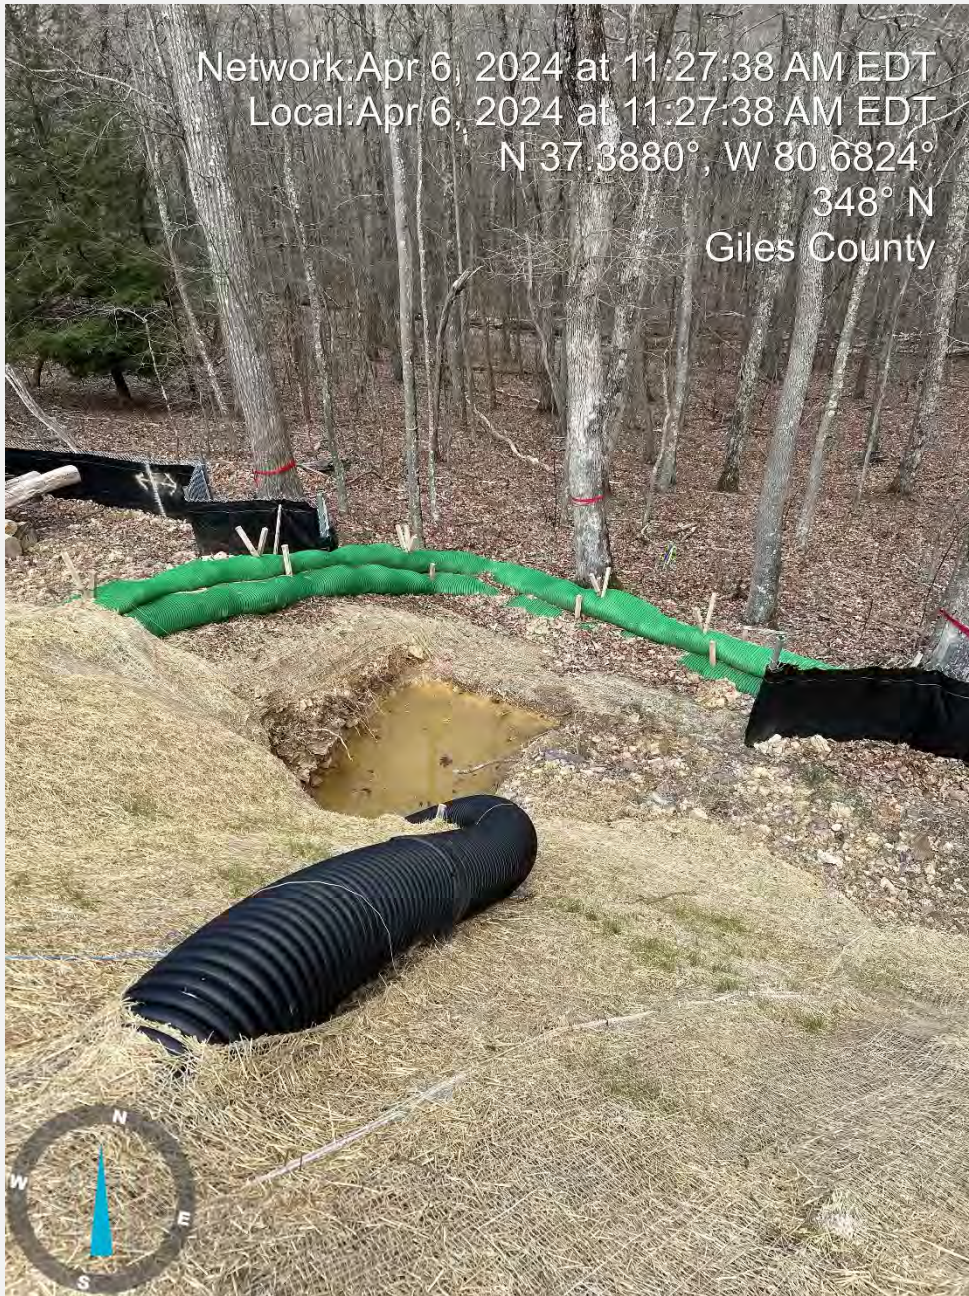
Photo: 49

Description: S-PP22 flows clear, ECDs appear to be functioning properly.

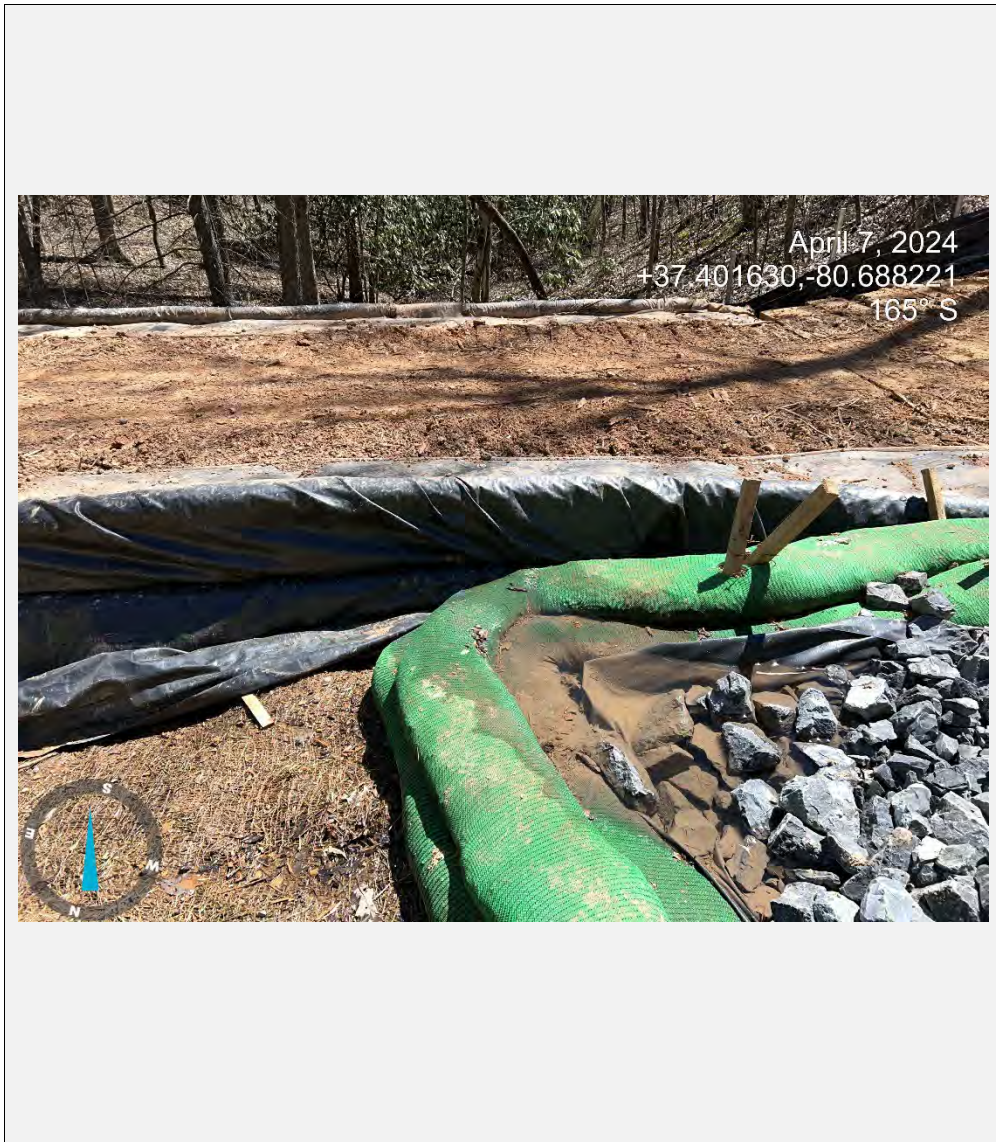
Date: April 6, 2024
Photo: 55
Aspect: sw
Milepost: 196.66
Station:
Key Items: Aquatic resources, Erosion control
Description: Spring water is flowing clear.

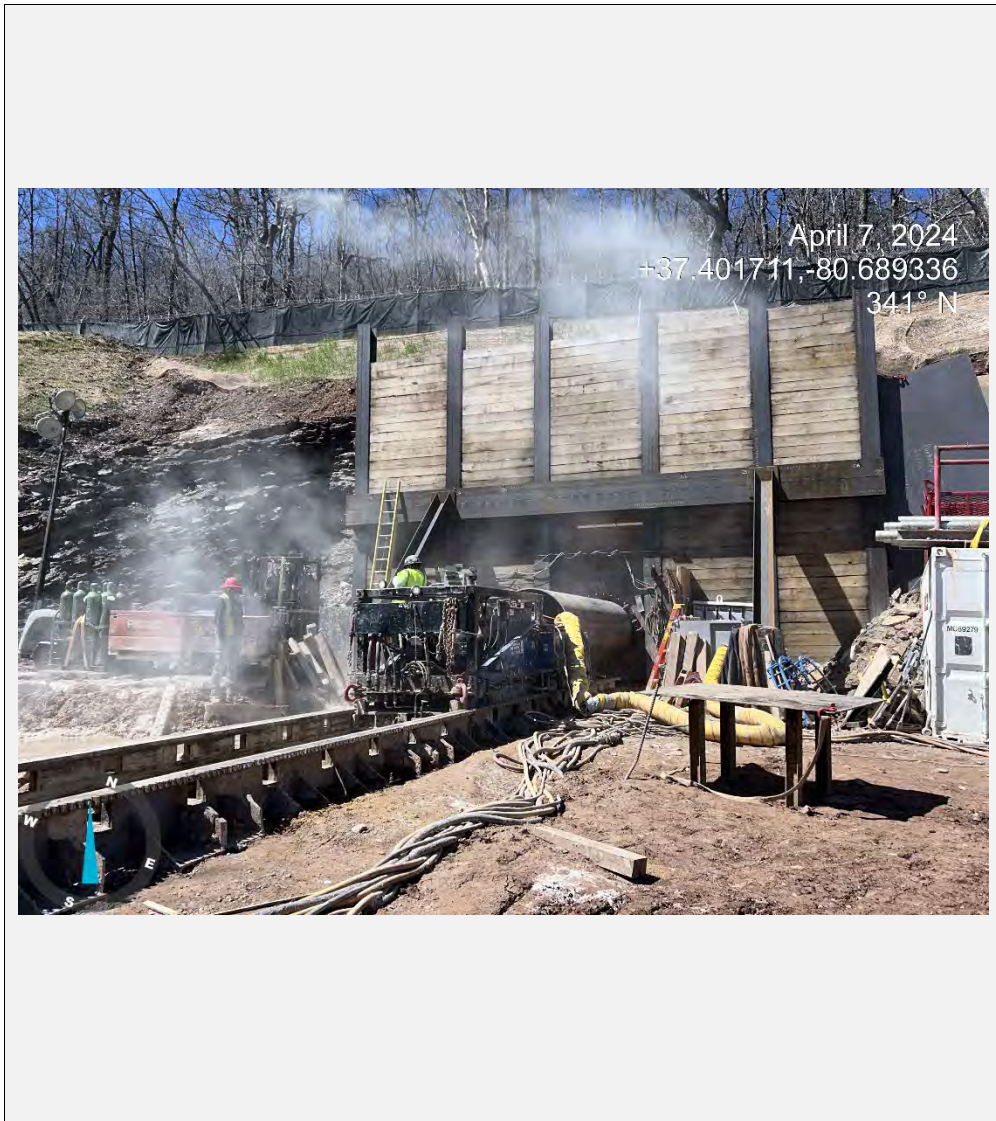
Date: April 7, 2024
Photo: 56
Aspect: South
Milepost: 196.66
Station: 10395+00
Key Items: Aquatic resources, Erosion control
Description: Seep water from cut hillside continues to overwhelm triple stacked filter sock. ECDs are effective.

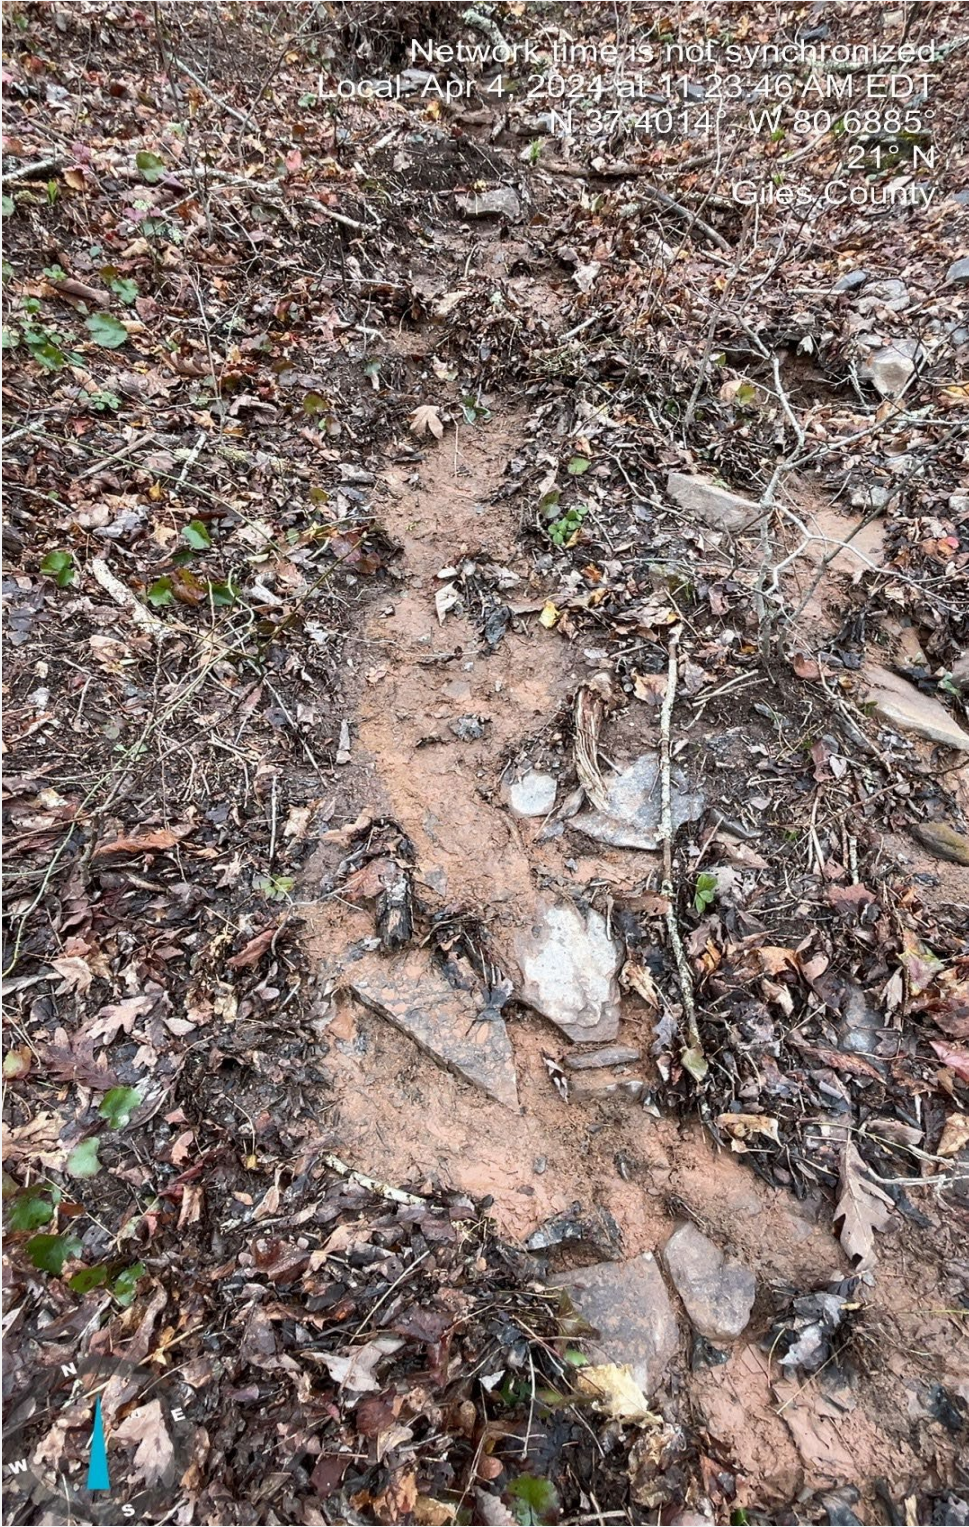
Eocene CIC were contacted by an MVP EI who discovered an area of sediment outside the LOD. CIC personnel arrived at the site and observed sediment outside the LOD at S-KL24 for approximately 110 linear feet (sta. 10386+88 to sta. 10385+78). The flow of water from the ECDs had generally subsided but not stopped entirely. MVP and CIC personnel were appropriately alerted to the issue.

Date: April 4, 2024
Photo: 3
Aspect: N
Milepost: 196.53
Station: 10386+50
Key Items: Aquatic resources, Erosion control
Description: Sediment outside LOD in S-KL24.

The CIC recommends that the JNF require MVP to retrieve the sediment within the affected linear area parallel to LOD stationing 10386+88 to 10385+78 (approximately 100 feet of affected area). Sediment in this section is substantial enough to warrant retrieval.

Retrieval shall be conducted by personnel on foot and using only hand tools outside the LOD. Sediment retrieval shall coordinated with the Eocene CIC so that they can ensure conditions are adequate for retrieval and be present on-site to assess conditions in the field and potentially adjust the area where sediment is to be retrieved.

This is the second occurrence of sedimentation outside the LOD at this location. The CIC recommends that the JNF request a plan for improving the ECDs at this location to reduce the likelihood of reoccurring impact to S-KL24. Adjustment should be made so that the ECDs can sufficiently handle both stormwater flow and flow from the bore site area uphill.

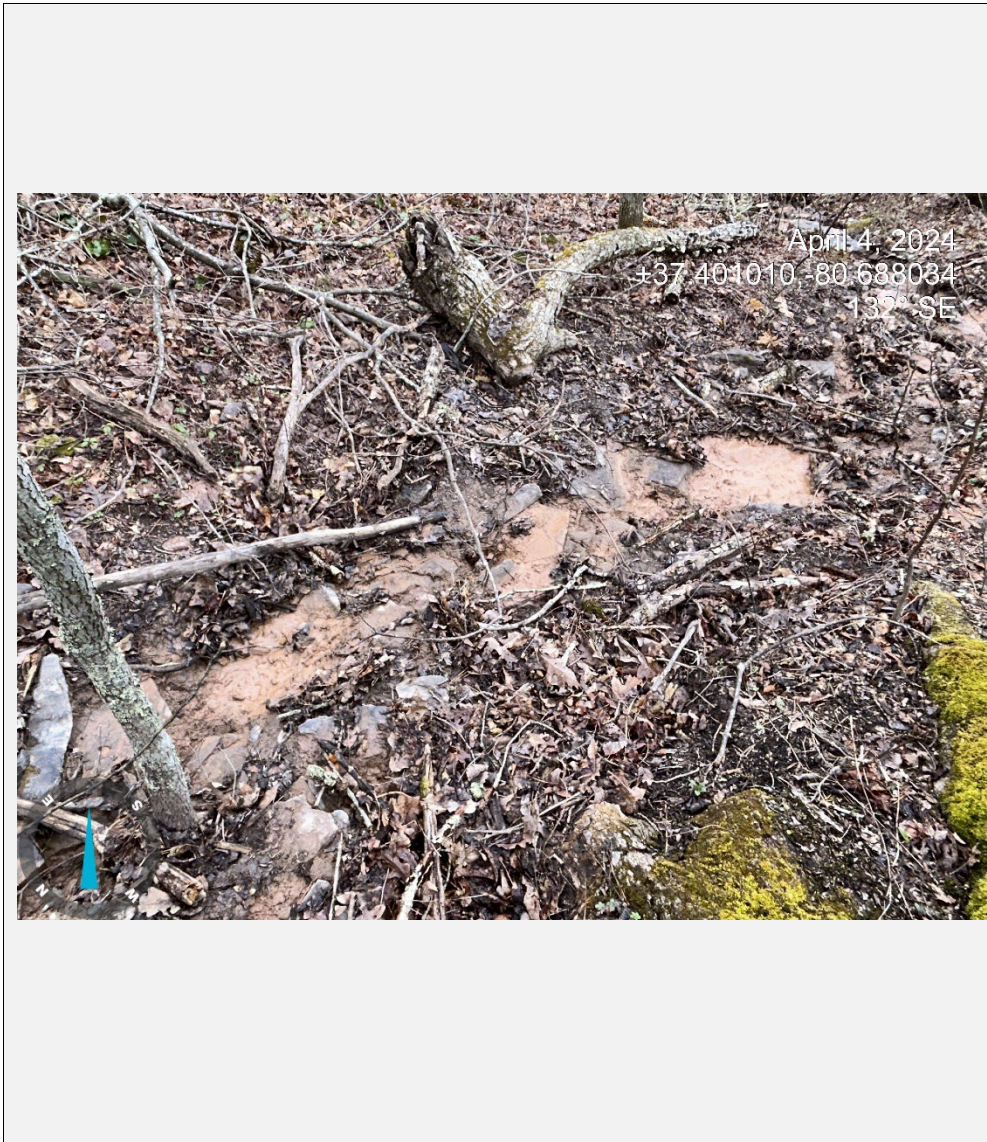
Date: April 4, 2024
Photo: 4
Aspect: NE
Milepost: 196.51
Station: 10386+10
Key Items: Aquatic resources, Erosion control
Description: Sediment outside LOD at S-KL24.

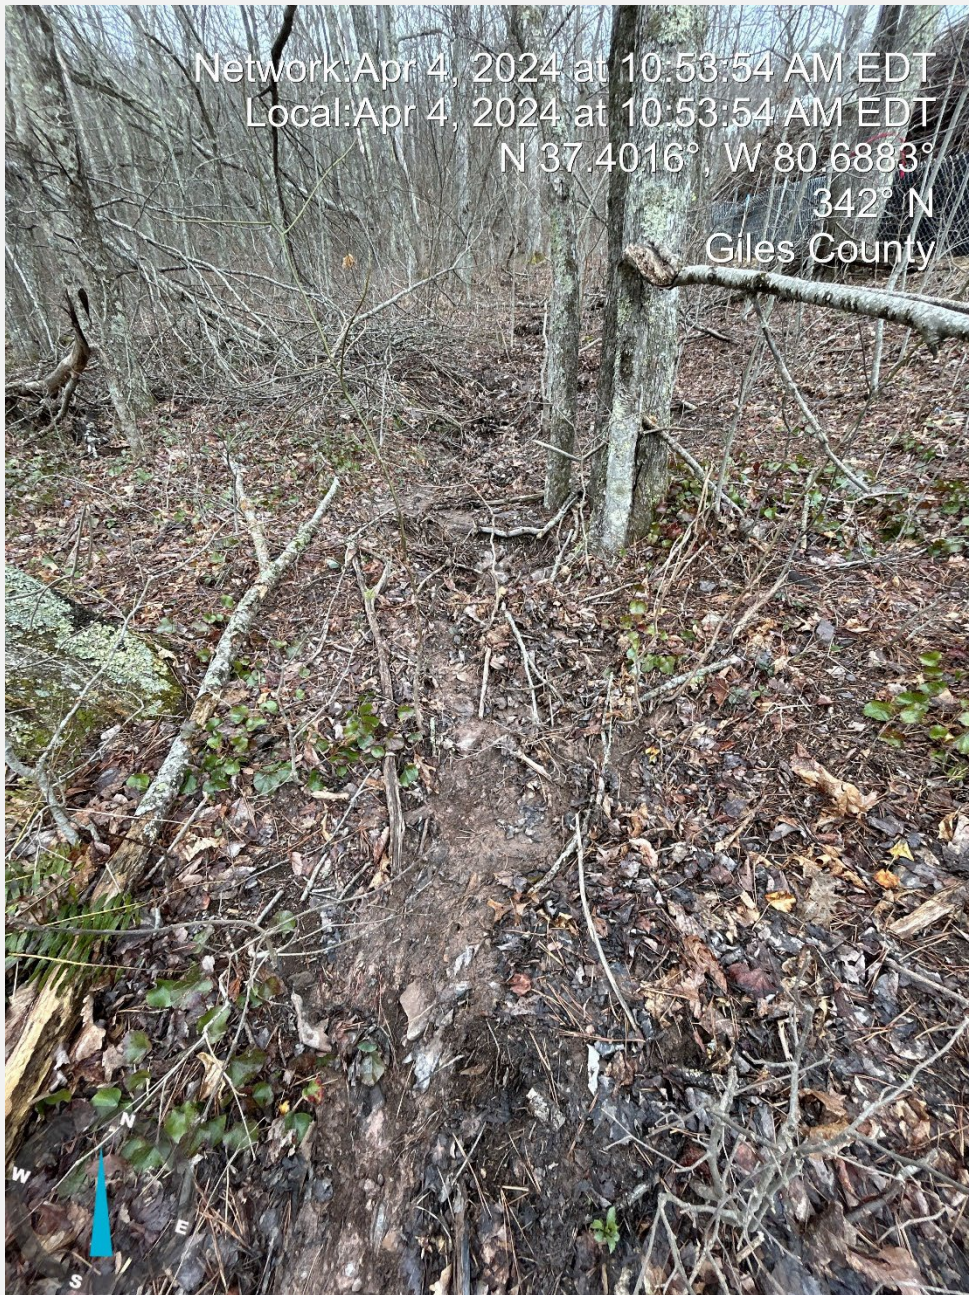
Date: April 4, 2024
Photo: 5
Aspect: Southeast
Milepost: 196.5
Station: 10385+78 to 10386+88
Key Items: Construction, Aquatic resources, Erosion control
Description: Sediment outside LOD at S-KL24.
